# *Manitowoc* COUNTY COURT HOUSE

*Historic Structure Report, August 2004*

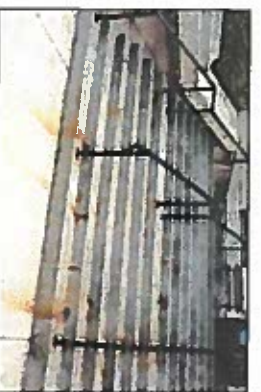
### 3) NORTH, EAST AND SOUTH EXTERIOR STAIRS

*Existing stairs are the third generation of stairway construction. Reconstruction of each stair and repairs to adjacent sand stone walls is recommended to address maintenance, safety and aesthetic needs. Replacement of existing pole lights placed on top of flanking walls is also recommended to achieve an appearance that is historically more consistent with the original design.*

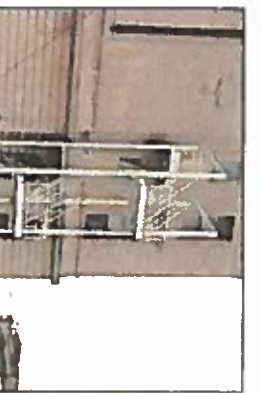
### 5) EXTERIOR FIRE STAIR

*This stair was added in 1975 to provide a State of Wisconsin code-required second exit for the second and third floors. Removal of this stair and construction of a new second interior stairway is recommended to address this need. Completion of this work is considered of equal importance to the successful completion of other select restoration work.*

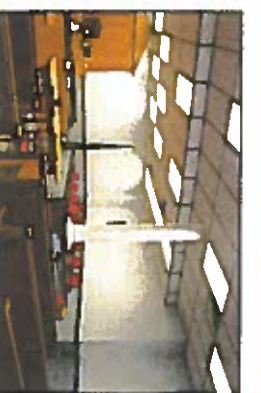
### 6) BRANCH COURT NO. 3

*Significant previous remodeling that is dramatically out of character with that of the remainder of the original design and public functions within the building has been completed. Restoration of this room in a manner that is more sympathetic with the character of Branch Court No. 3 and the rest of the building is recommended.*

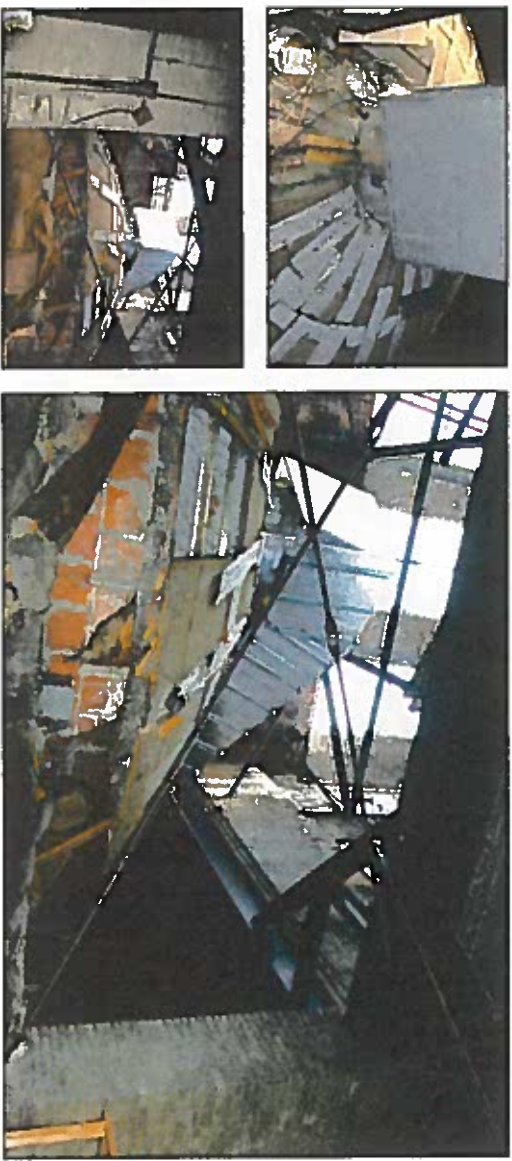
EXISTING INSULATION AND VENTILATING SYSTEM COVERING TOP OF INTERIOR DOME

design and intent of the original interior dome. Removal of the existing rigid insulation system and ventilating ductwork system currently place on top of the dome is recommended. The location of the existing supply and exhaust grill system must be re-evaluated with consideration of integrating required grilles into the vertical wall support located beneath the dome. Integration of new, discrete lighting on top of or beneath the dome, or a combination thereof, is recommended.

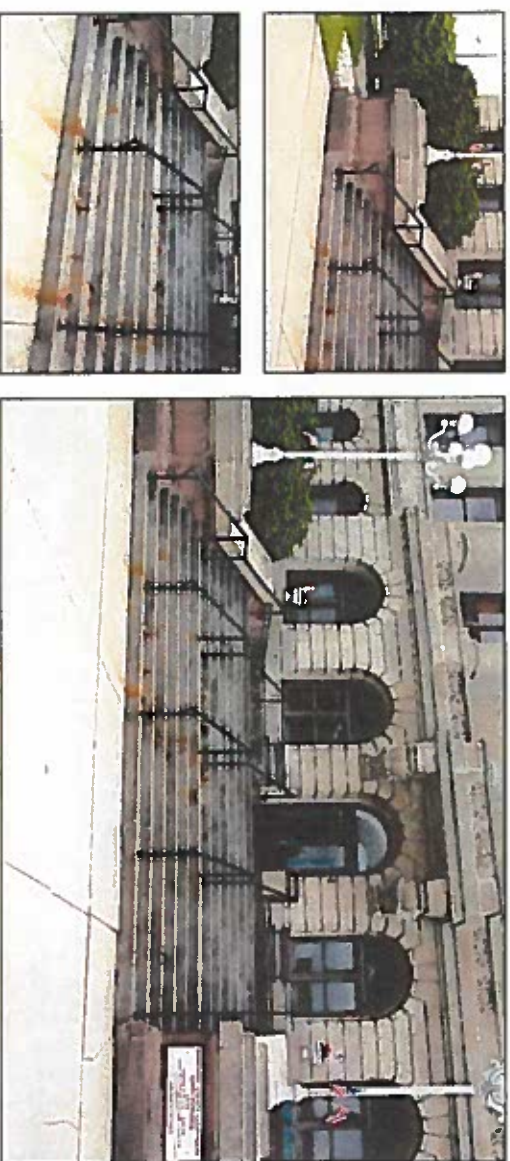
EXISTING DETERIORATING EXTERIOR STAIRS

All three concrete stairways located at the north, east and south have been extensively patched or replaced. The surfaces of the concrete treads and risers are irregular in profile and are not consistent with the appearance of the finishes and materials that were originally constructed. Some research indicates that the original stairs may have been constructed with granite, in lieu of the current concrete. This must be verified through additional research. While cut stone may be initially higher in cost than concrete, a cut stone system will have a longer lifetime as compared to concrete, when properly designed, installed and maintained. In addition, the current handrails do not fit the original historic character of the building. Significant rust stains have been noted on the stair risers in numerous locations. This is caused by moisture penetration into steel reinforcing placed beneath the exposed surfaces of the risers and treads. The south stair, potentially the most heavily used as a connection to the new county jail, also has a gray-colored surface on the treads and risers. Complete replacement of the stairs and handrails is recommended. Replacement with new stairs that more closely harmonize with the historical context of the building is recommended. Additional research to confirm whether or not the original stairs were constructed of cut stone or of concrete must be completed. Lastly, the original light poles that are located on top of the walls that flank the stairs have been replaced with fixtures that were intended to be similar to the original units but are smaller than the original units. This is apparent in the placement of the remaining anchor bolts that are now exposed to view. Selection of new fixtures whose size, design and finish matches the original fixtures will significantly add to the sense of appropriate and sensitive historical restoration.

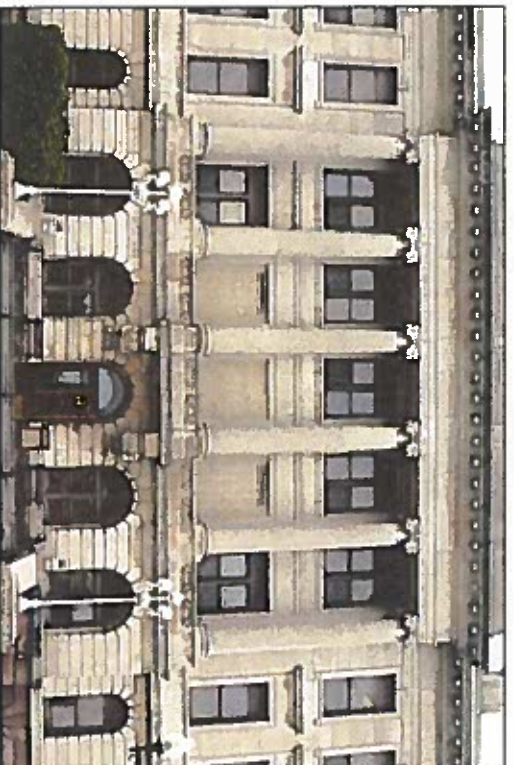
NORTH ELEVATION ~  
ORIGINAL WINDOWS  
REMOVED AND REPLACED  
WITH MASONRY INFILL

- **North Elevation:** At the second floor, original windows were removed and replaced with stack bond, cream-colored face brick to accommodate the functional needs of the court room located behind these panels. Removal and replacement with either functional windows matching the other windows (with corresponding court room remodeling required), or replacement with windows that have opaque, reflective glazing to allow the original window pattern to be restored, is recommended.
- **South Elevation:** Research completed to date concludes that the existing stone infill panels that occur at window openings are not of original construction. They may have been added as part of a court room remodeling. If not original, provide new windows and glazing in a manner similar to the options noted for the north elevation.

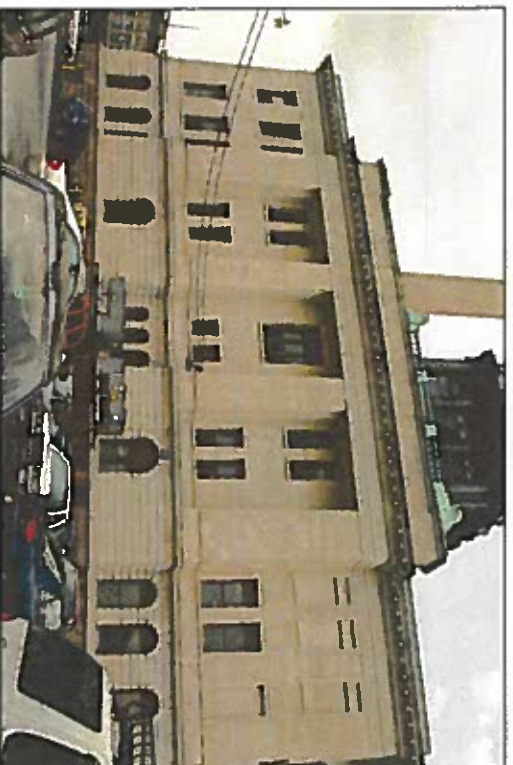
WEST ELEVATION ~  
ORIGINAL WINDOWS  
REMOVED AND REPLACED  
WITH MASONRY INFILL

- **West Elevation:** The pattern of windows at the second floor and at the first floor is not consistent with the rest of the building, with one window at the second floor and two at the first floor missing in the rhythm of windows that occur on the facade. If not part of the original construction, consider provision of new windows in a manner similar to the options noted at the north and south elevations. The original chimney was modified with a vertical extension. Retention of this extension but replacement of the extension materials with masonry work that matches the original chimney construction below is recommended.

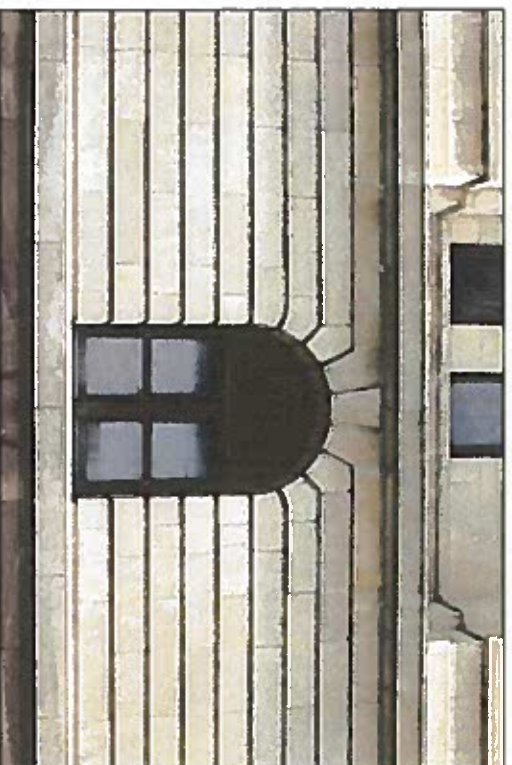
ALL ELEVATIONS ~  
ORIGINAL CLEAR  
ARCHED WINDOWS  
REPLACED WITH OPAQUE  
TRANSOM PANELS

- **All Facades:** Original windows were replaced with new, aluminum-framed, insulated glass units in 1978. While the window size, mullion placement, profile and mullion spacing is similar to that of the original units, opaque, upper transom panels are now typically located in front of interior, suspended acoustical tile ceilings that are at a lower height than the top of the window head. Replacement of the windows with frame profiles and glazing that more closely matches the original units, and required remodeling of the related interior ceilings, is not considered functionally or fiscally prudent at this time. However, replacement of the current non-reflective opaque transom panels with reflective, opaque glazing is recommended. This will more closely simulate a window and will provide an appearance that will be more consistent with the design and construction of the original building.

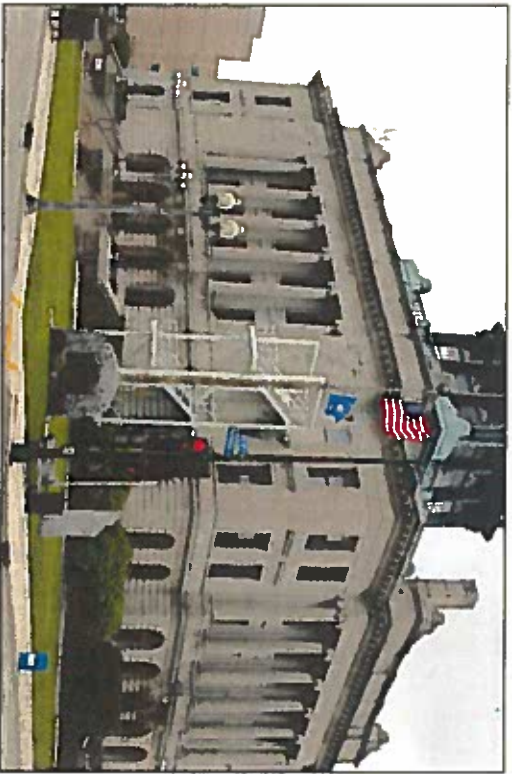
EXTERIOR SECONDARY

FIRE EXIT STAIR  
CONSTRUCTED IN 1975

This existing building function is a key facet in completing the successful, selective restoration of the court house to its original design and appearance. Although visually smaller in scale than the dome, replacement of the stair is in many ways of equal importance to the success of the exterior restoration effort. The existing open, steel structure stair constructed in 1975 is located at the north end of the east facade, and is an obvious and inconsistent change from the original building design. It significantly detracts from the design and civic image of the court house. Assuming that the stair is needed for functional and code conformance purposes, removal of the exterior stair and reconstruction of the stair at a new location within the building is recommended. This will require a careful evaluation of where the stair can be reconstructed internally while minimizing adverse affects on internal space use. Since all Manitowoc County functions are not currently placed within the court house, and future total departmental space needs exceed that additional internal space to accommodate the stair, and moving select functions (or portions thereof) to other locations within the building, or to an off-site location. Completion of this reconstruction is recommended to ensure that the final selected scope of restoration work meets the restoration goals that have been established. An option of locating this stair in a future addition that will connect the court house with the existing county jail has also been discussed conceptually by county representatives.

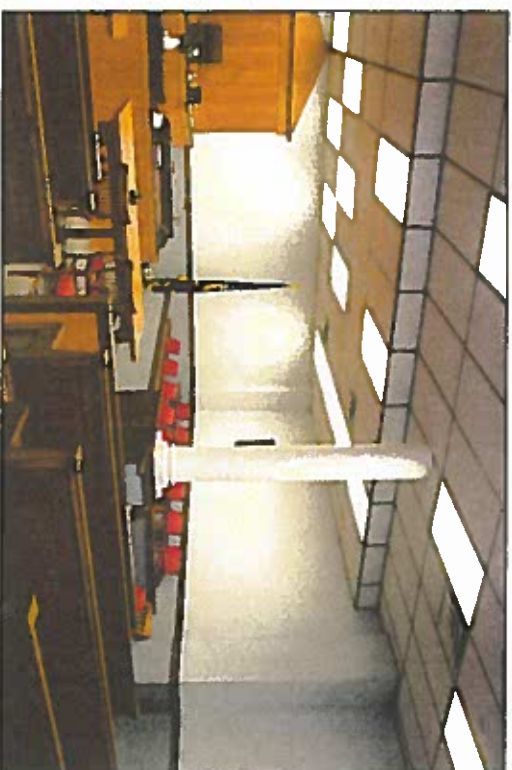
INTERIOR VIEW OF  
BRANCH COURT NO. 3

Extensive previous remodeling of this room exhibits a dramatic and inconsistent fit with the original building design. We recommend that the room be completely remodeled. Replacement of wall finishes, flooring, suspended ceiling, lighting, millwork and wood trim detailing with new construction and finishes that more closely match that of the original building is recommended. The design details of Circuit Court No. 2 may serve as a foundation for the implementation of functional and aesthetic solutions in this room.
