## County Dome and Facility Improvements Study

Prepared for:  
Manitowoc County Department of Public Works  
Manitowoc, Wisconsin

Strang Project #2022011

June 30, 2022

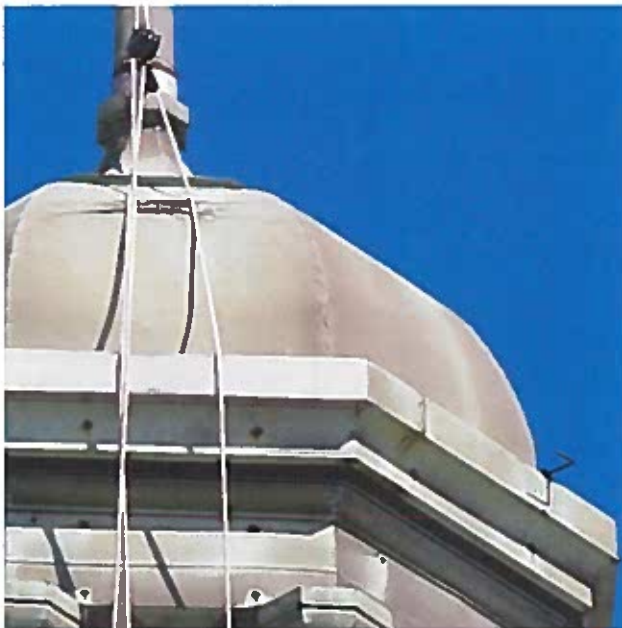
Halyards rubbing on dome and pulled taught to edge of cornice.

- The replacement rigging system is incomplete, resulting in damage to the building as the halyards rub against the copper dome and the stainless steel brake metal panel installed over the cornice. This type of system typically requires a horizontal boom or standoff at the base of the dome to always hold the halyards off the building.

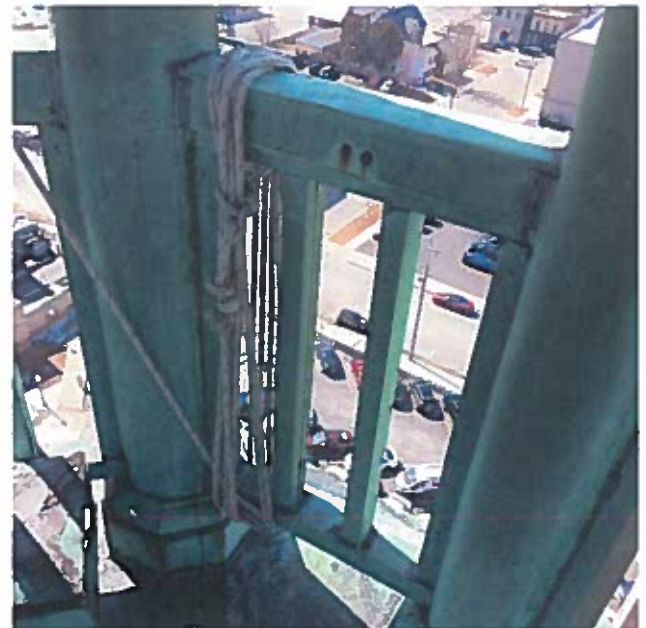
Halyards tied around guardrail. Note rusted anchors for missing cleat on rail.

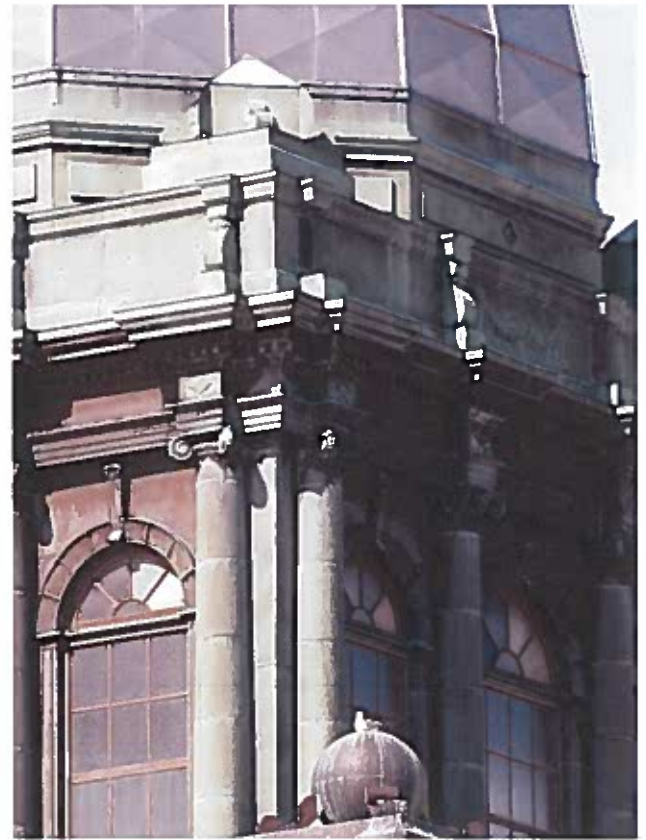
May, 2022: Extensive missing ornament and the simplified window frames of the 1950s repairs.

- The copper cladding and is at the end of its serviceable life and requires complete replacement.
- The observation and assessments made in the previous condition reviews of the copper cladding were readily confirmed in this review of existing conditions. These include:

- Lack of continuous backing for skyward surfaces resulting in deformation, cracks and tears, open joints.
  - Missing anchorage caps, corrosion of and staining from exposed ferrous anchors.

- Worn and failed solder joints
  - Worn and failed copper cladding.
- Water infiltration through the failing cladding has impacted various structural elements, armatures, and fasteners. Unfortunately, many of the most vulnerable areas and surfaces are hidden from view by construction and cannot be assessed unless opened or the element fails in a manner that exposes the damage.

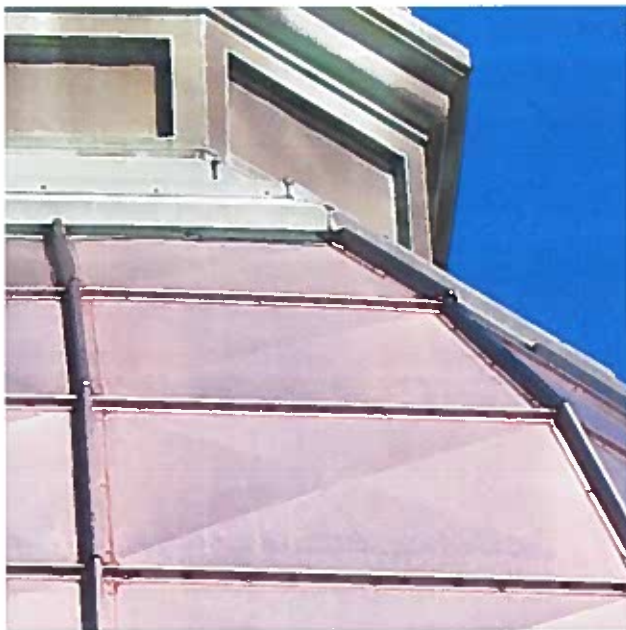
Stainless steel panels and ribs of the 1950s repairs.

- The stainless steel, although somewhat soiled and stained, appears in good condition.
- The effectiveness of the shingling of the stainless steel panels as executed is questionable given damage seen to the dome armatures and interior framing.
- The partial open tops of the vertical ribs are introducing a limited but regular amount of runoff into the ribbing from the copper lantern skirt just above. Depending on the amount of shingled overlap and its ability to fully cover the armature and structure below, this condition is likely leading to some corrosion of the armature and dome structure. Given this runoff washes across the copper lantern skirt, additional corrosion from galvanic action is possible.

- The light but noticeable staining on the panels appears to emanate from the weepholes at the underside of the horizontal ribs covers. Presumably the particulate collecting at the upper side of the horizontal joint covers eventually overflows the cover or works its way through the skyward joint and weeps out at the underside of the cover.

- If the intent is to maintain the current stainless steel cladding, it should be further reviewed and observed from inside during heavy rain to confirm weaknesses in the design and then modified to eliminate these shortcomings to the greatest extent possible.

- The current cladding is not historic or sympathetic to the character of the original design. Since the stainless steel cladding would need to be at least temporarily removed to address final assessment, repair, and priming and painting of the dome structure and support armature, it is well work while to review the cost of reglazing the dome or at least replacing the stainless steel with copper panels and copper ribs designed to replicate the original copper ribs.

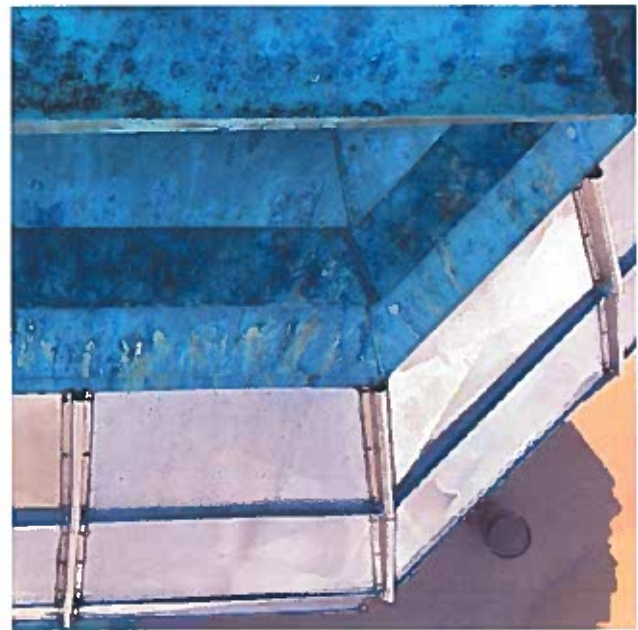
Note the open tops of the stainless steel ribs.

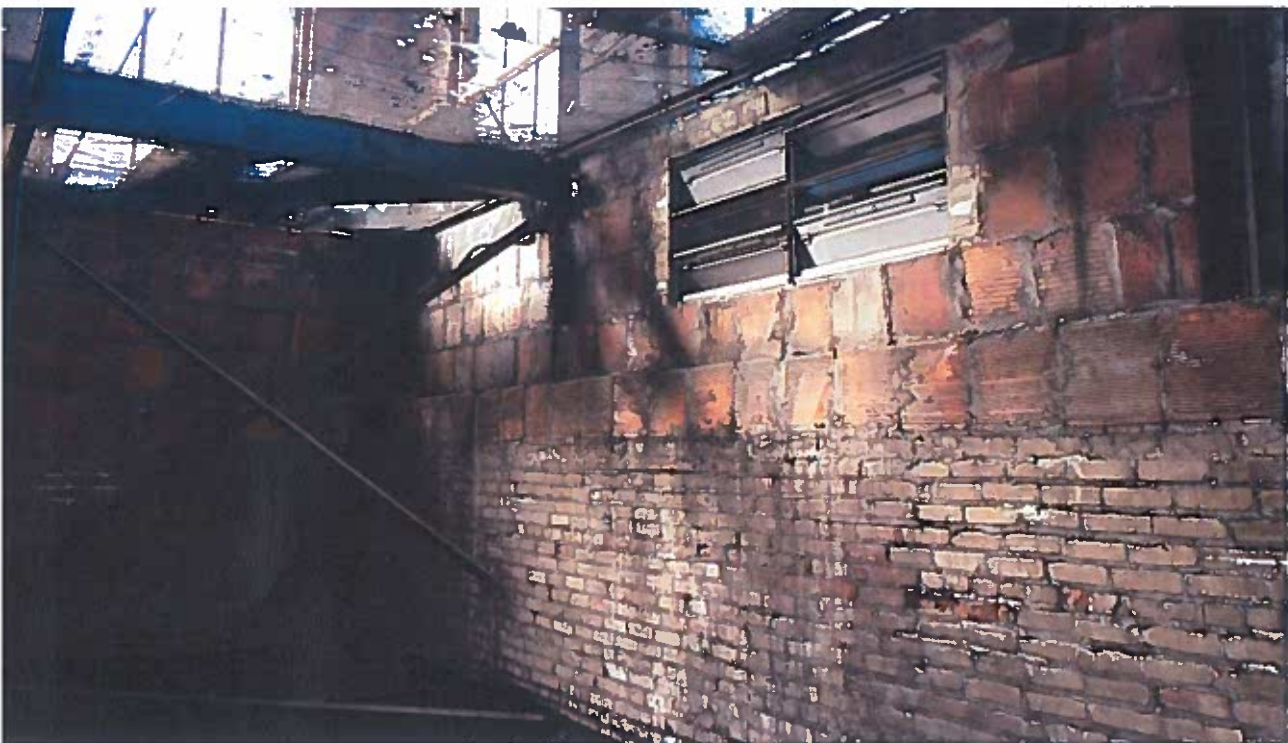
View of the clerestory just below the debris screen. Limited efflorescence and spalling brick indicate a minimum amount of water infiltration of the past 100 years. Note barometric pressure louver below center window.

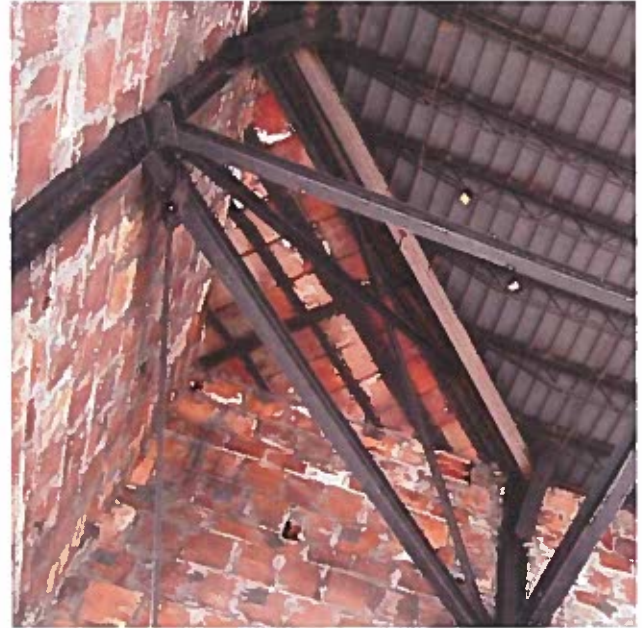
There is extensive water staining and efflorescence on the clay tile along the ceiling in the corners and adjacent to the columns. Several spalled structural clay tiles, some with mortar repairs, were observed. Some tile between the closely spaced columns and windows appear loose. At the lower portion of the walls, the structural clay tile infill shows only limited staining and efflorescence. No cracks in the units or mortar joints were observed at these locations. Numerous thru wall anchors attached to sheet metal anchor plates are from previous repairs to the exterior cladding.

Water staining and efflorescence on structural clay tile walls and corner ceiling.

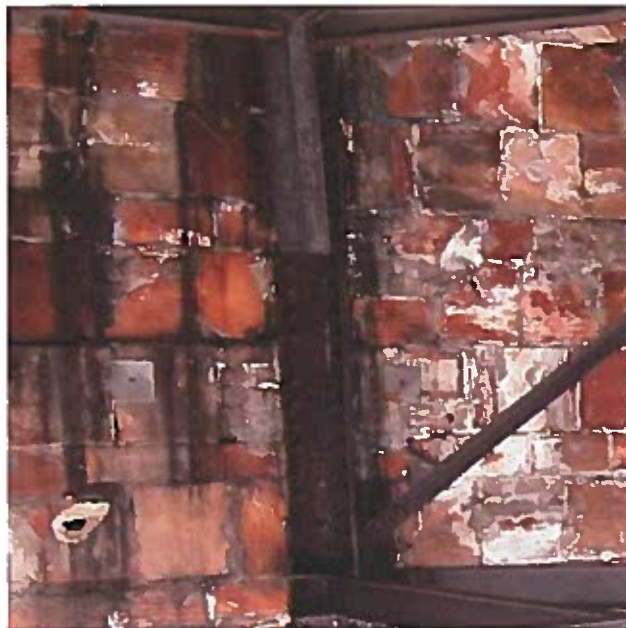
Extensive water staining and efflorescence of structural clay tile. Note heavy corrosion of steel column supporting dome truss

- The visible heavy steel corrosion at the top of the clerestory points to long term water infiltration. The condition of the embedded steel is unknown and can only be assessed by a closeup inspection and ultimately removal of the clay tile covering. There is concern about the unknown condition of the steel embedded within the structural clay tile infill and its impact on the structural framing's overall capacity. The conditions should be observed during prolonged rain events to determine if water infiltration is actively occurring, allowing the deterioration of the steel and masonry to continue and intensify. If infiltration is occurring, action should be taken sooner rather than later as structural stability issues will inevitably result.

- The visible steel structure within in the clerestory along with the ship ladder to the dome and the remaining portion of the original access ladder require repainting to protect them from corrosion. The existing coating is inadequate and has surpassed its useful life and may also contain lead.

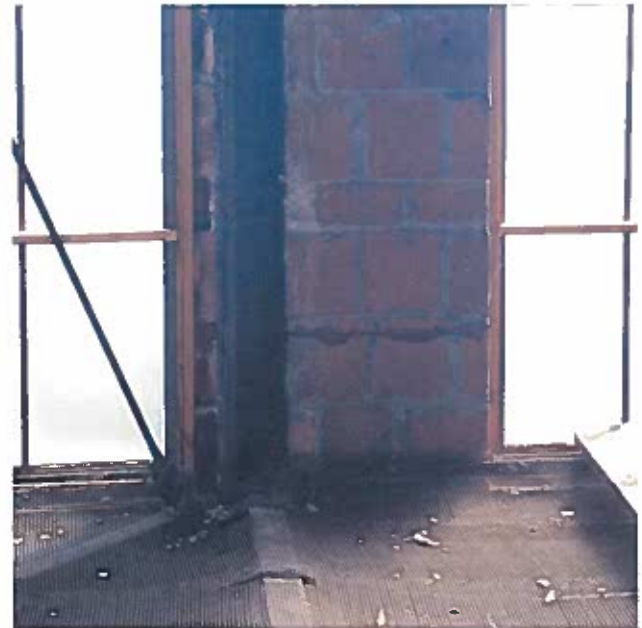
Broken infill tile between window and steel column.

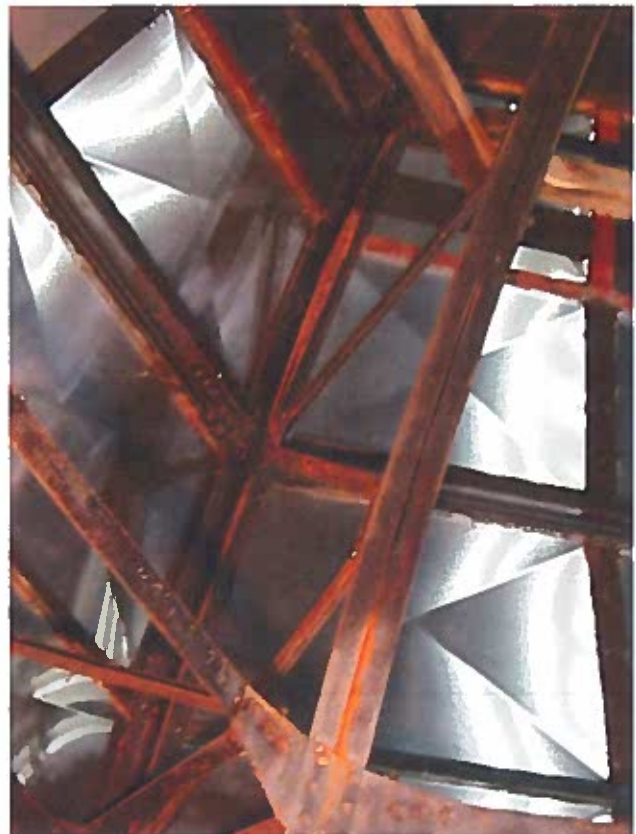
The coating on the visible structural steel of the dome and lantern is thin and heavily compromised. Mild surface corrosion can be seen on most surfaces. Of greater concern are the concentrated areas of intense corrosion located about three quarters of the way up on all the trusses. Two of the eight trusses have extensive delamination of the steel angle top chords while the other six exhibit minimal to heavy surface corrosion. Corrosion on the various elements of the trusses continues downstream of these locations. The condition of the lantern framing is hidden within the lantern construction and could not be observed.

Past leaks have not only corroded the trusses but have also begun to push apart the members.

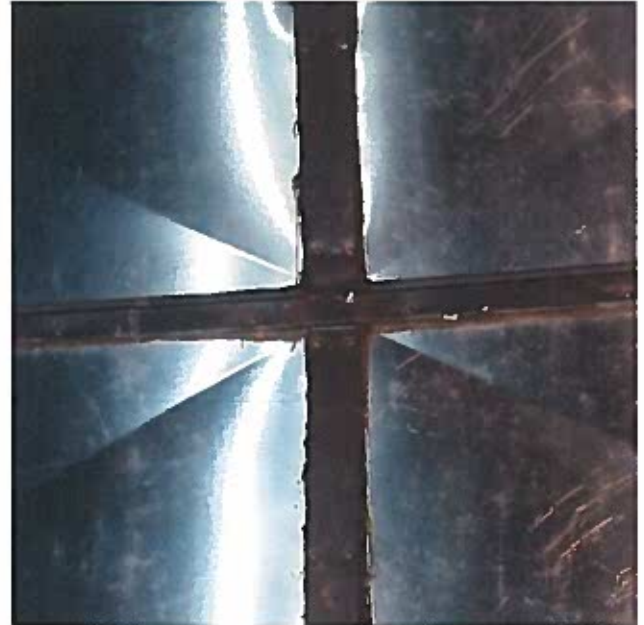
While it is unknown how the glass was secured, the stainless steel panels were field drilled and thru-bolted.

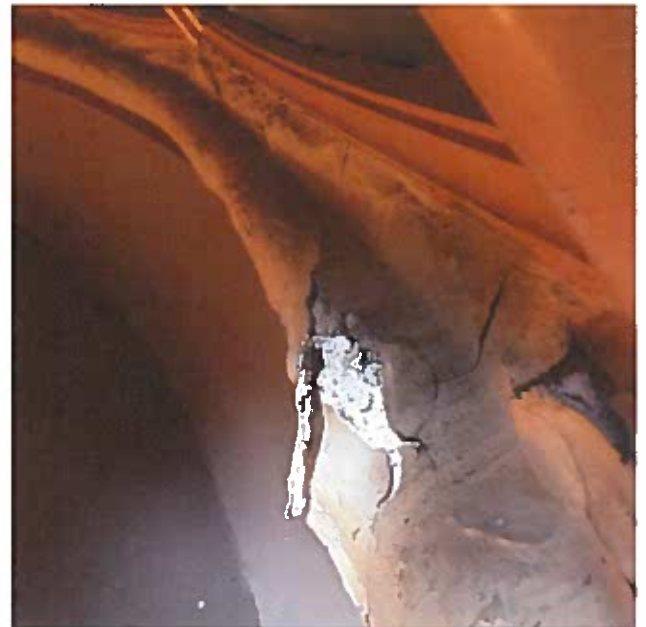
- c. Water infiltration from the tower has damaged the plasterwork just under the dome and requires repair.
3. Courthouse Exterior Windows Replacement:

Moisture related damage to plaster at base of dome.

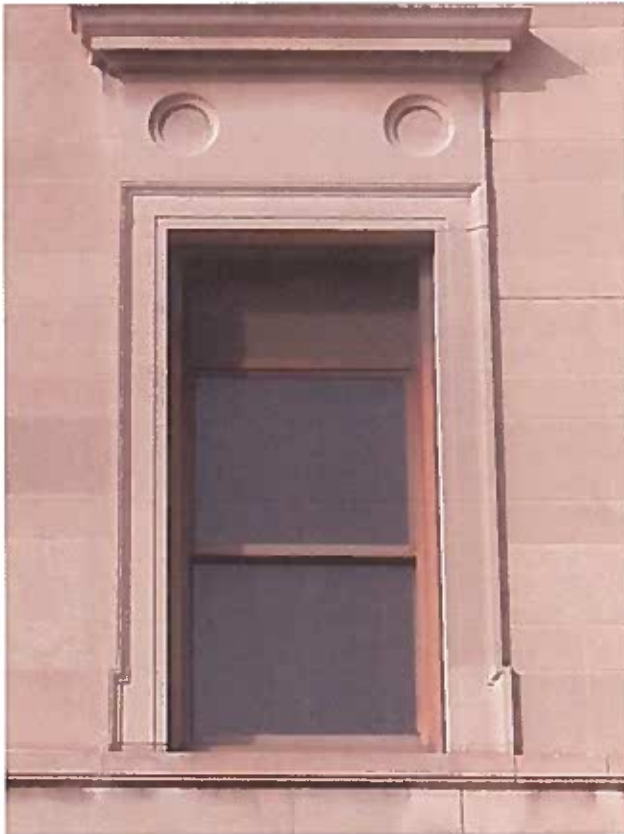
- a. Originally replaced in 1978, the windows have begun to experience maintenance issues, particularly the failing of the integral blinds.
  - b. The dark bronze anodizing has faded to gold in areas that are continually exposed to the sun, resulting in a noticeable uneven appearance.

Typical aluminum exterior window, note fading of dark bronze anodizing. Reduced sash size allows for the insertion of an opaque spandrel panel.

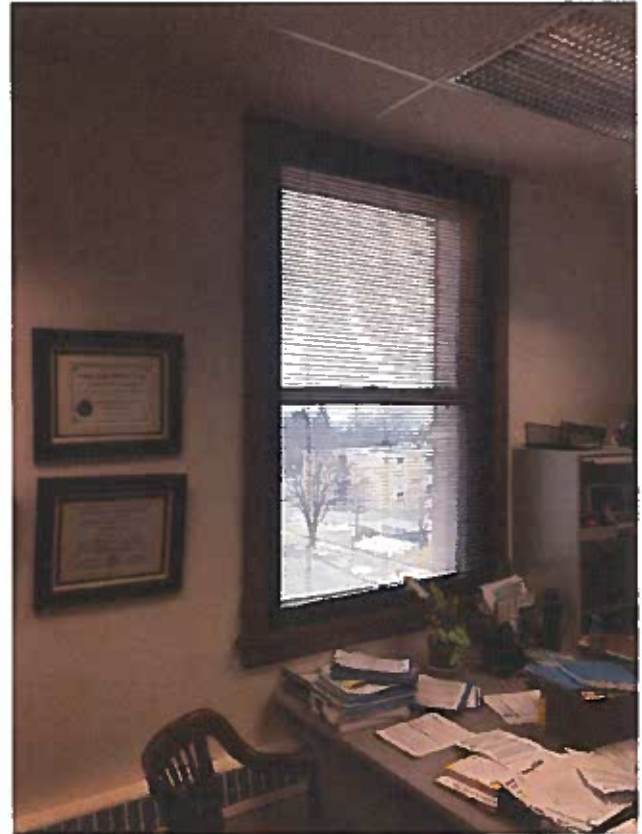
Typical window at interior. Note how dropped ceiling cuts off top of window. The spandrel panel is above the ceiling line.
