COUNTY OF MANITOWOC
COURTHOUSE DOME
CONDITION ASSESSMENT REPORT

January 30, 2008

Engberg Anderson

BLOOM
CONSULTANTS, LLC
Engineers Planners Architects

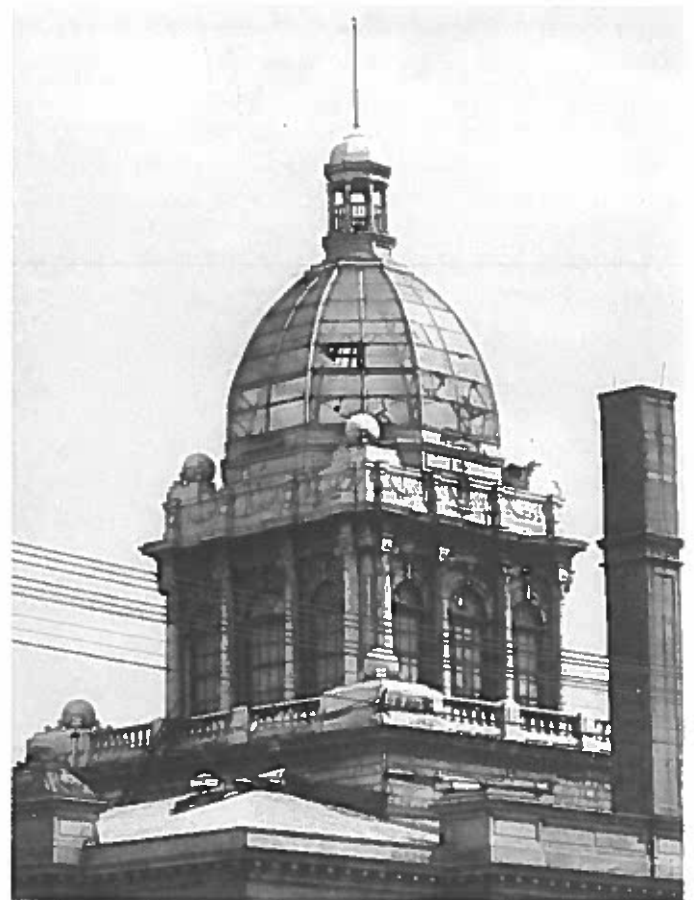
The extent of the damage was documented in an historic photo. (figure 2) Close examination of this photo also provides evidence of previous attempted glass repairs. As the production of prismatic glass ceased in the 1930s, simple replacement was not an option.¹ In response to the damage, a full repair and remodeling of the central tower was undertaken. The existing copper balustrade and cupola were repaired while the rest of the tower was re-clad. As part of the project, the glass lites and copper weather caps of the dome were removed and replaced with stainless steel panels and weather caps. Additional work undertaken at

Figure 2 The 1950 storm damage.

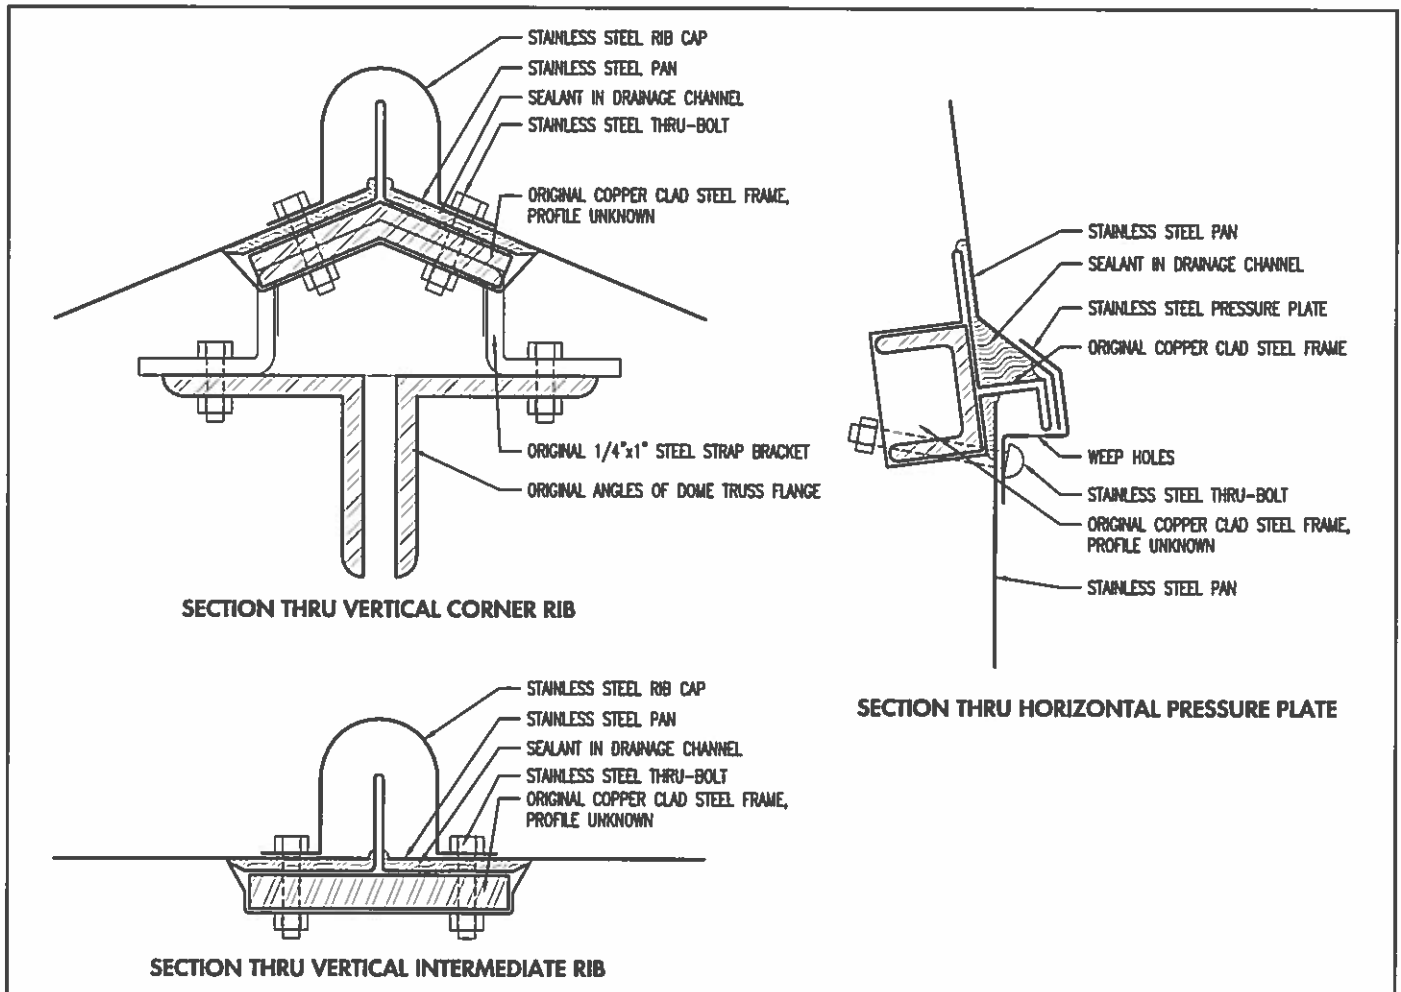
Figure 6 Detail of existing cladding conditions.

the curved outer edge of the dome by a series of ¼" thick by 1" wide metal straps that are bolted back to the trusses. The copper flashing is wrapped around these members in a manner to create a central rib and a shallow drainage trough to either side of the rib. (figure 6) The horizontal members are directly bolted into the dome trusses. The copper flashing is formed in an 'h' profile, permitting the bottom of the panel above to rest on top without trapping water while the top edge of the panel below nests into a receiver pocket, shedding water from above over the glass and not behind it. (figure 6)

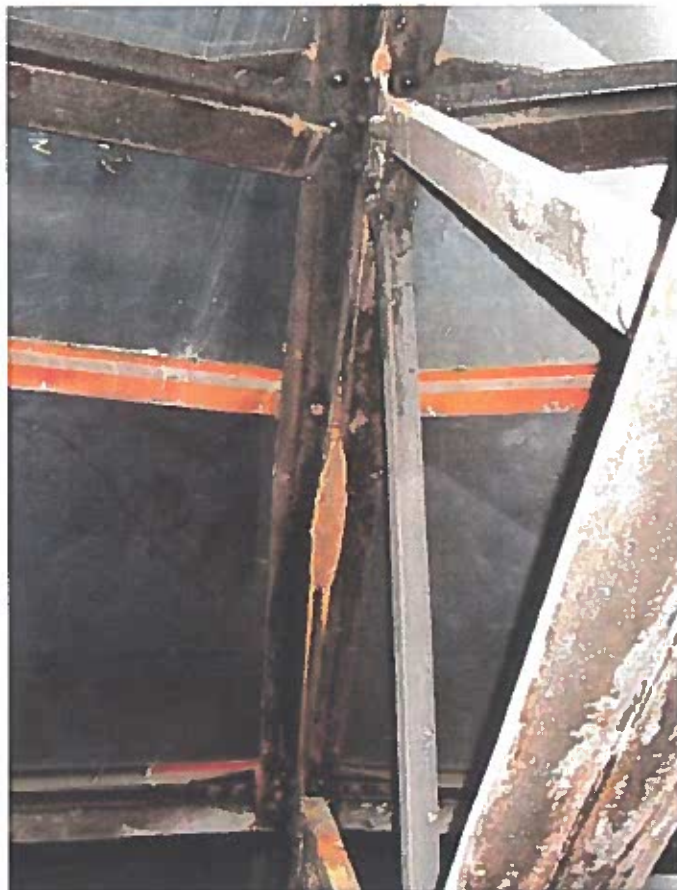
Figure 7 Rust jacking at upper truss.

Our assessment is based on a visual inspection the dome structure made in November 2007. The major structural framing elements, arch-trusses and compression ring, are generally in very good condition with limited deterioration. Observed deterioration was limited to the top chord of each of the arch trusses at the location one purlin line approximately 2/3 the height of the dome. There was significant rusting and subsequent rust jacking at the double angle top chord members of the arch truss at the purlin framing connection. The structural deterioration in this area should be readily repairable by welding or bolting plate new structural sections to reinforce the damaged area. The remainder of the areas showed no indication of structural deterioration.

The purlin row at the deteriorated connections will need to be replaced. The remainder of the purlins are in good condition and can remain. Secondary framing members supported by the purlins will be replaced with the new glazing system. The major structural framing system should be adequate for support of a new non-insulated laminated glazing system without reinforcement. If a heavier insulated glazing system were to be utilized, a detailed structural analysis and reinforcing will likely be required to determine the structural carrying capacity of the framing system.

The existing superstructure and purling system will require cleaning, media blasting and inspection prior to coating with a new high performance protective coating system.

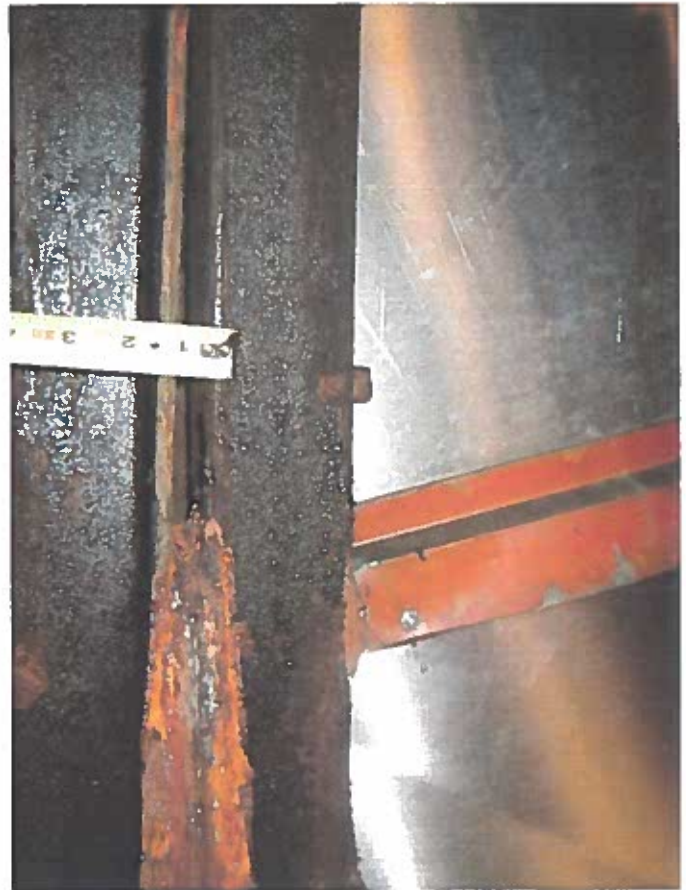
As the copper clad horizontal framing members are in direct contact with the steel dome trusses, most locations were found to have some limited galvanic action induced corrosion in form of scale. Significant corrosion was observed at the horizontal connection points at base of the top row of panels on the west, southwest, and south faces of the dome. (figures 7 & 8) These elevations face the prevailing southwest wind and will require repair of the structural members as noted in the structural assessment.

Figure 8 Close-up of rust jacking.

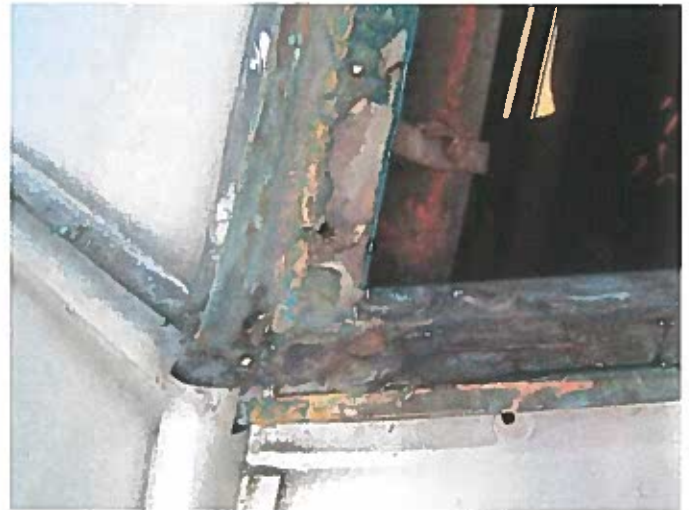
The stainless steel panels are flat panels cut to set into each framed opening. The bottom lip of the panel is formed to lap up and over the 'H' profile below. In order to create a watertight condition, the panels were set into sealant that generally completely filled the drainage troughs of the verticals and the beds of the horizontals. The sealant has become quite brittle, and numerous cracks and gaps were observed. Discoloration and corrosion patterns indicate that the sealant is no longer viable and is likely to continue to degrade through cyclical freeze thaw cycles. (figure 9)

Figure 9 Note brittle sealant around framed opening.

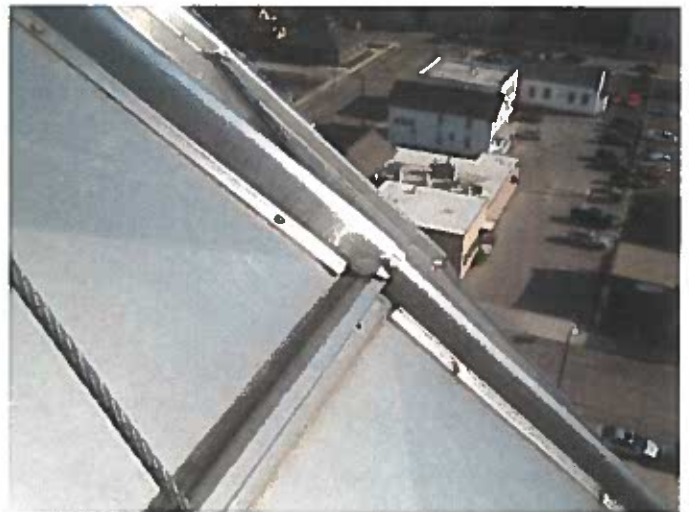
The stainless steel panels are held in place by a series of ornamental inverted 'U' shaped ribs at the corners and intermediate verticals, and 'Z' pressure plates at the horizontal edges. (figure 10) Both ribs and pressure plates are "through-bolted" to the framing with stainless steel bolts at 16" on center. Given the varying cross sectional location of these bolts, it is believed that these holes were field drilled at the time of the stainless steel installation and not part of the original installation. In addition, their general location would require the original glass to have been drilled to accommodate them.

Figure 10 Horizontal and vertical weather caps.

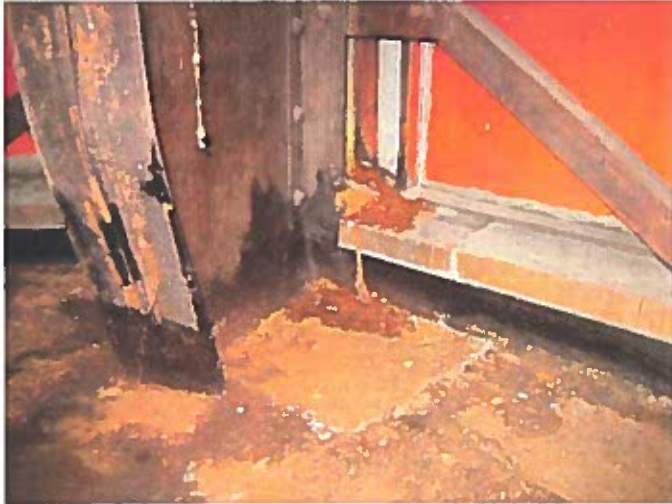
During the dome condition assessment, small mounds of rust and pieces of sheet metal were observed on the interior flat roof behind each of the trusses. (figure 11) Further investigation revealed that the galvanized sheet metal armature for securing the drum's copper cladding back to the steel structure has corroded in many locations to the point that it either no longer securely connects the cladding to the structure. In some locations, it has completely corroded away providing no support. These armatures must be replaced with a more durable material not susceptible to electrolytic interaction with the copper.

Figure 11 Rust piling up behind bottom of truss.
