# Lantern Photos

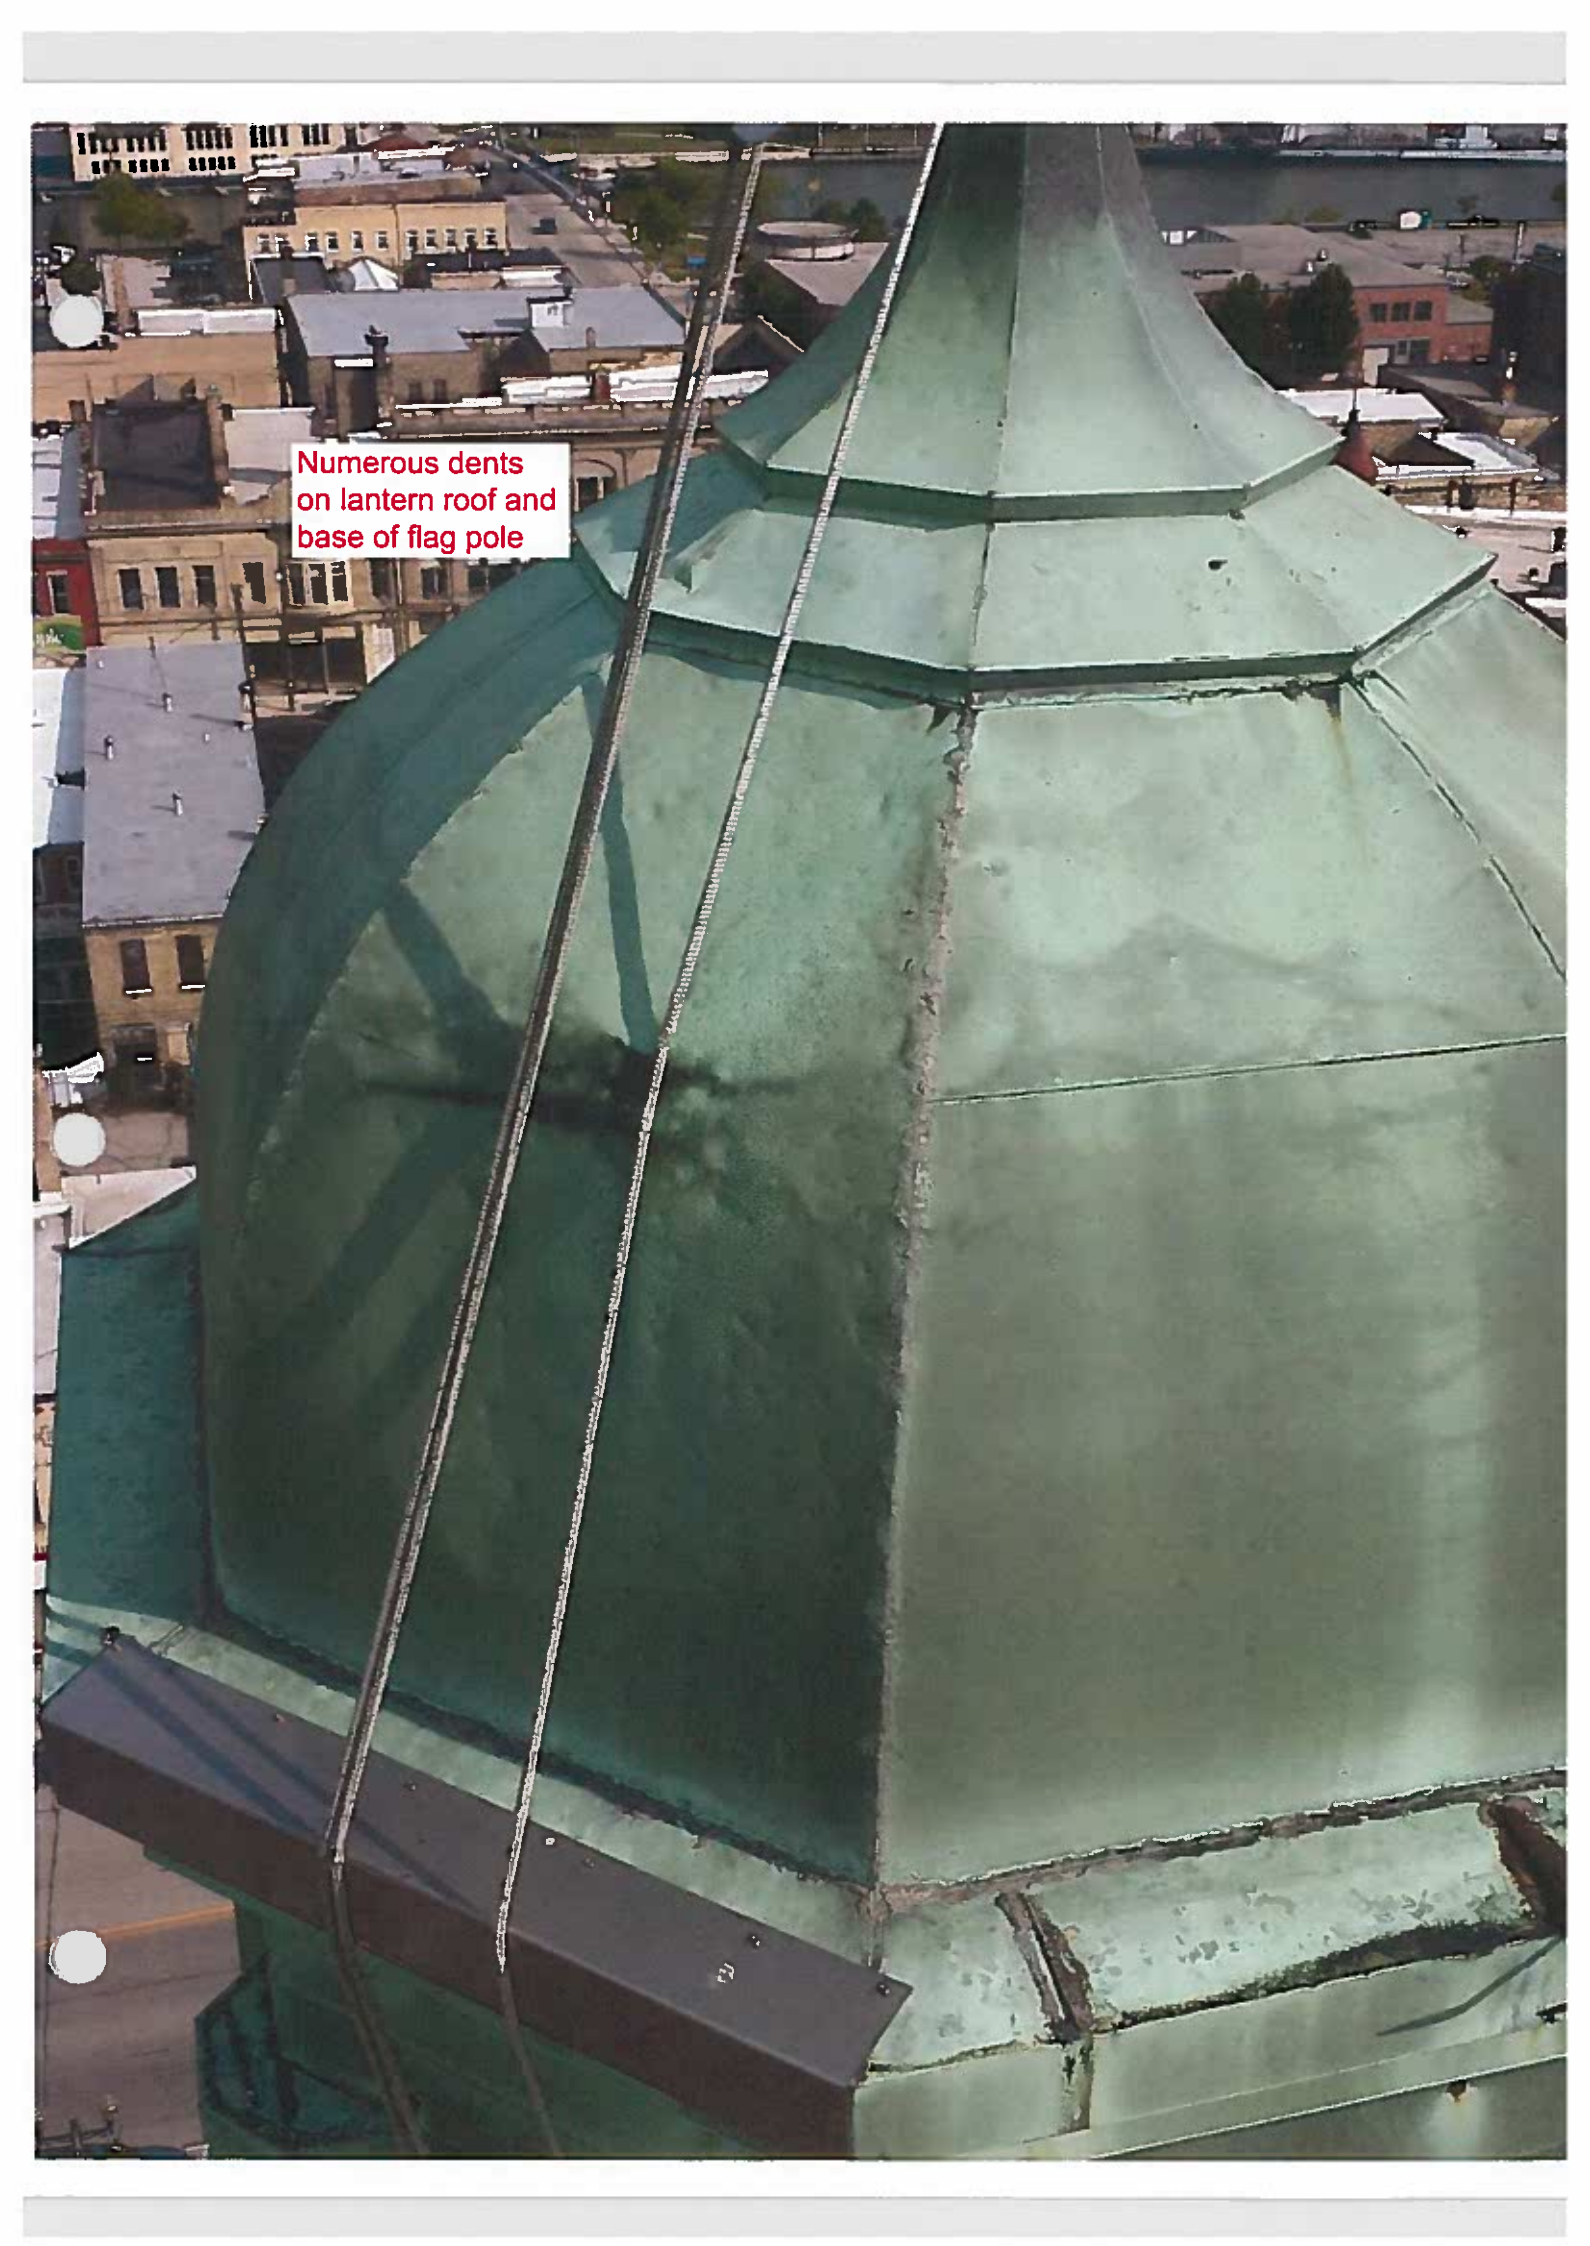
Numerous dents  
on lantern roof and  
base of flag pole

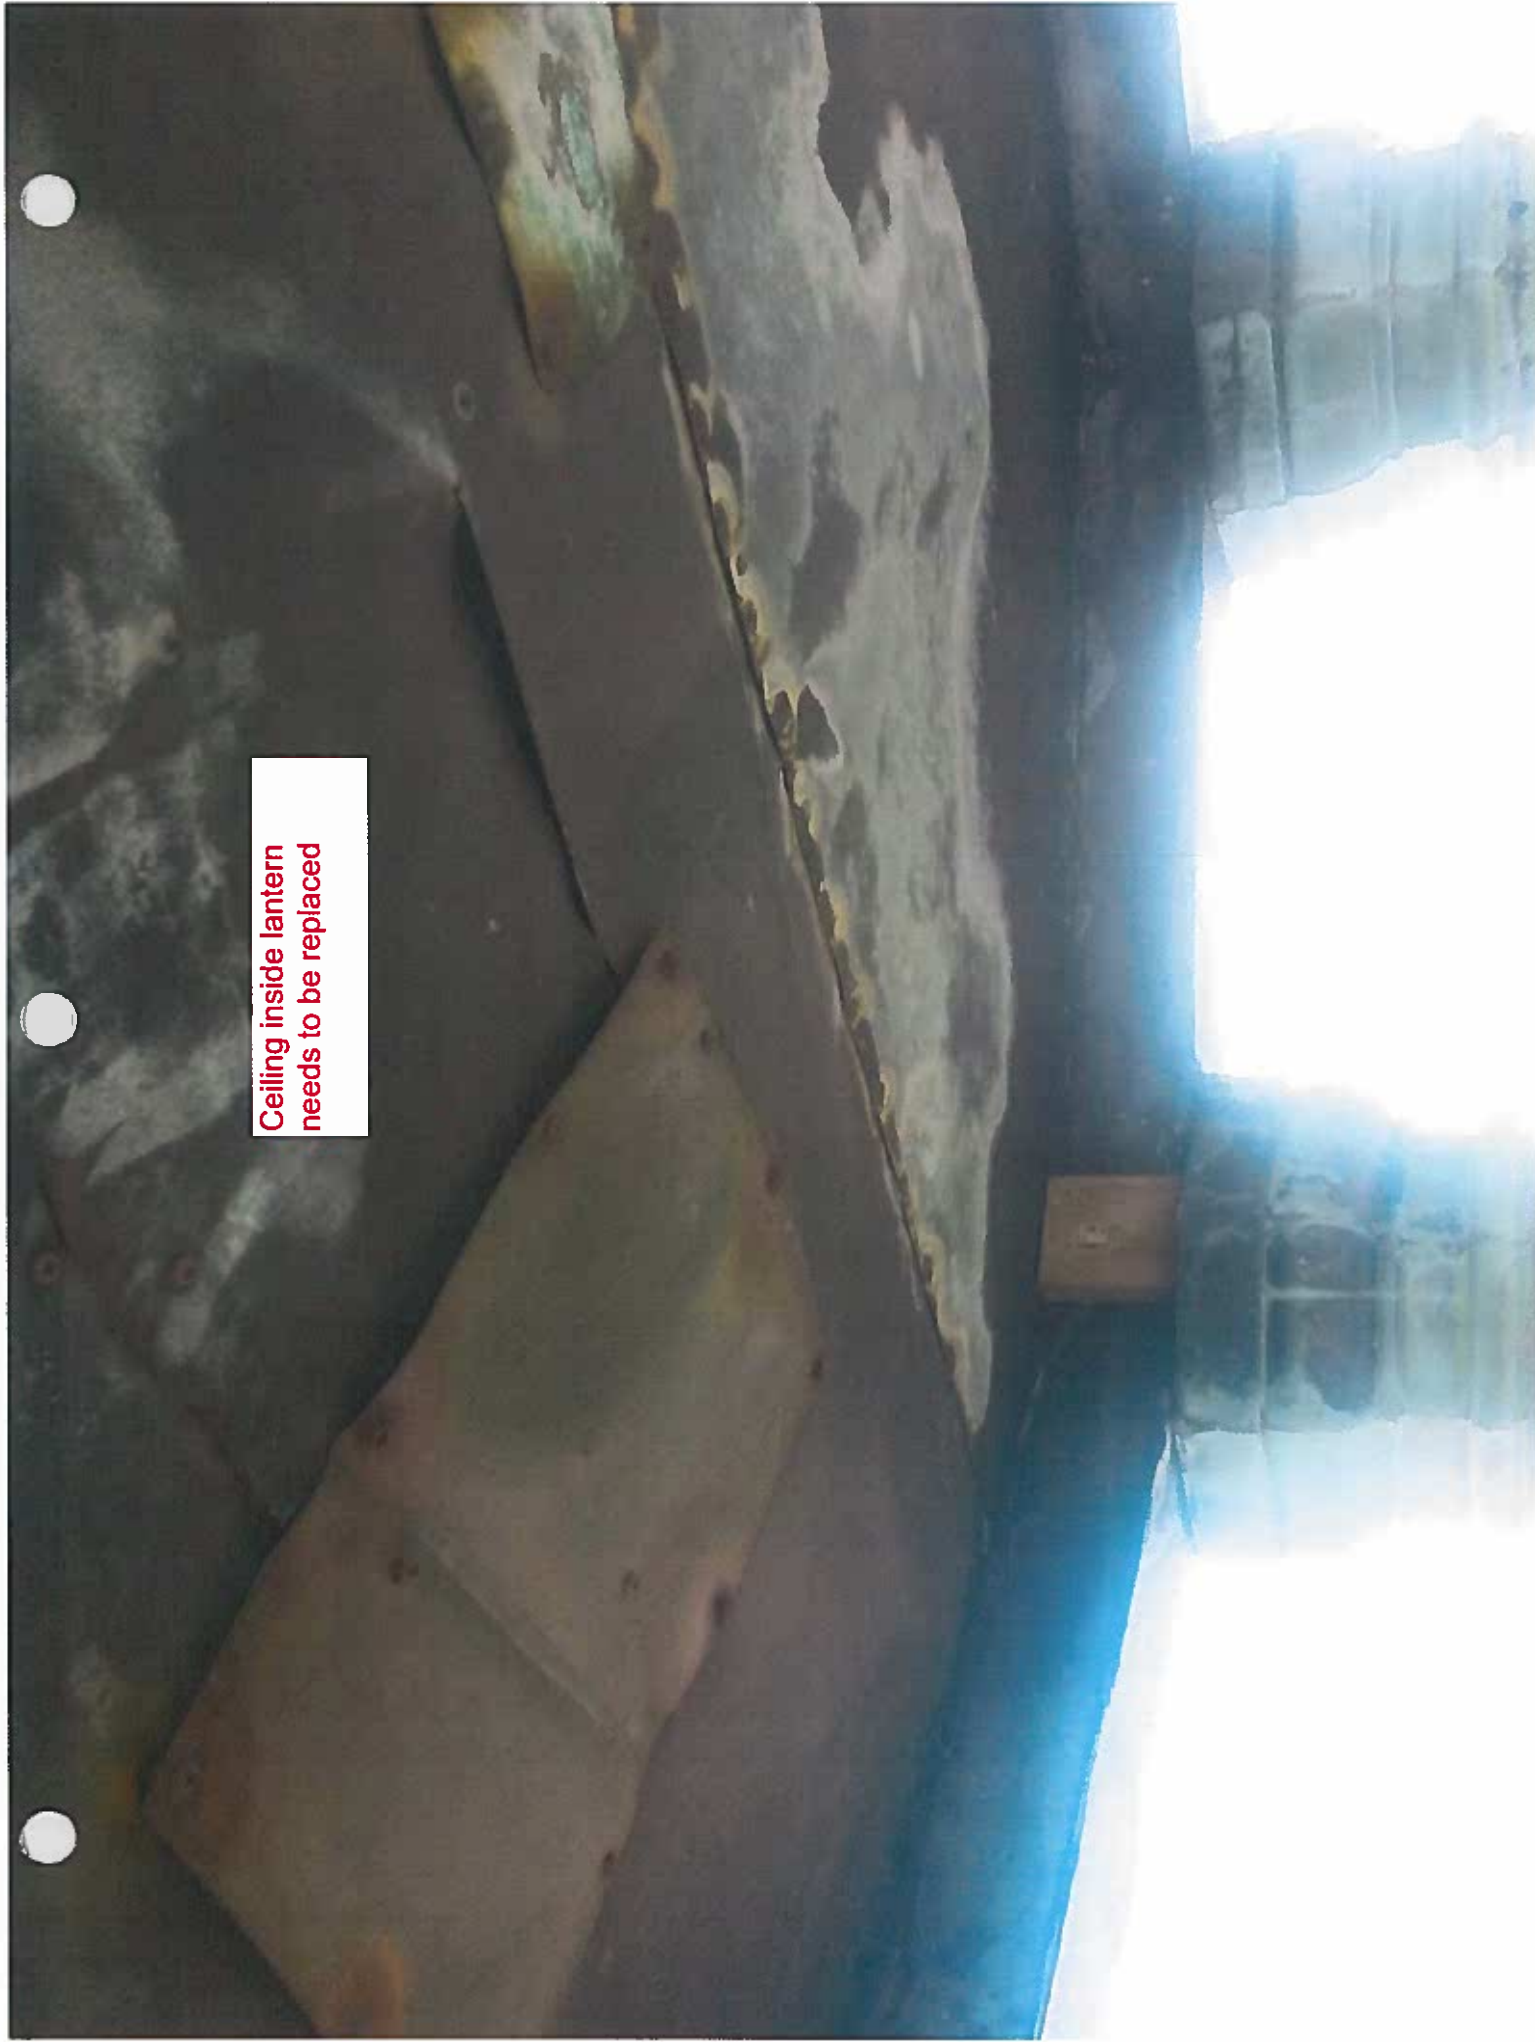
Ceiling inside lantern  
needs to be replaced

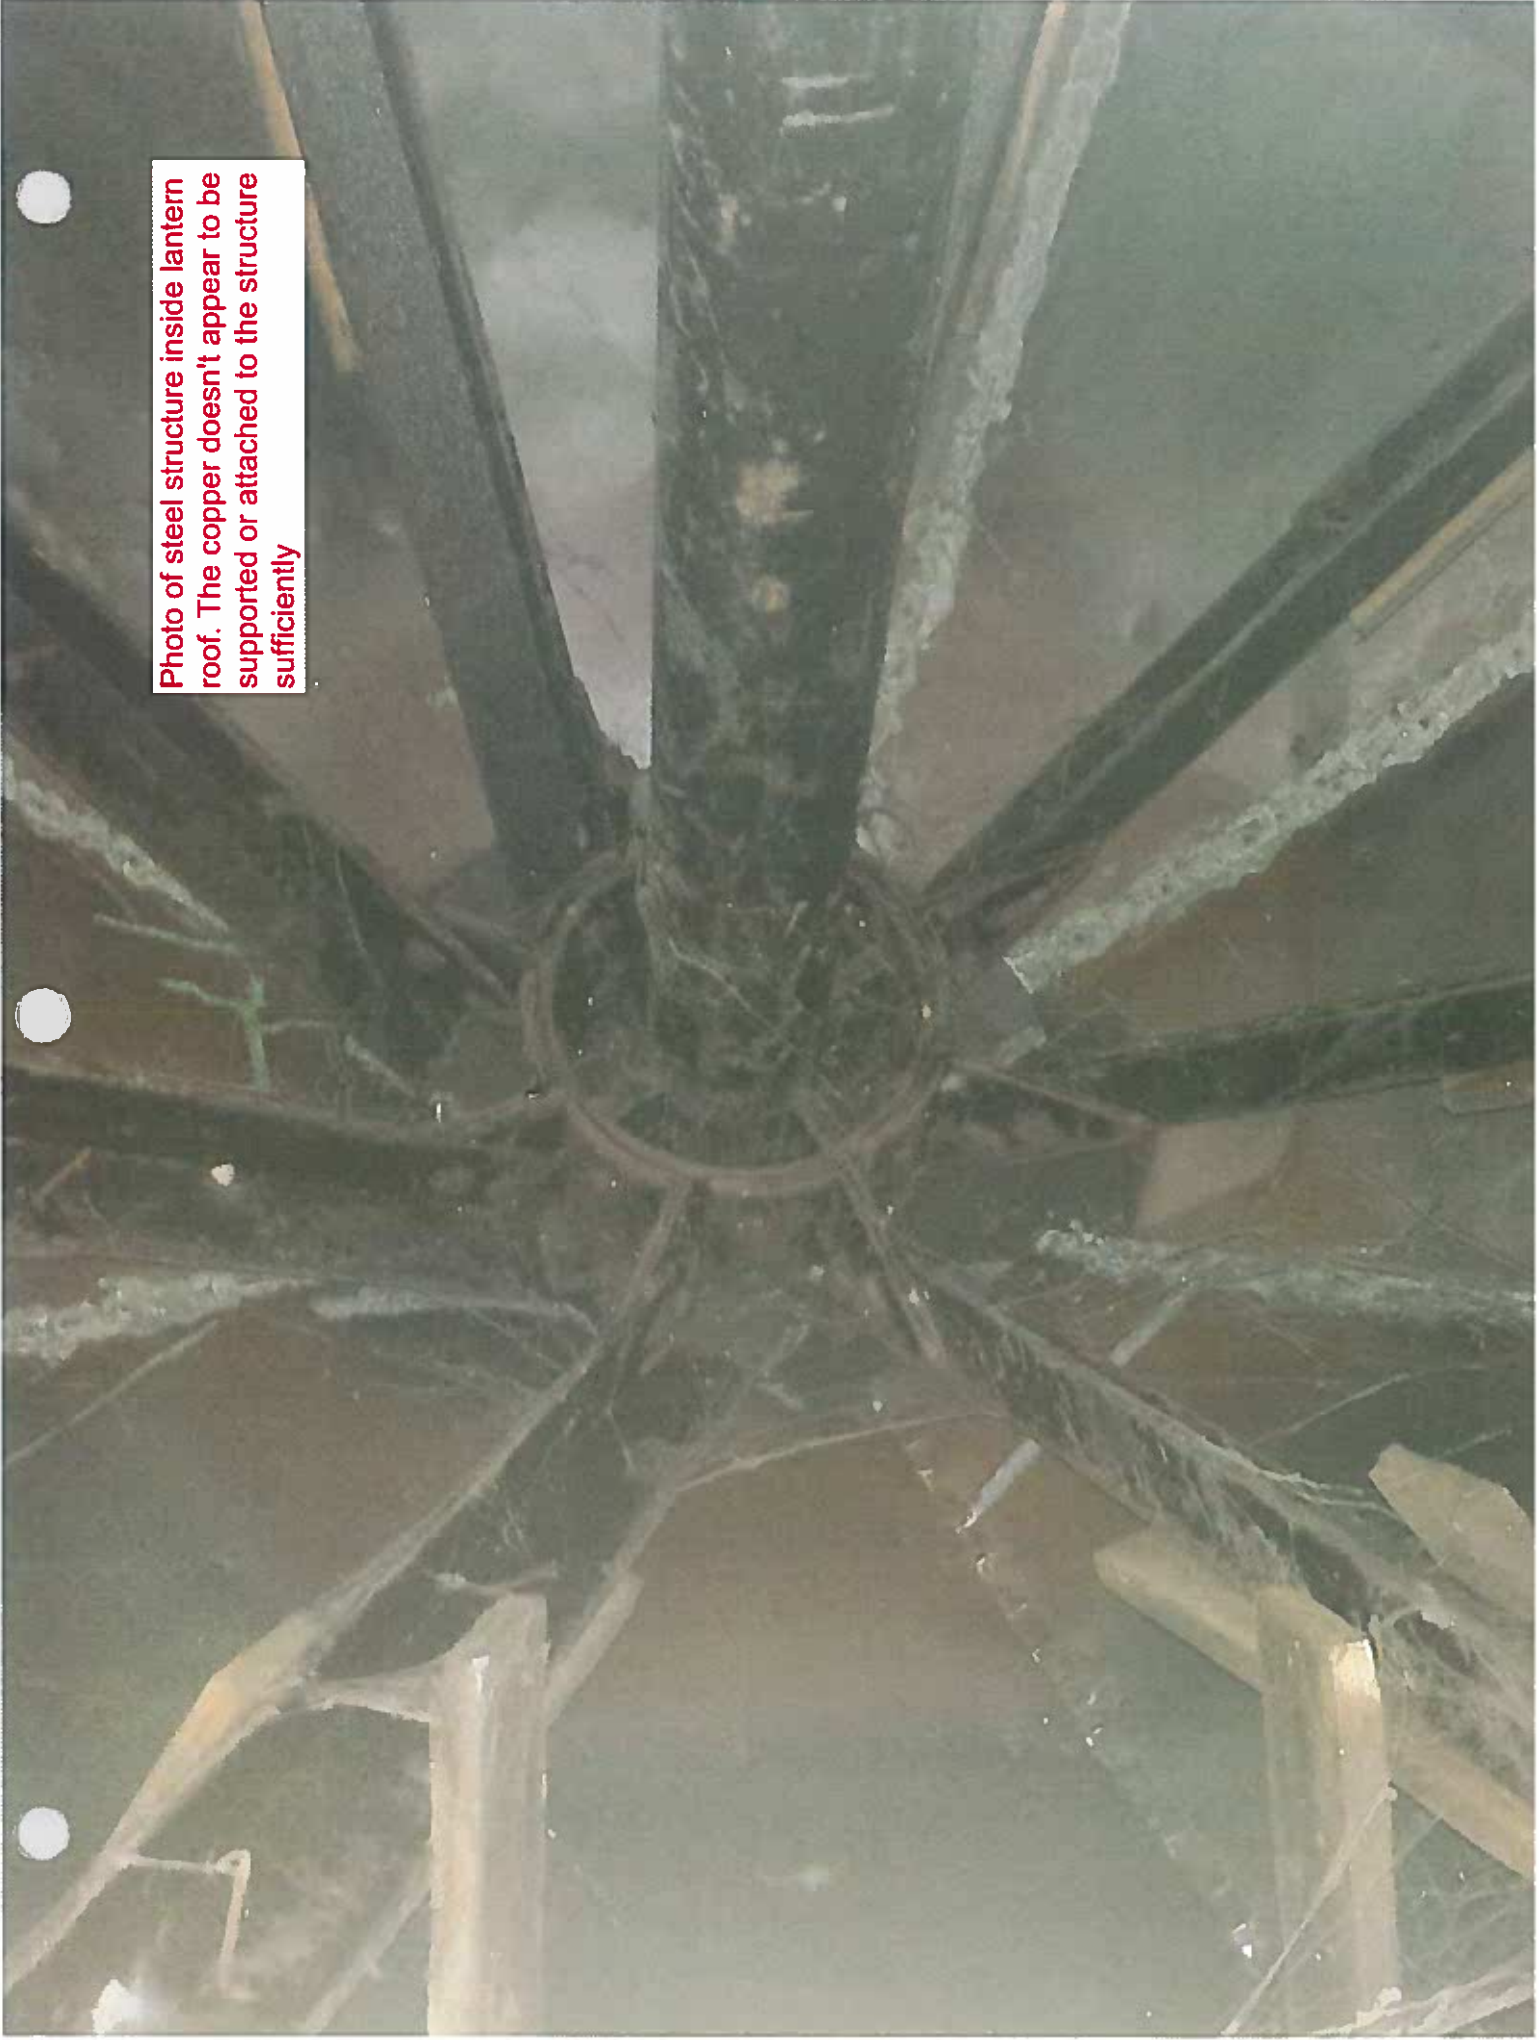
Photo of steel structure inside lantern  
roof. The copper doesn't appear to be  
supported or attached to the structure  
sufficiently

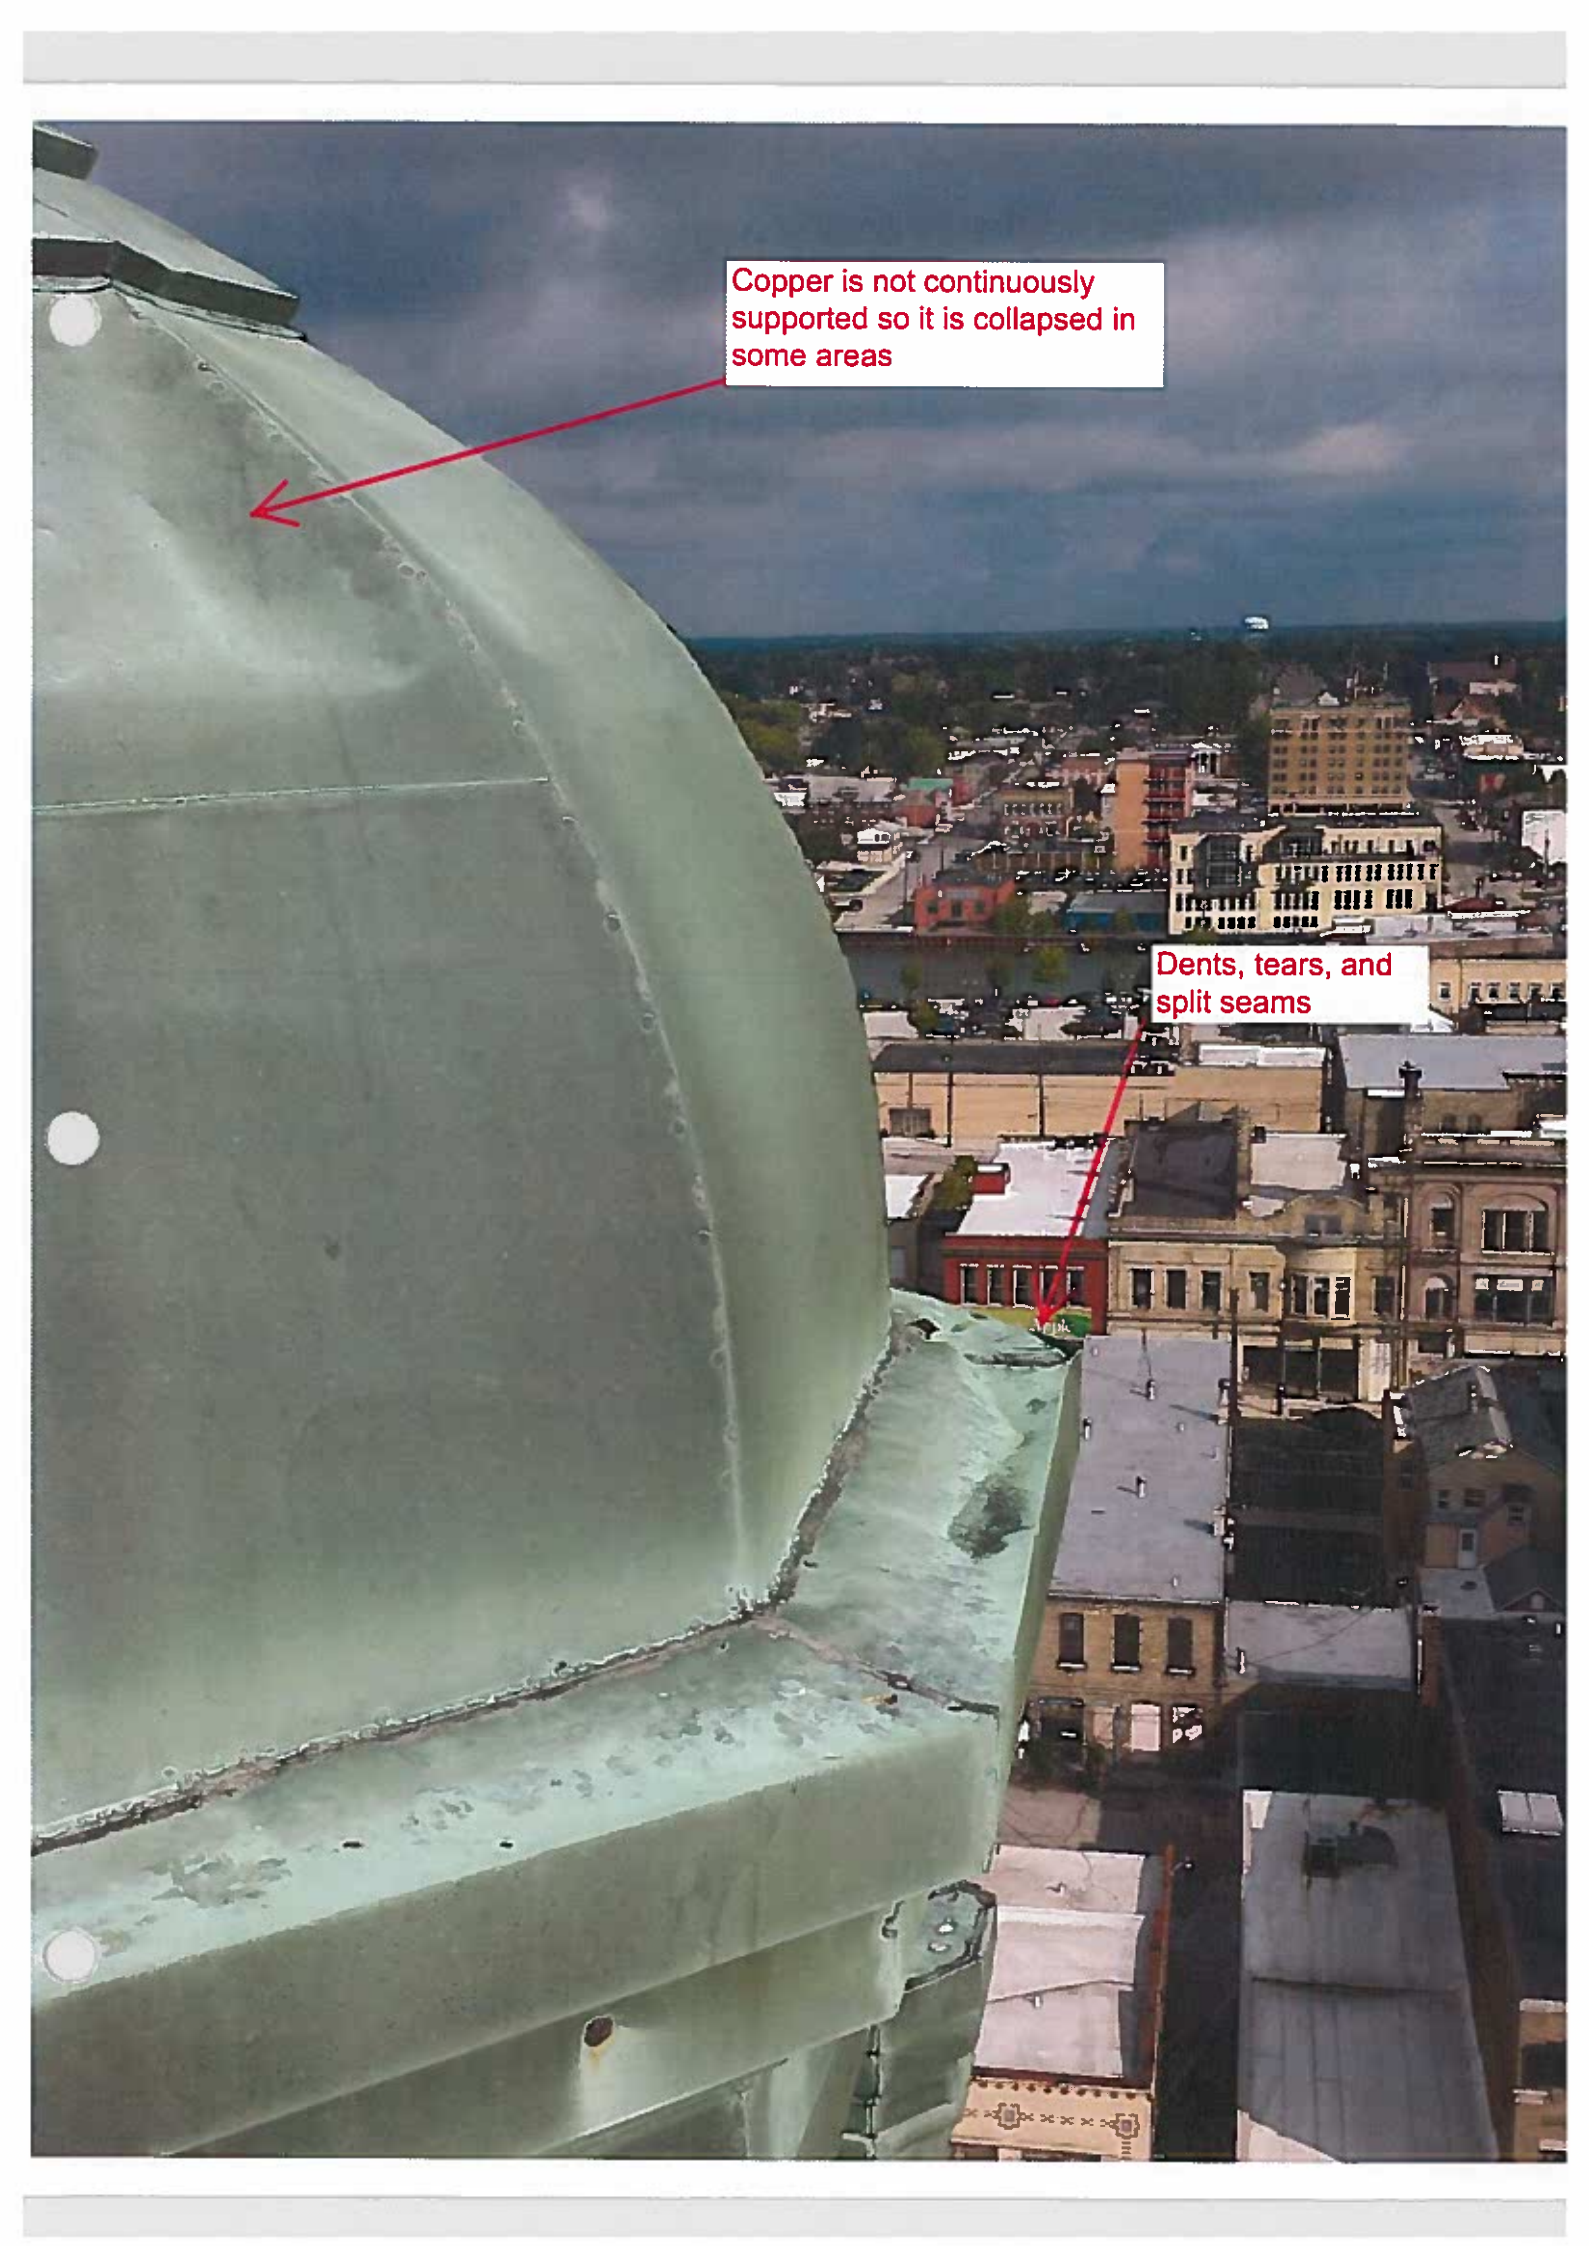
Copper is not continuously supported so it is collapsed in some areas

Dents, tears, and split seams

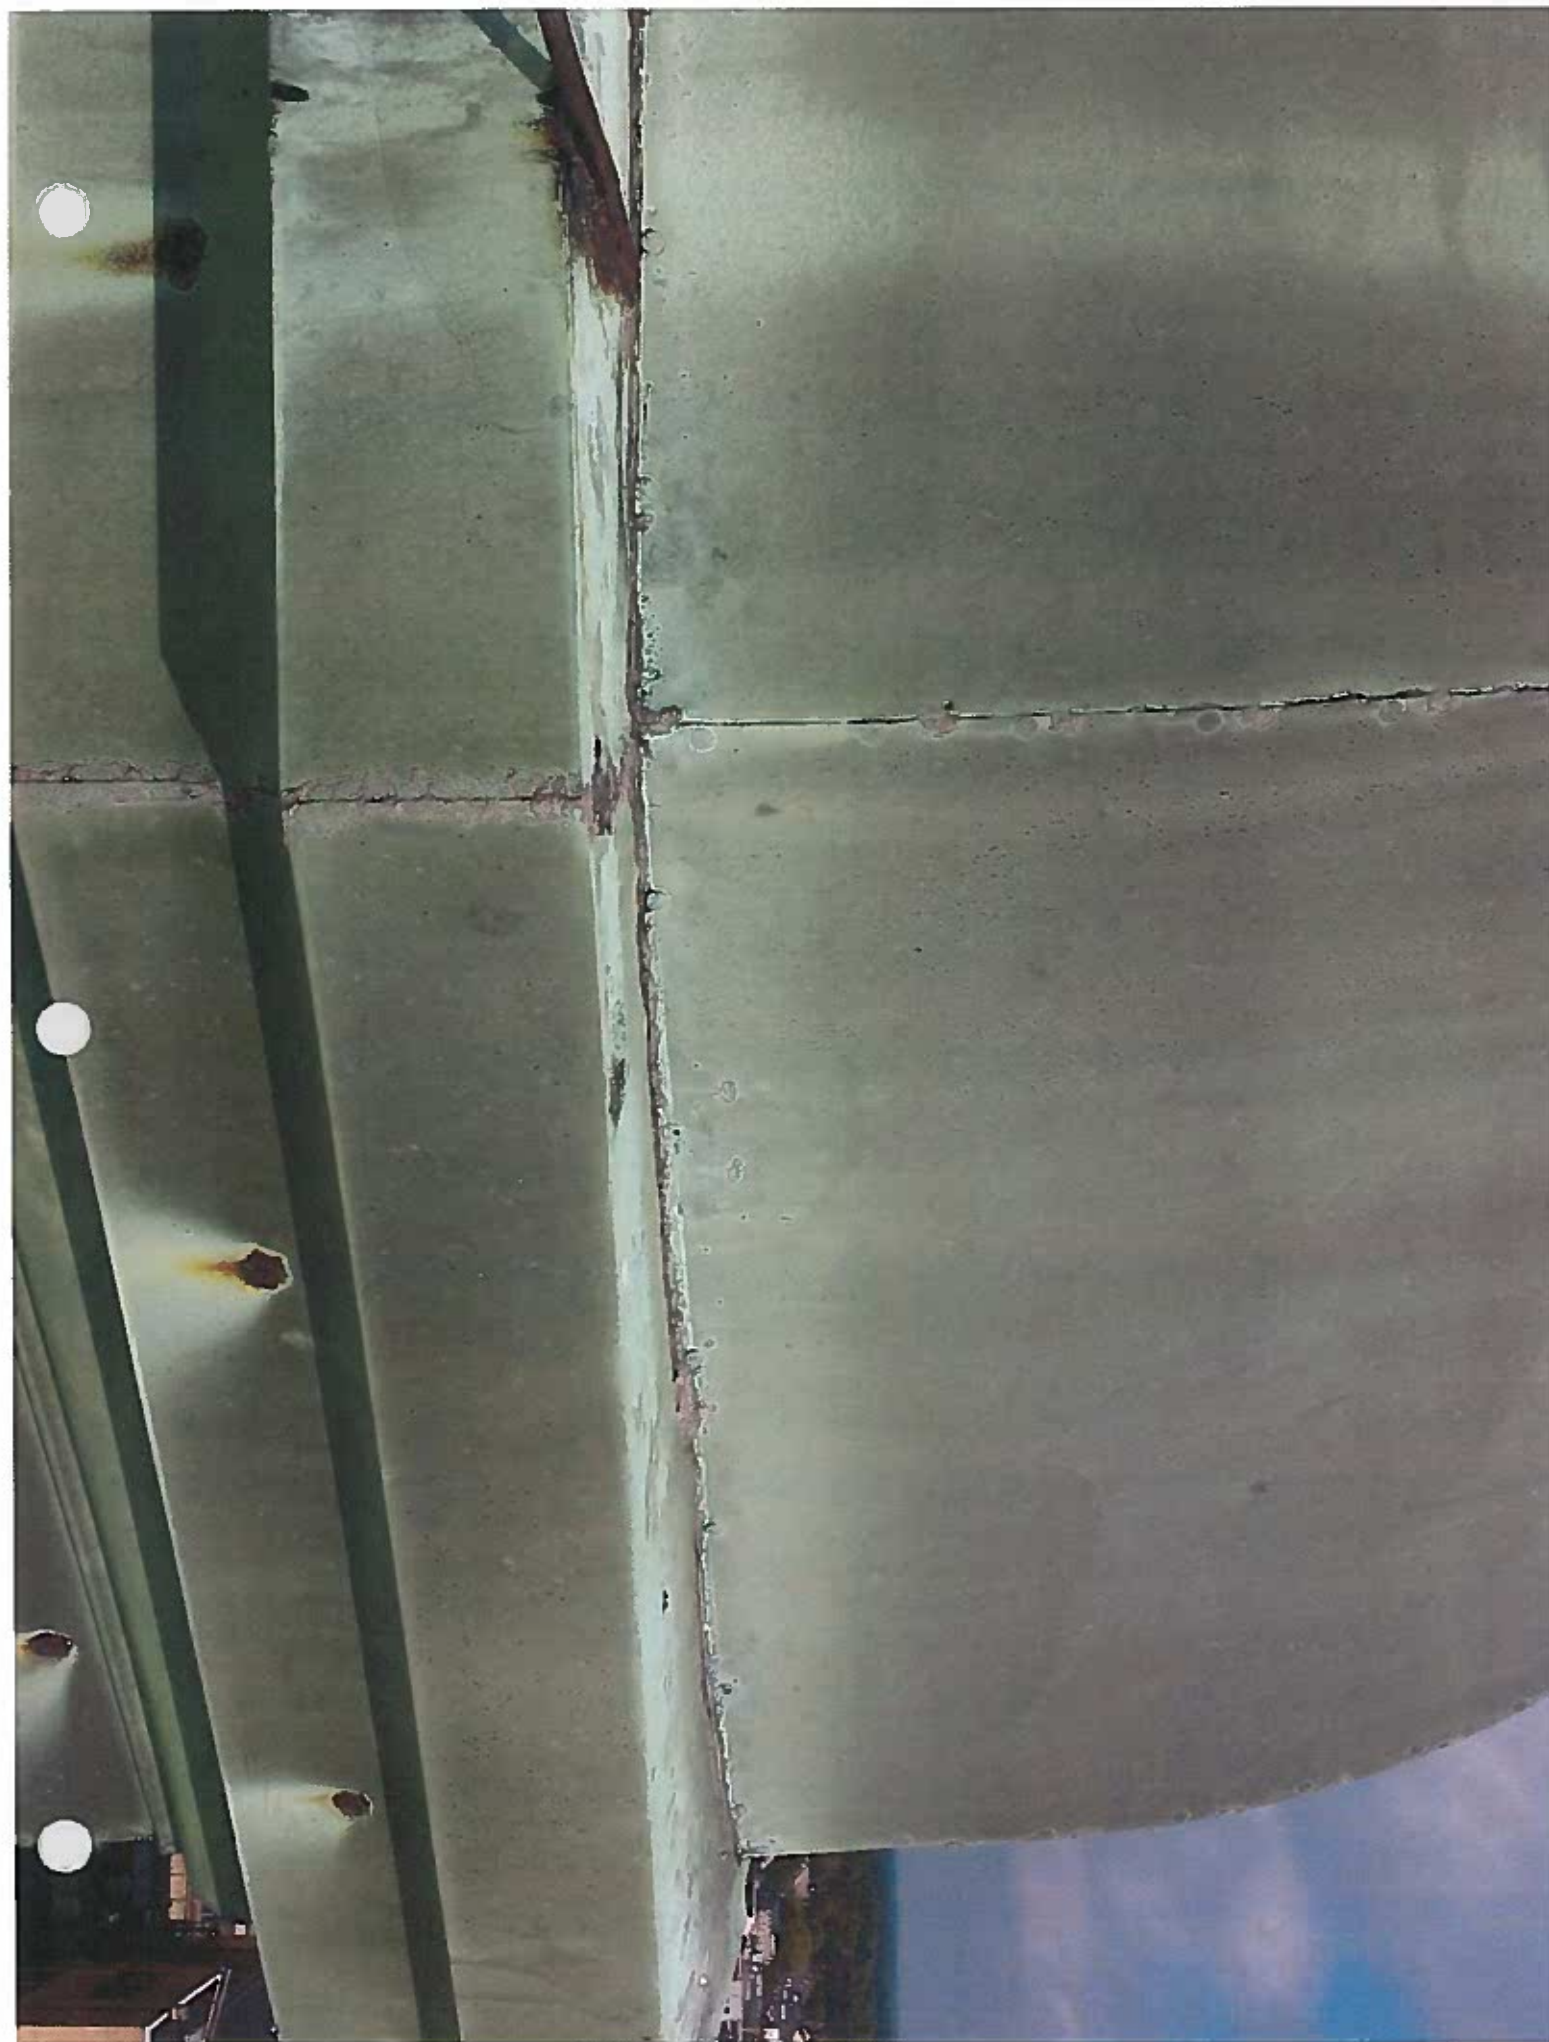
Tears and holes in copper

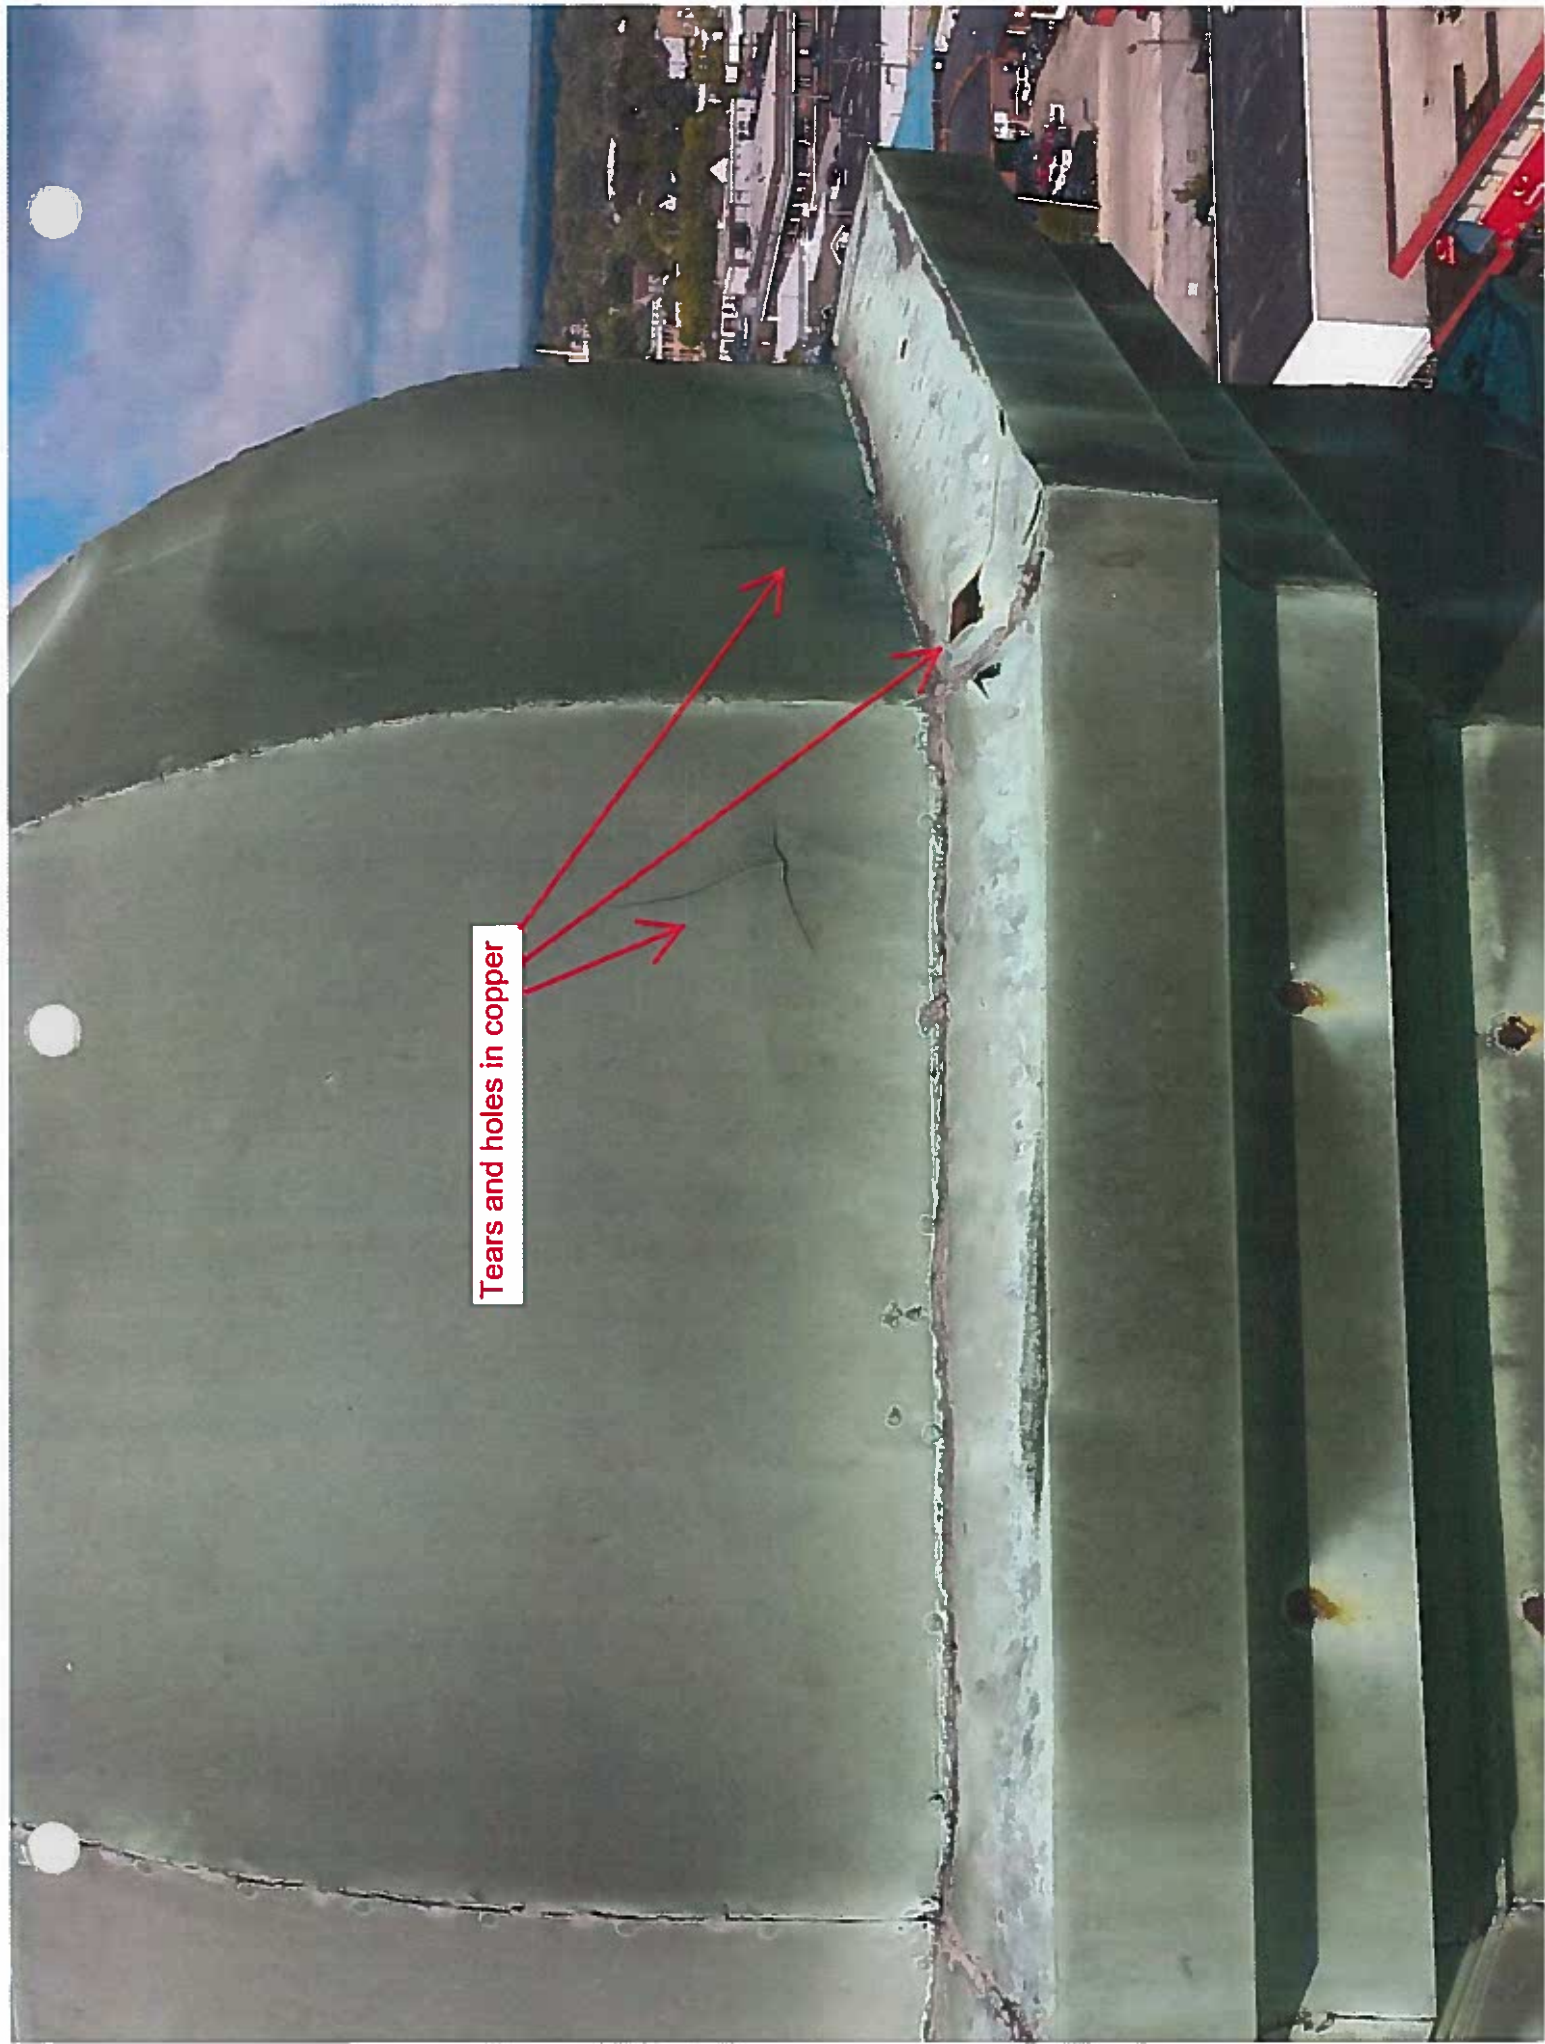
Holes in copper

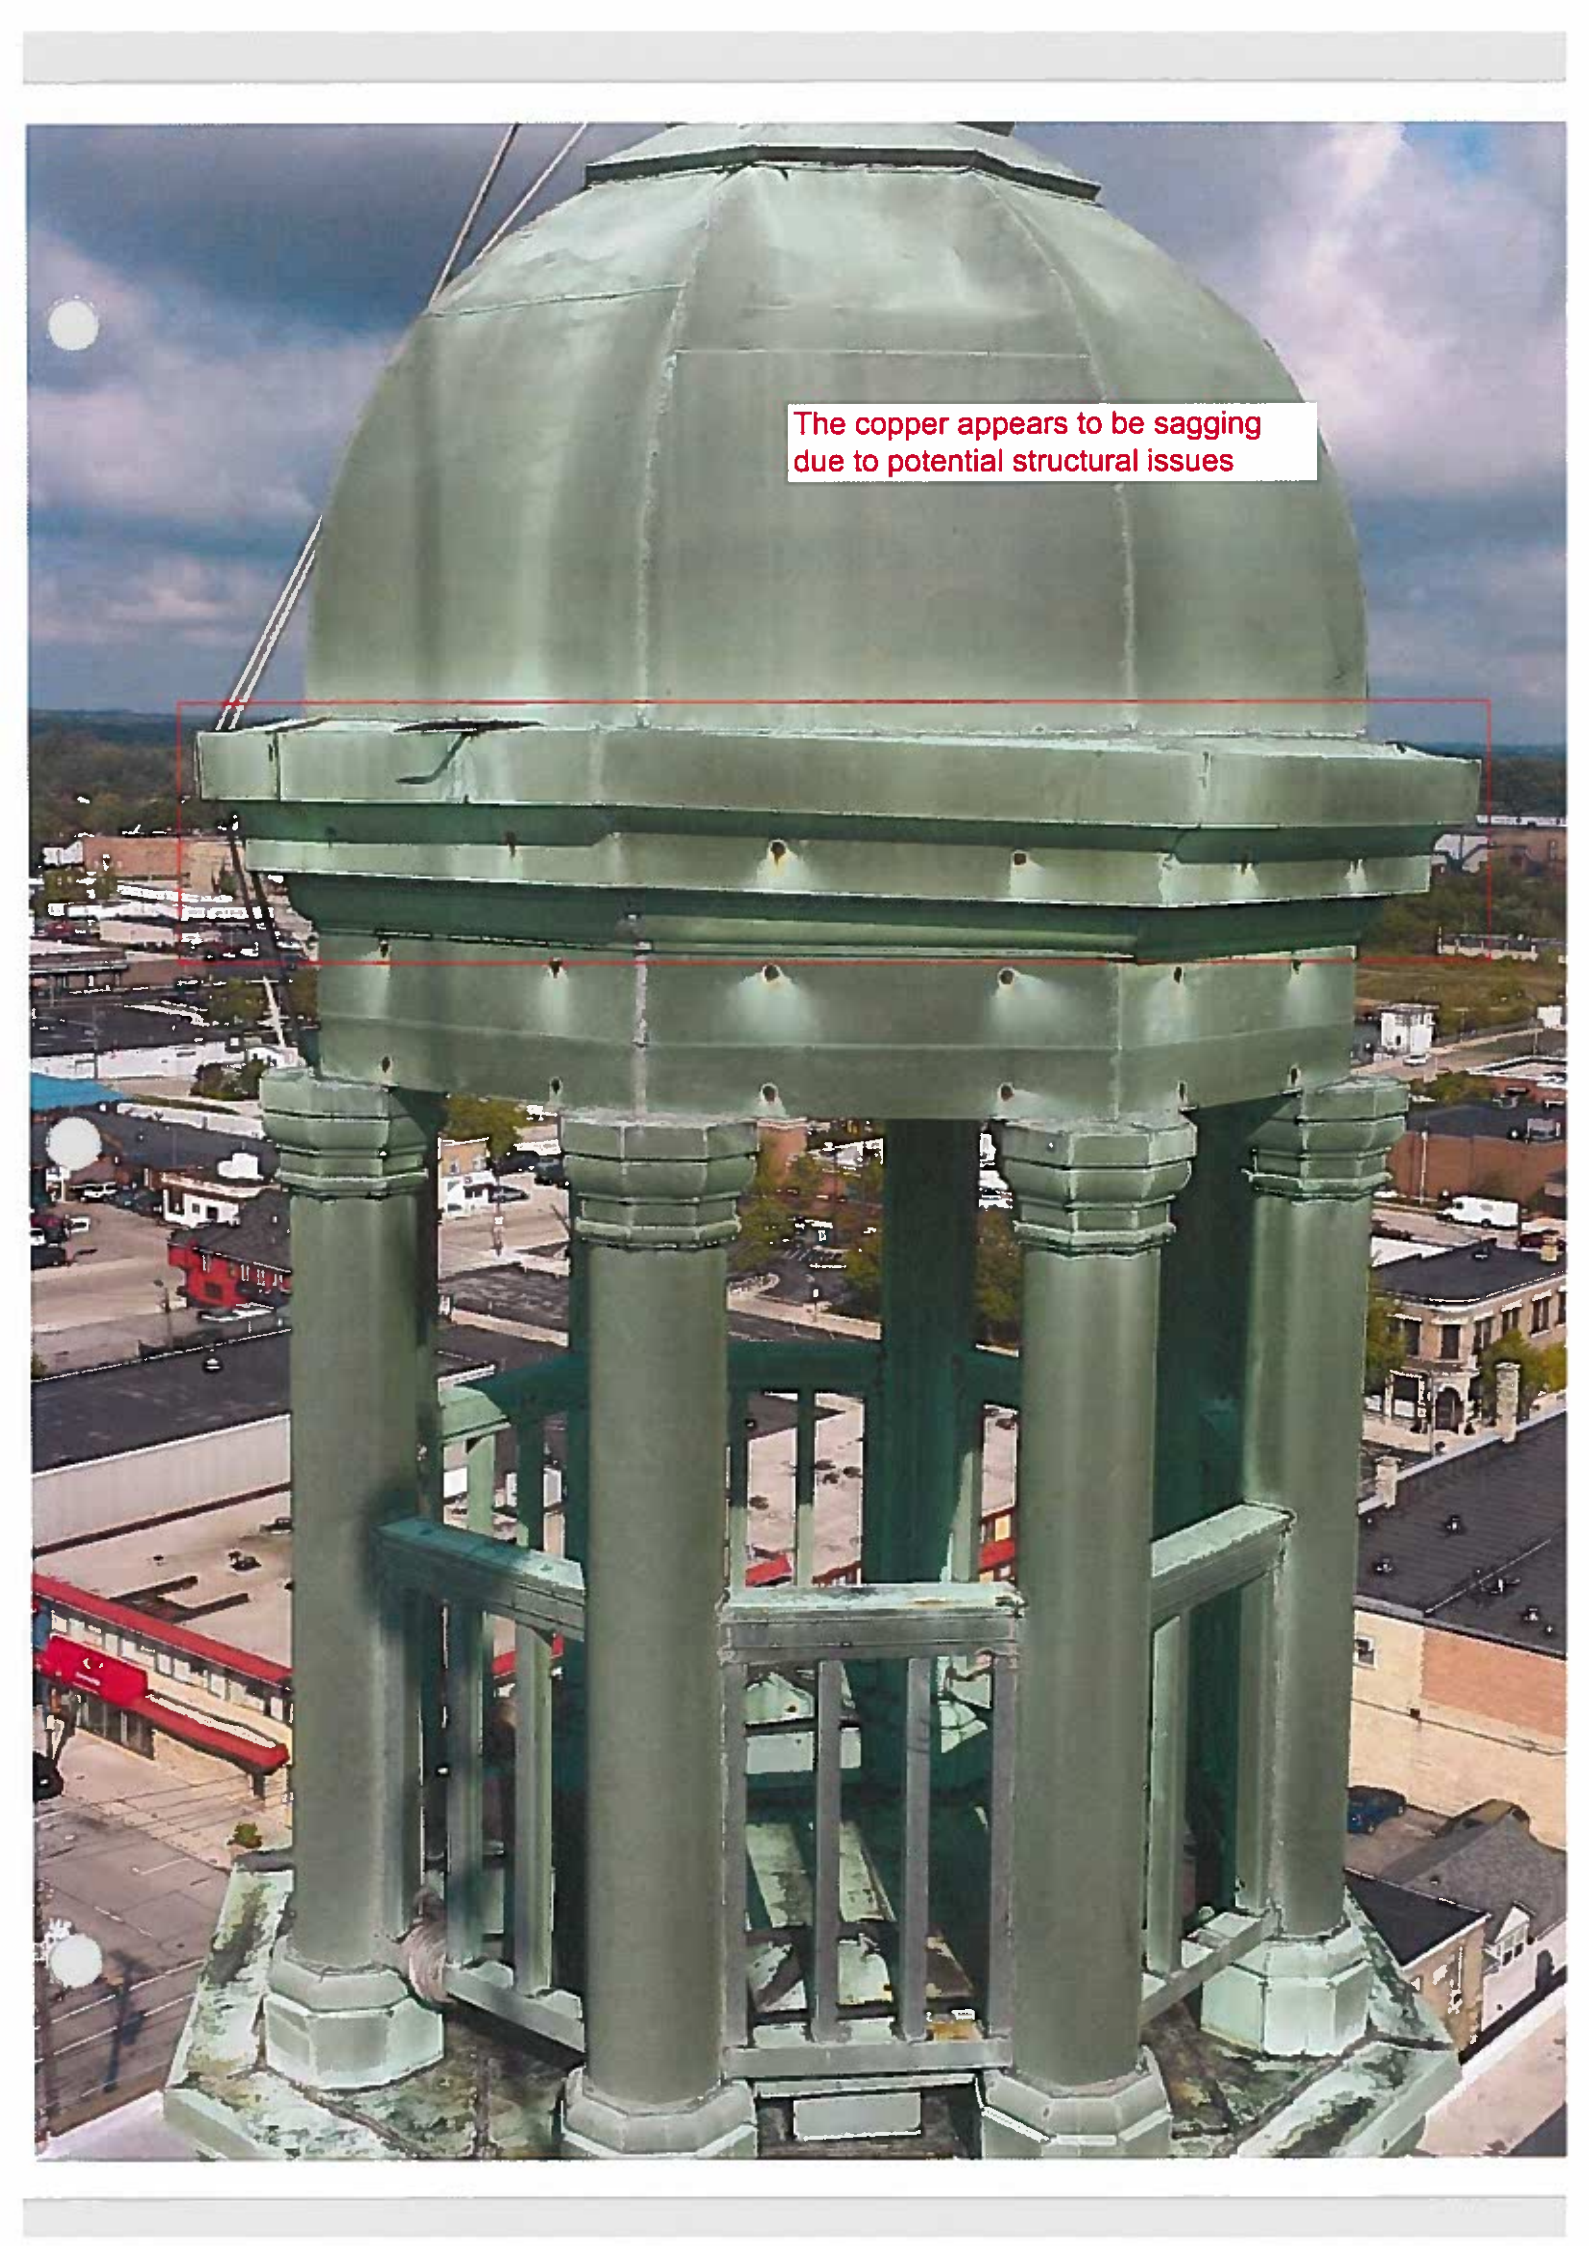
The copper appears to be sagging  
due to potential structural issues

Exposed fasteners are  
rusting and will eventually fail
