# Lantern Photos

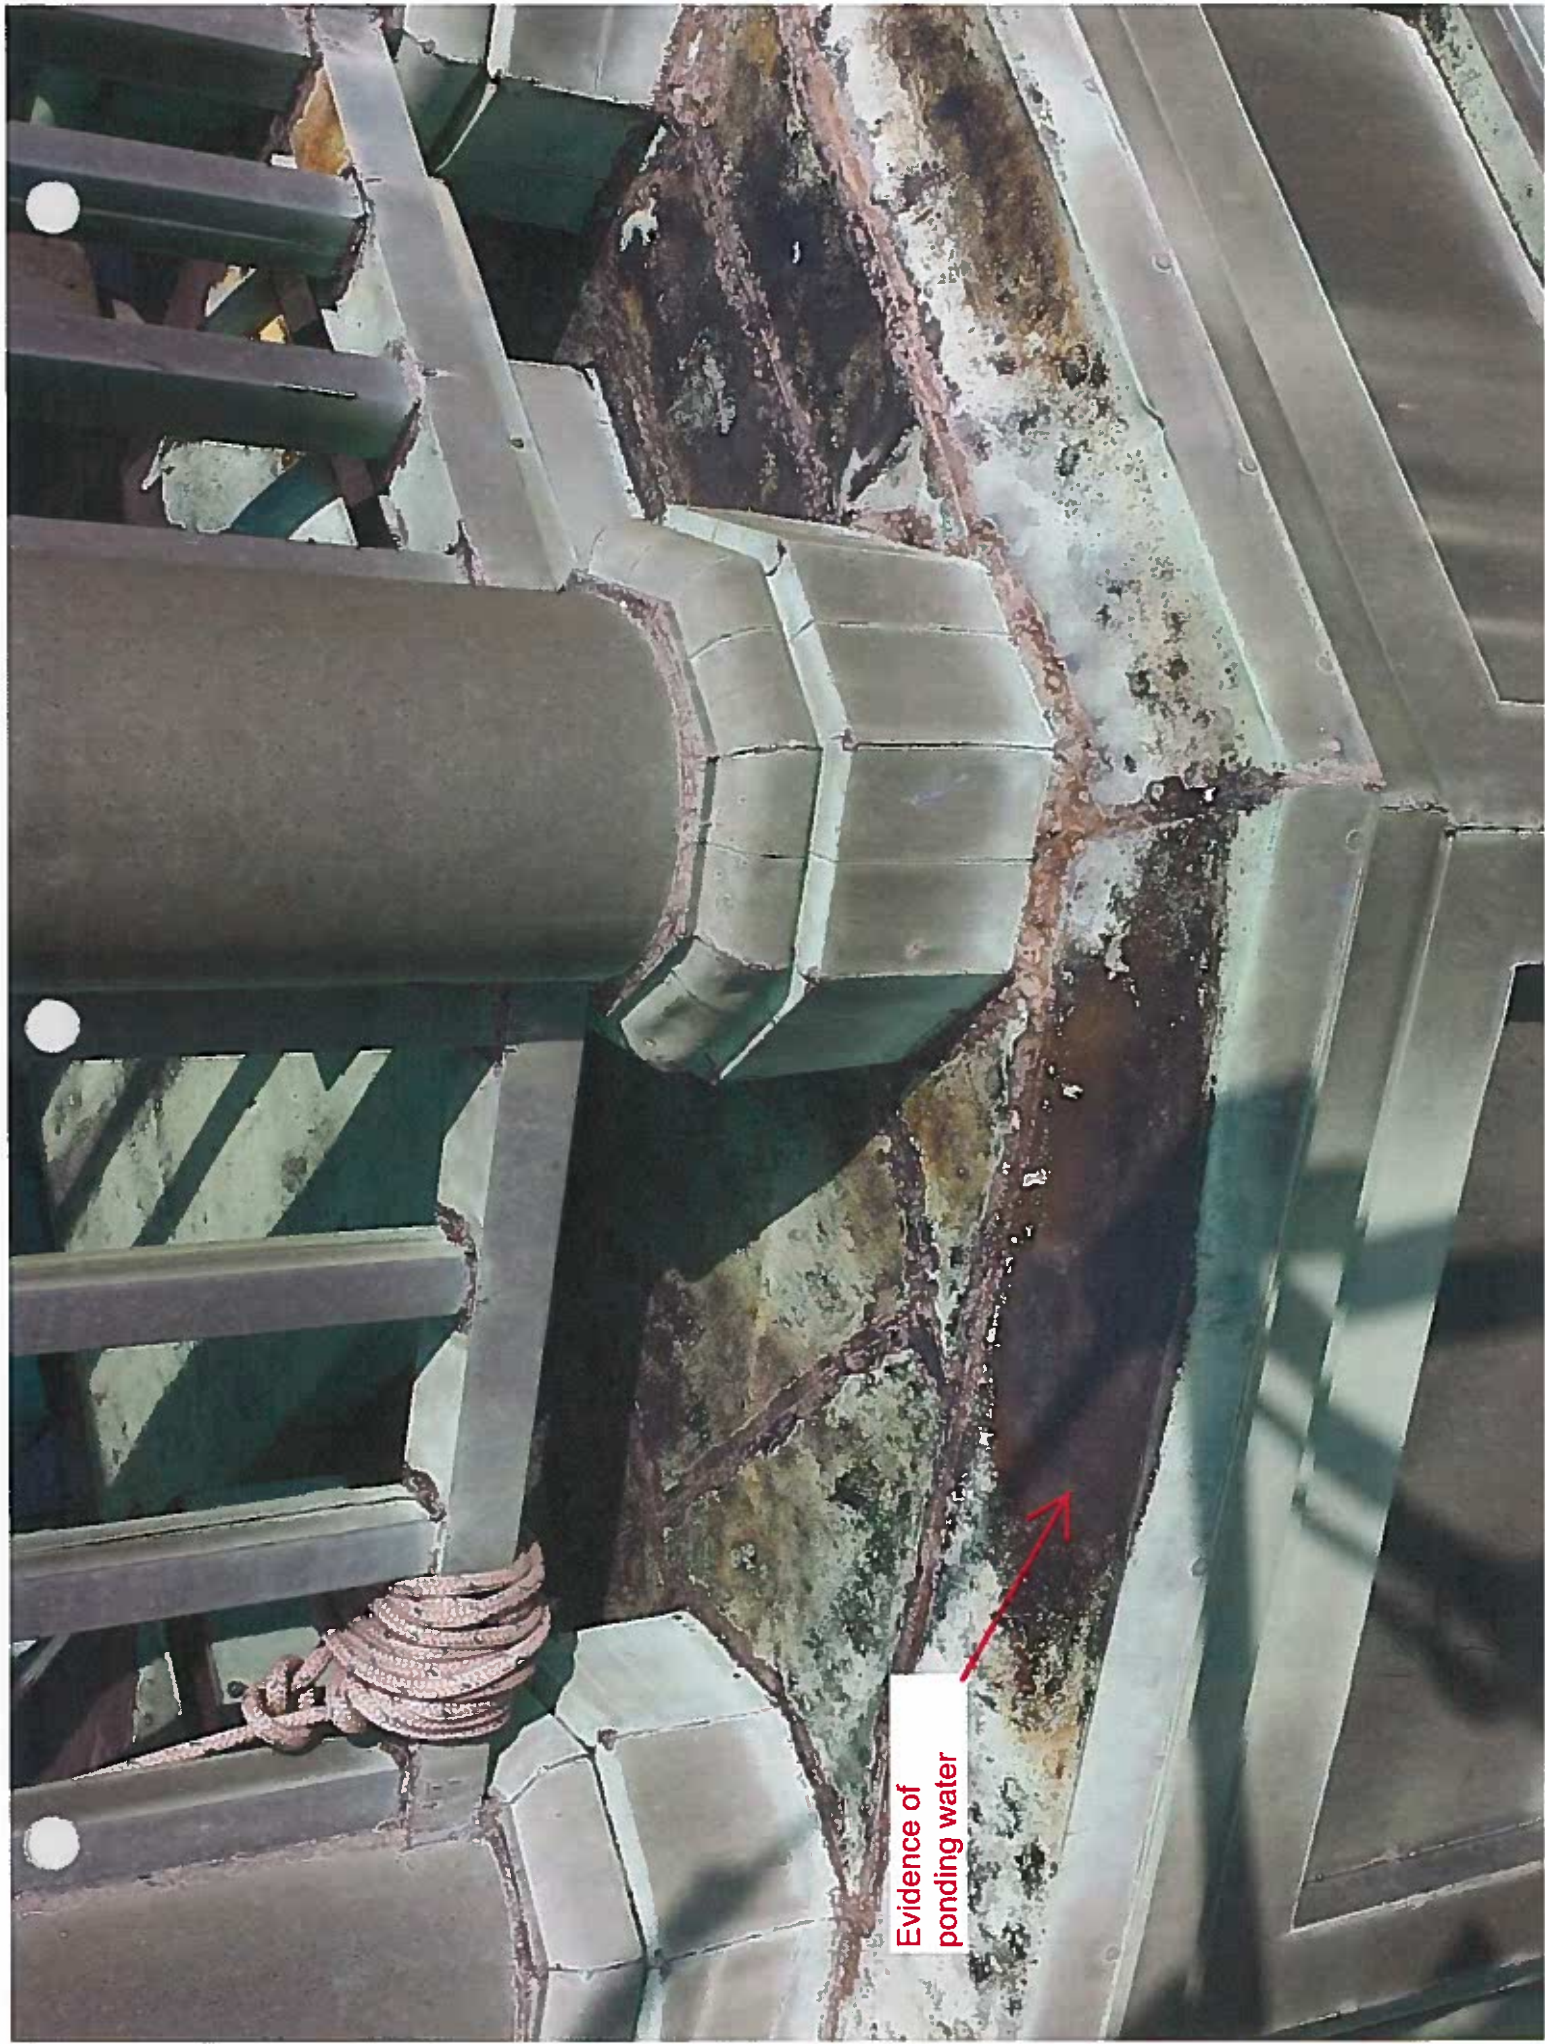
Evidence of  
ponding water

Copper is not supported  
and therefore dented and  
collapsing in areas

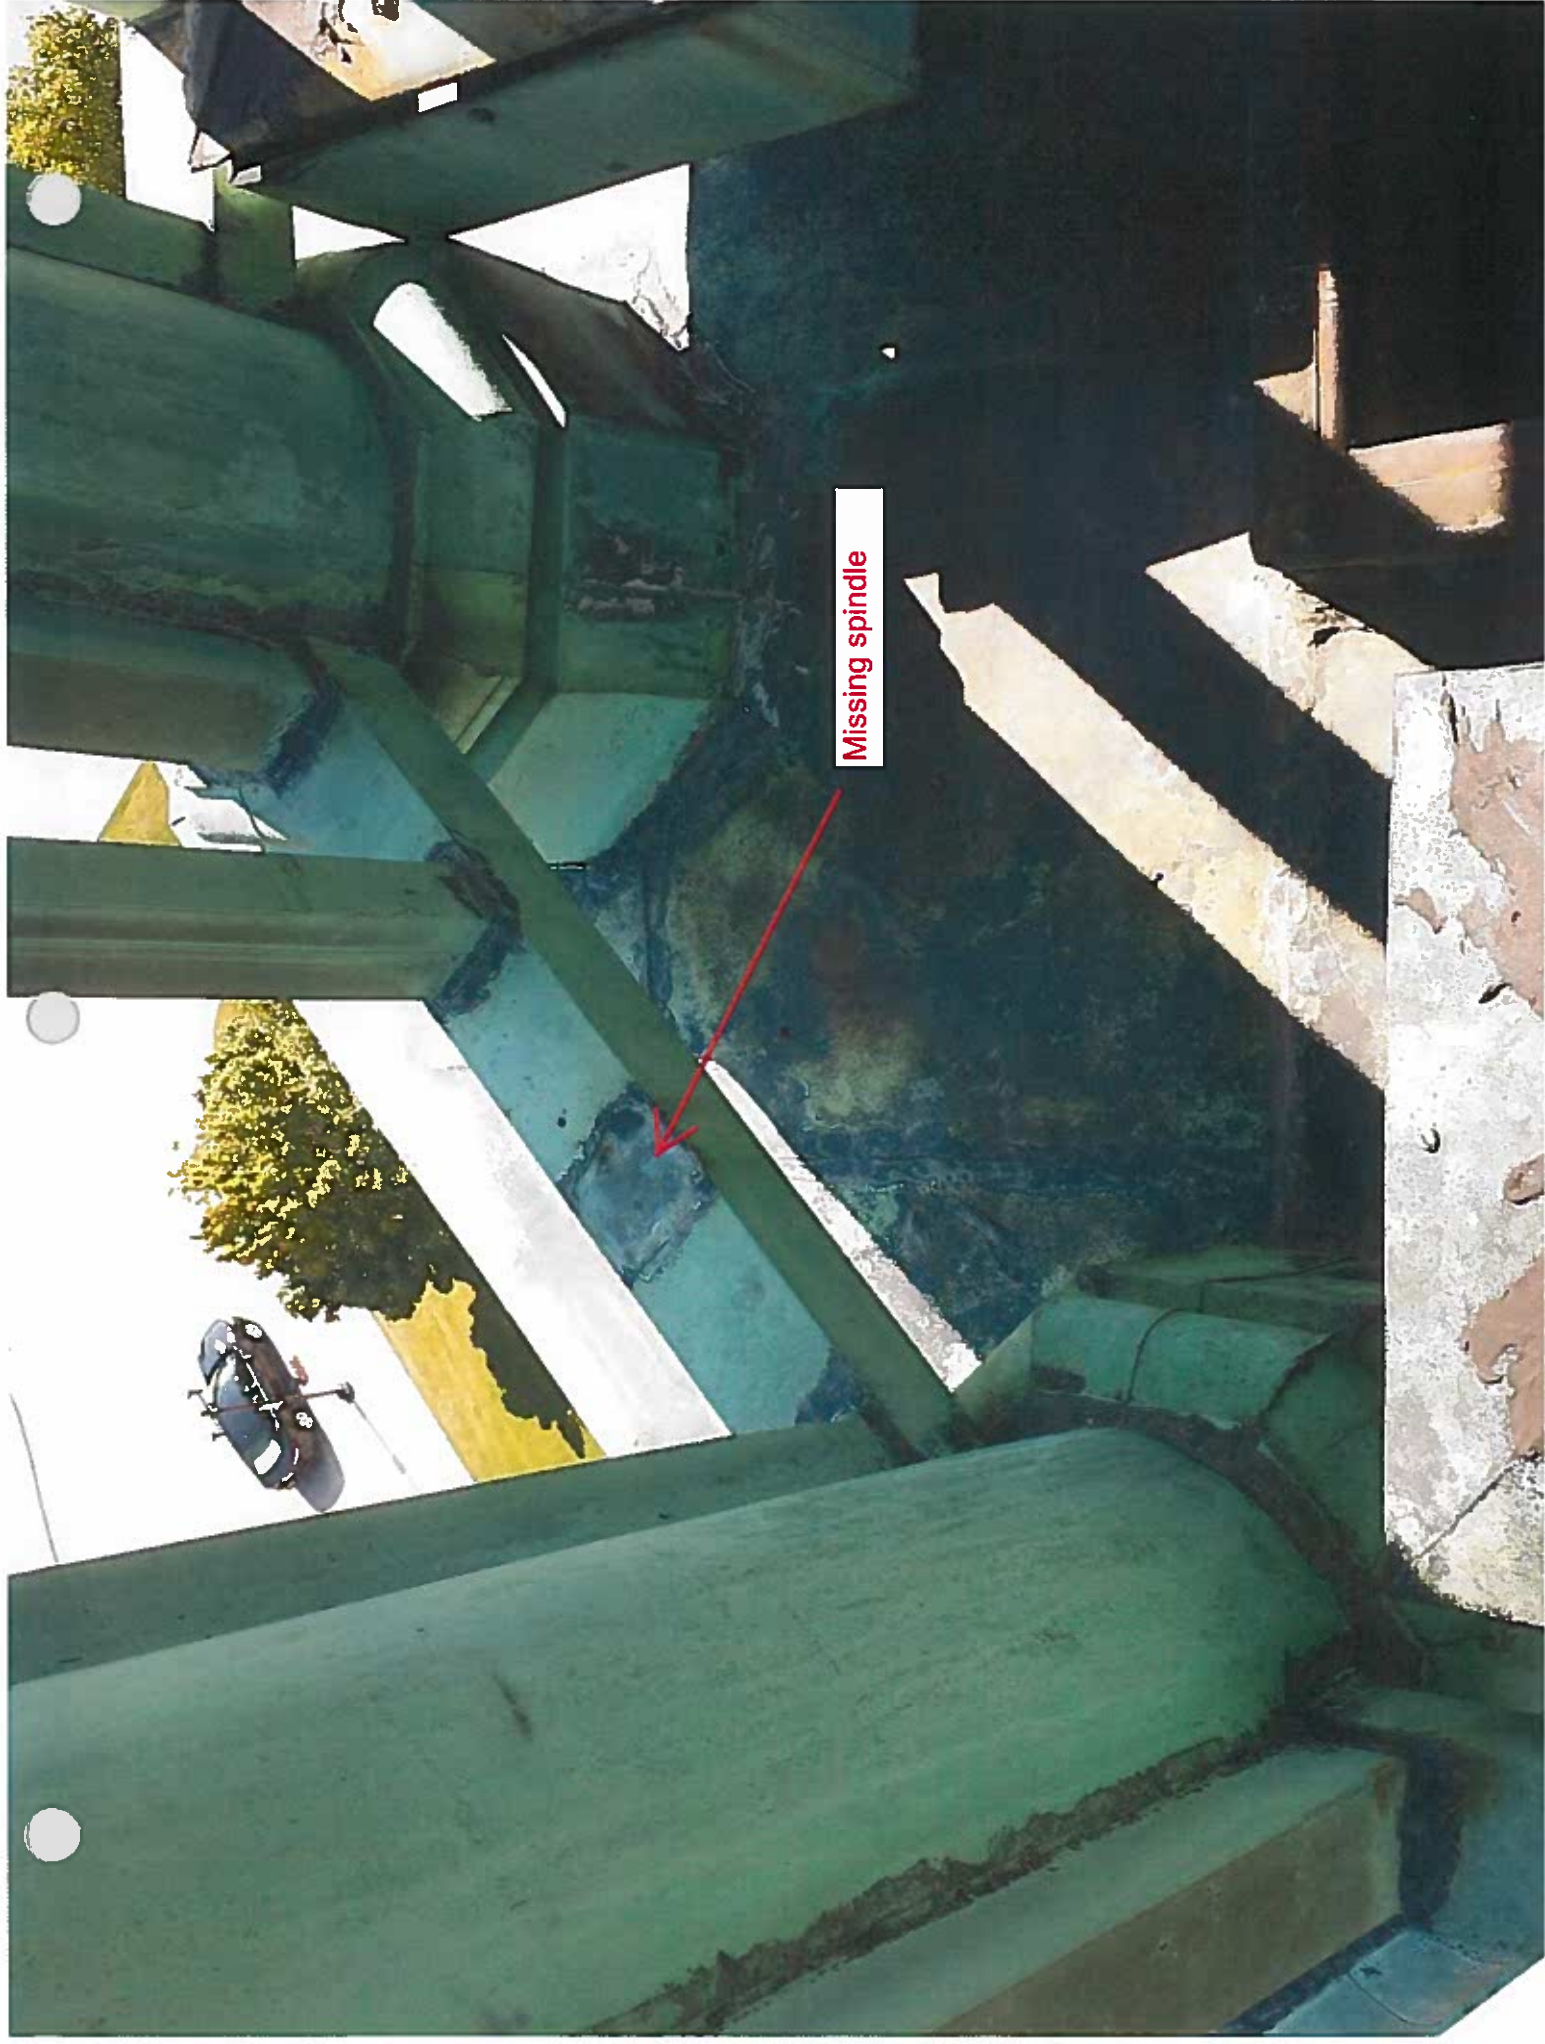
Missing spindle
