# Upper Ledge/ Base of Dome

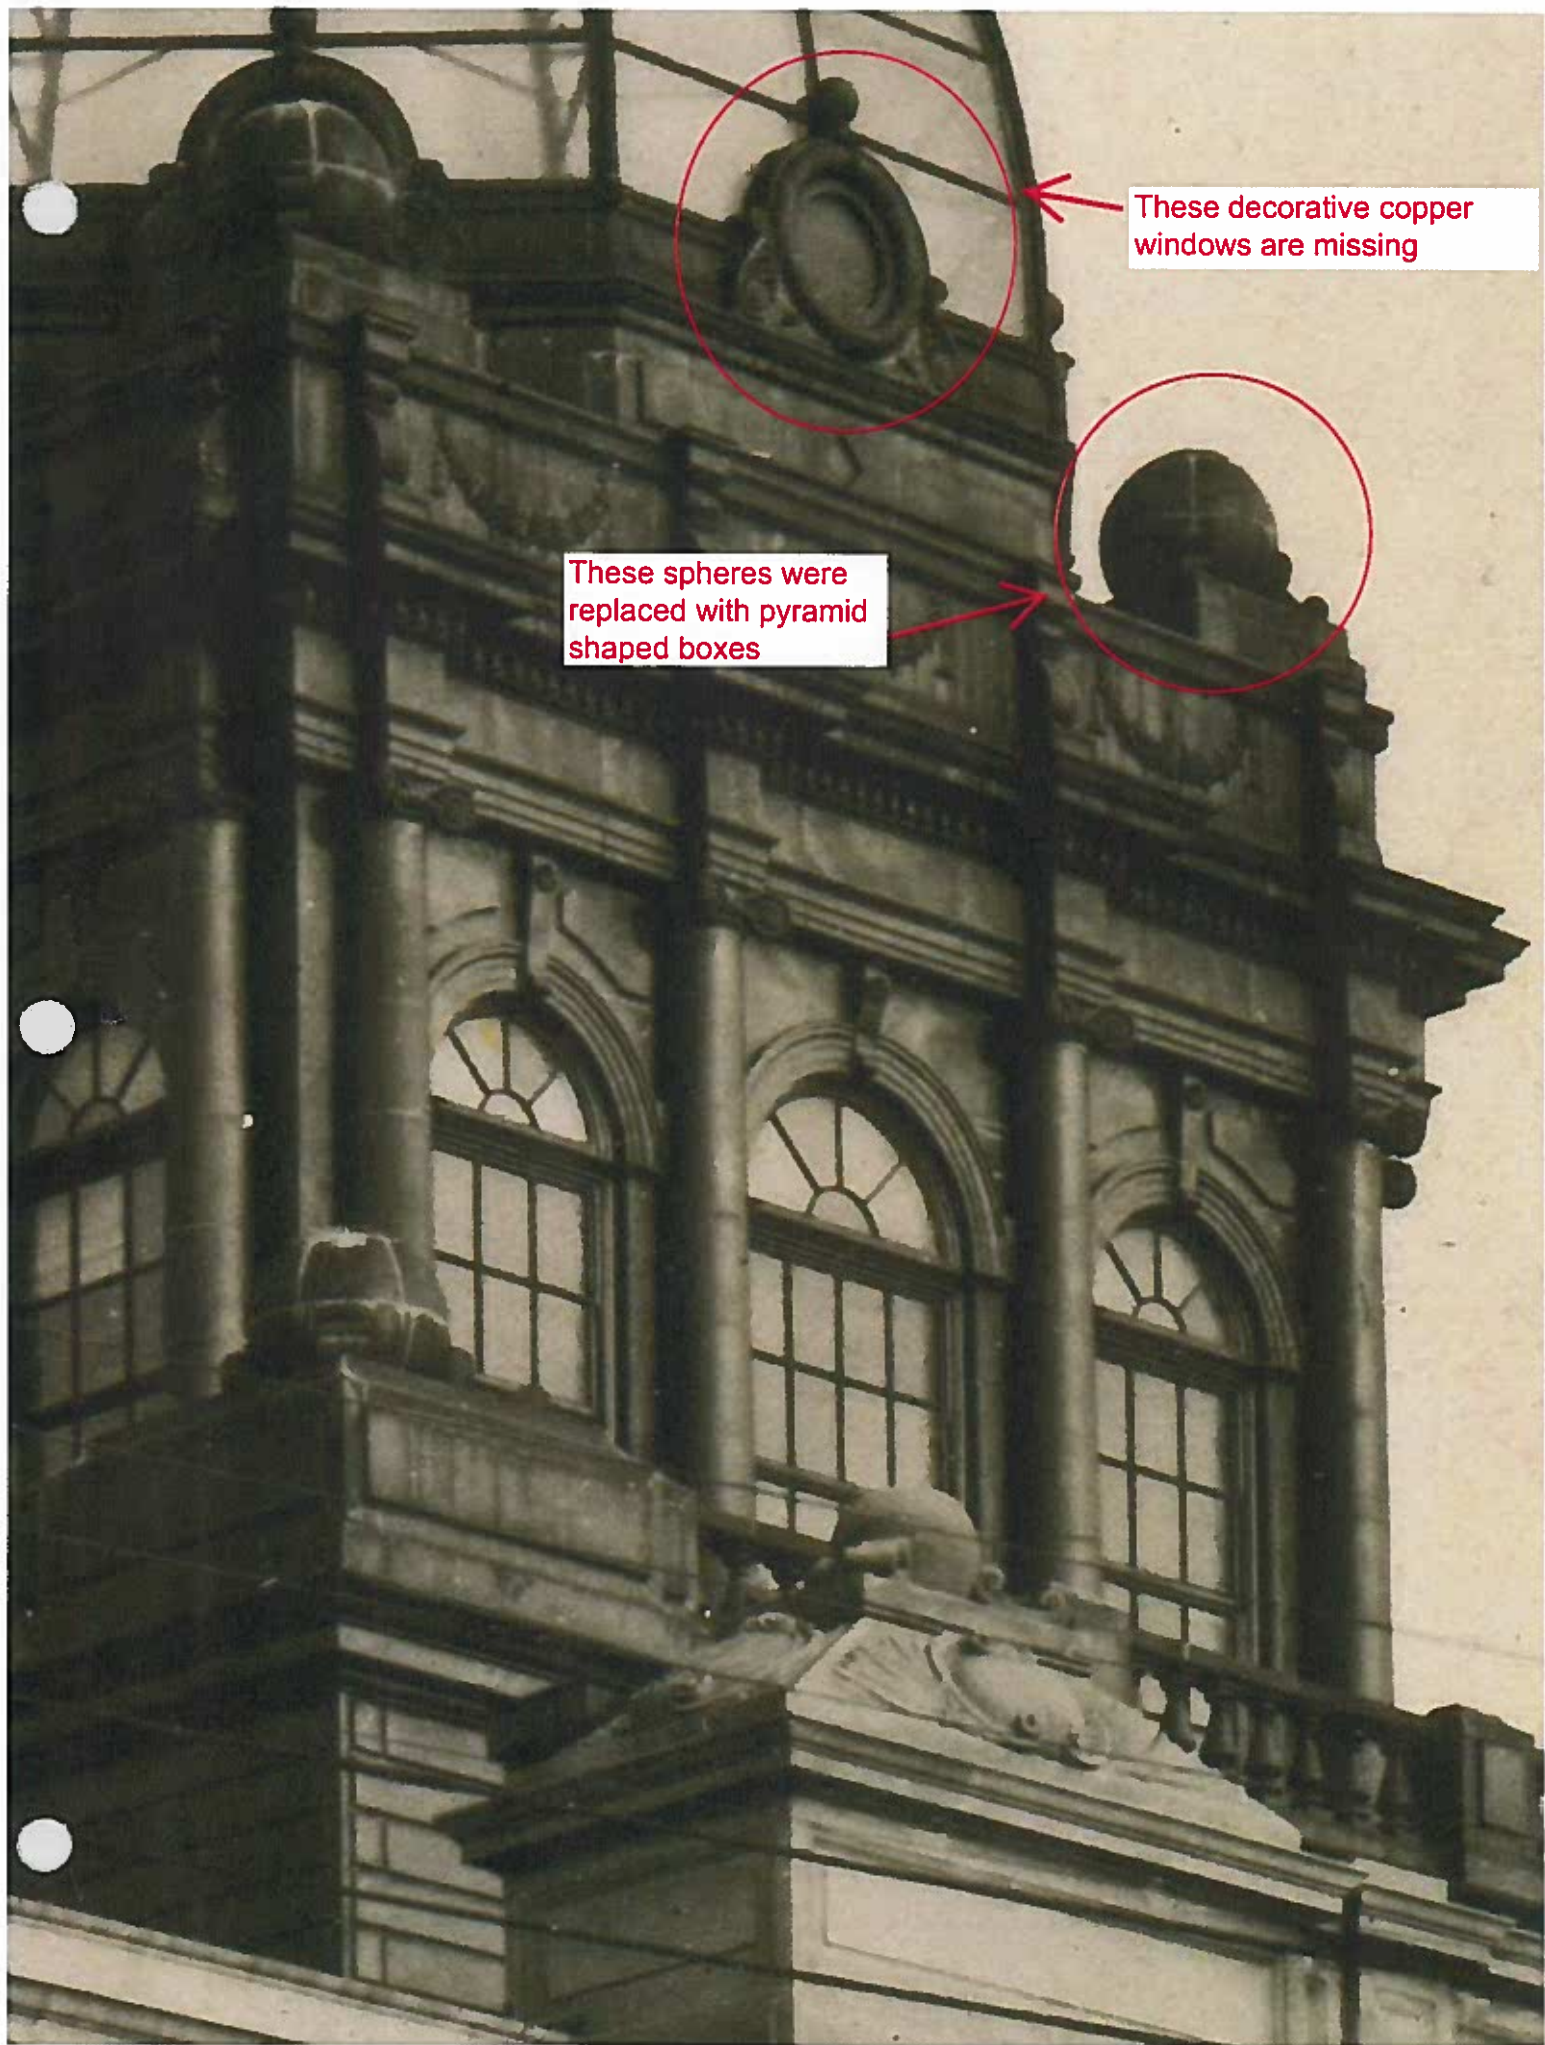
These decorative copper windows are missing

These spheres were replaced with pyramid shaped boxes

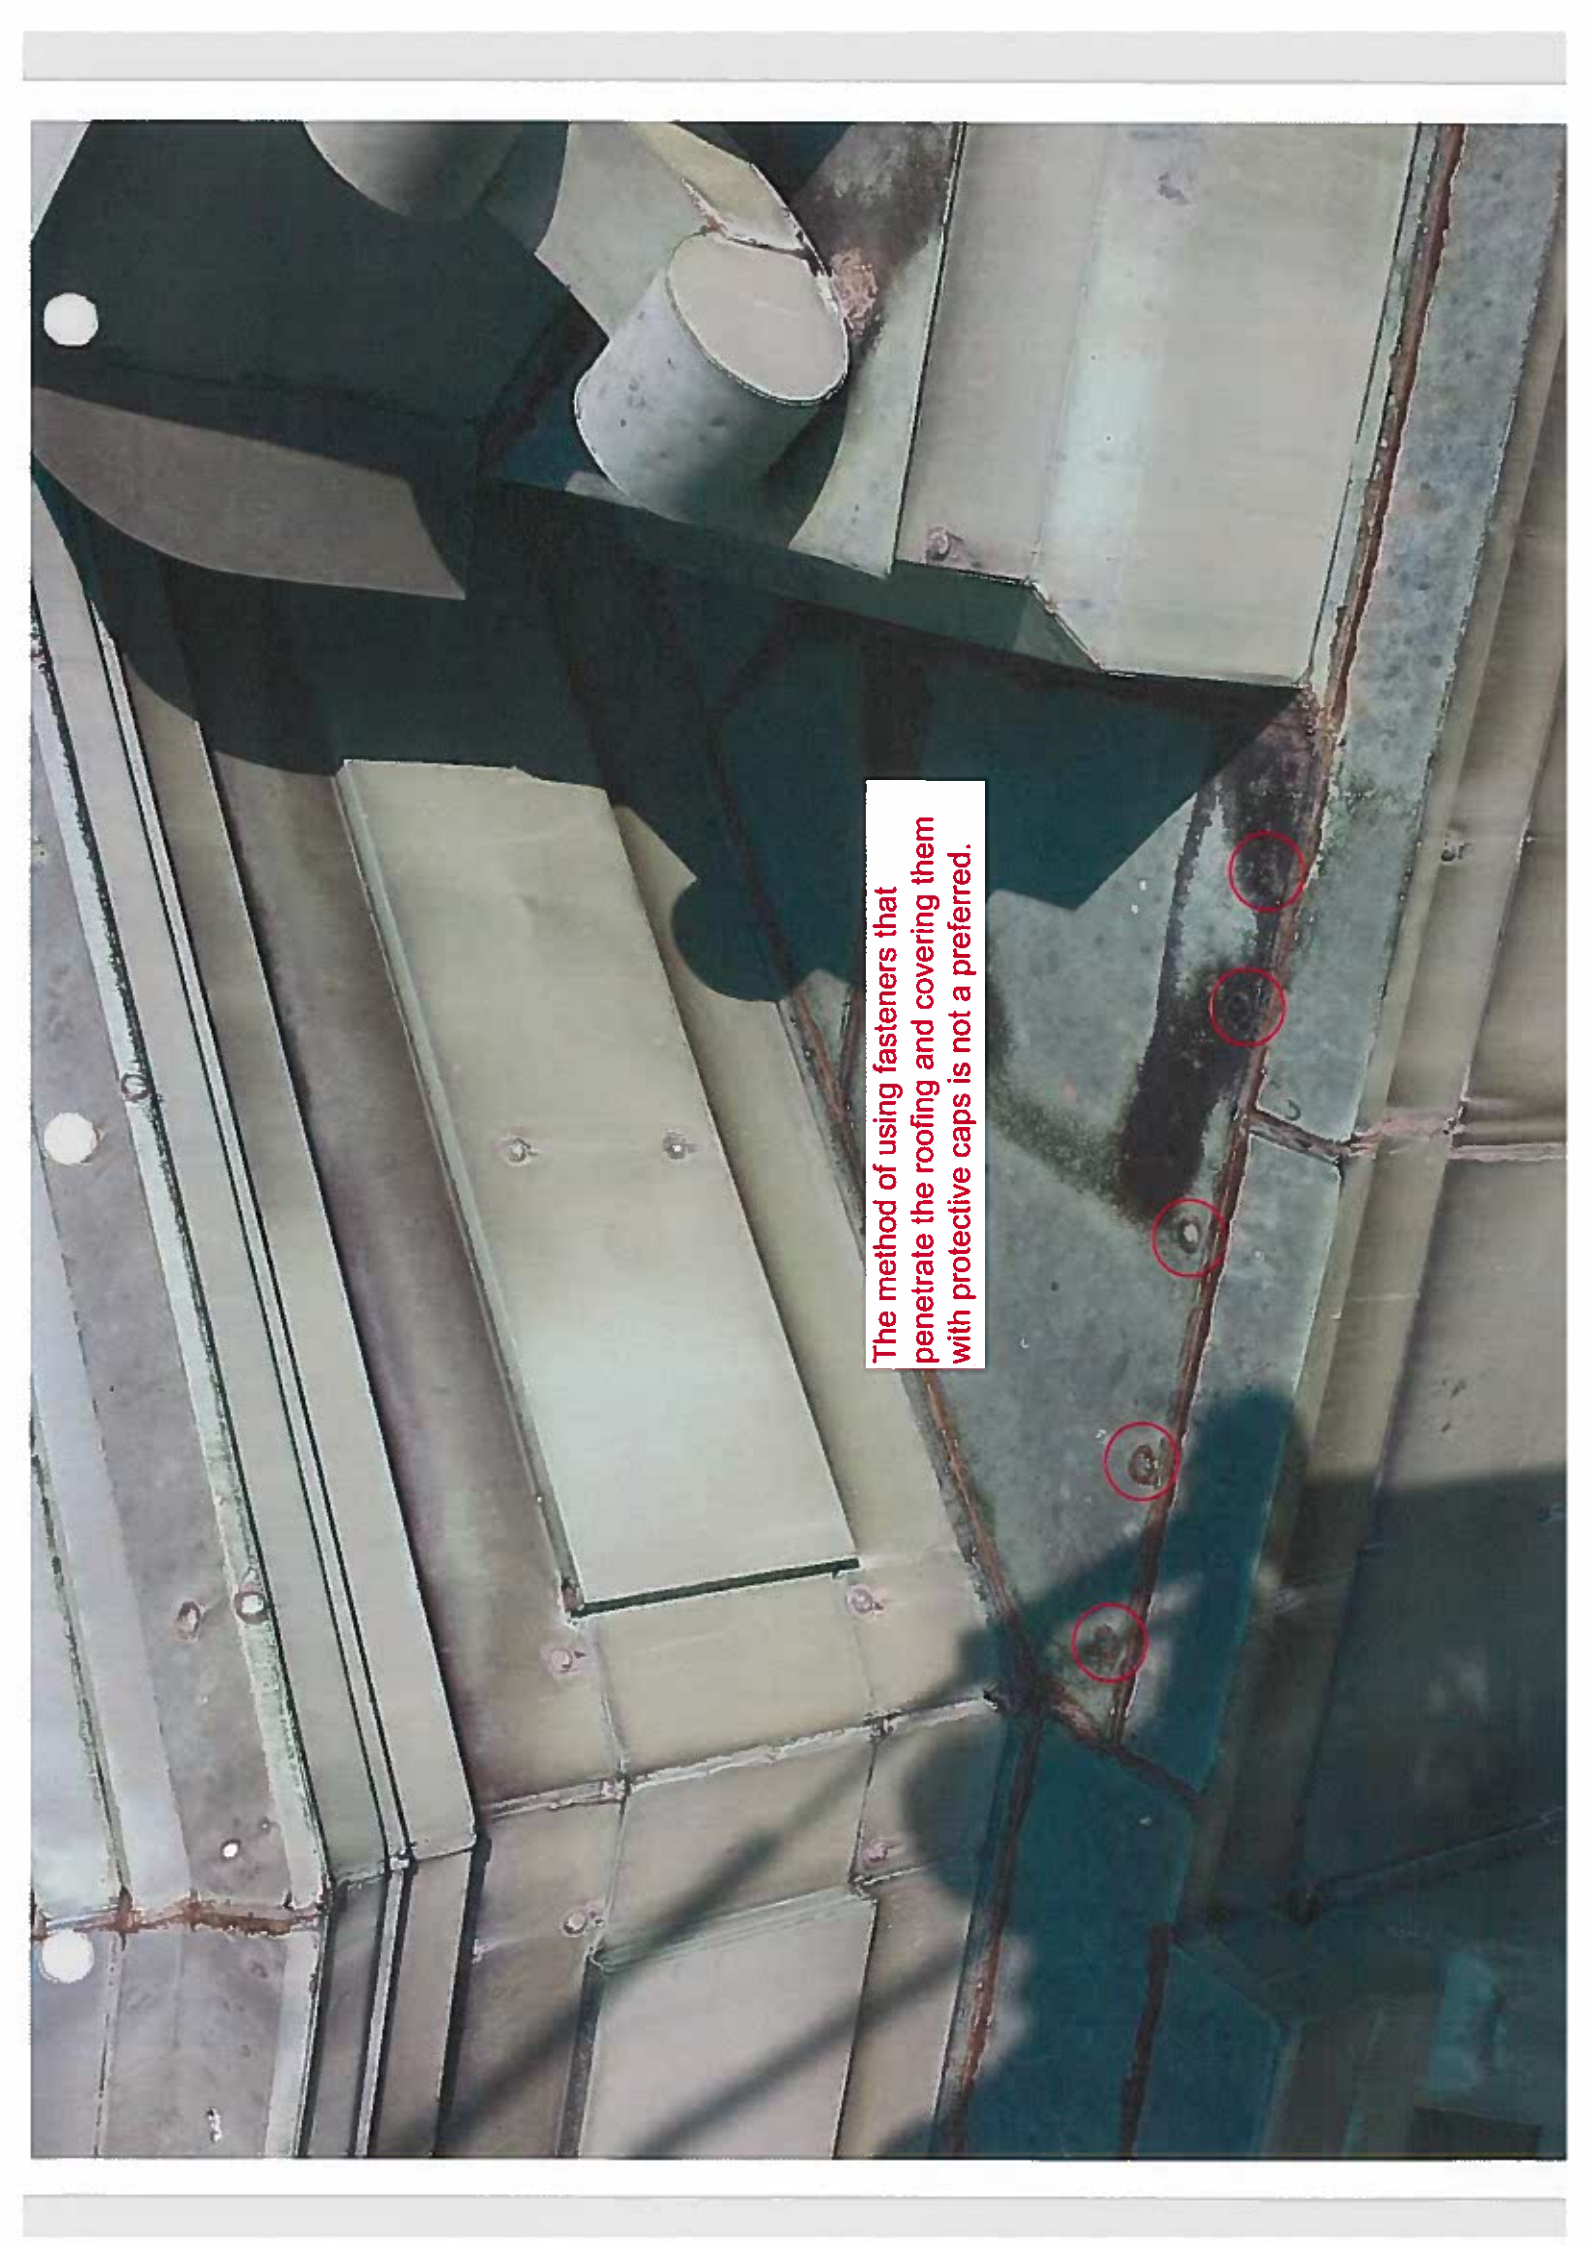
The method of using fasteners that penetrate the roofing and covering them with protective caps is not a preferred.

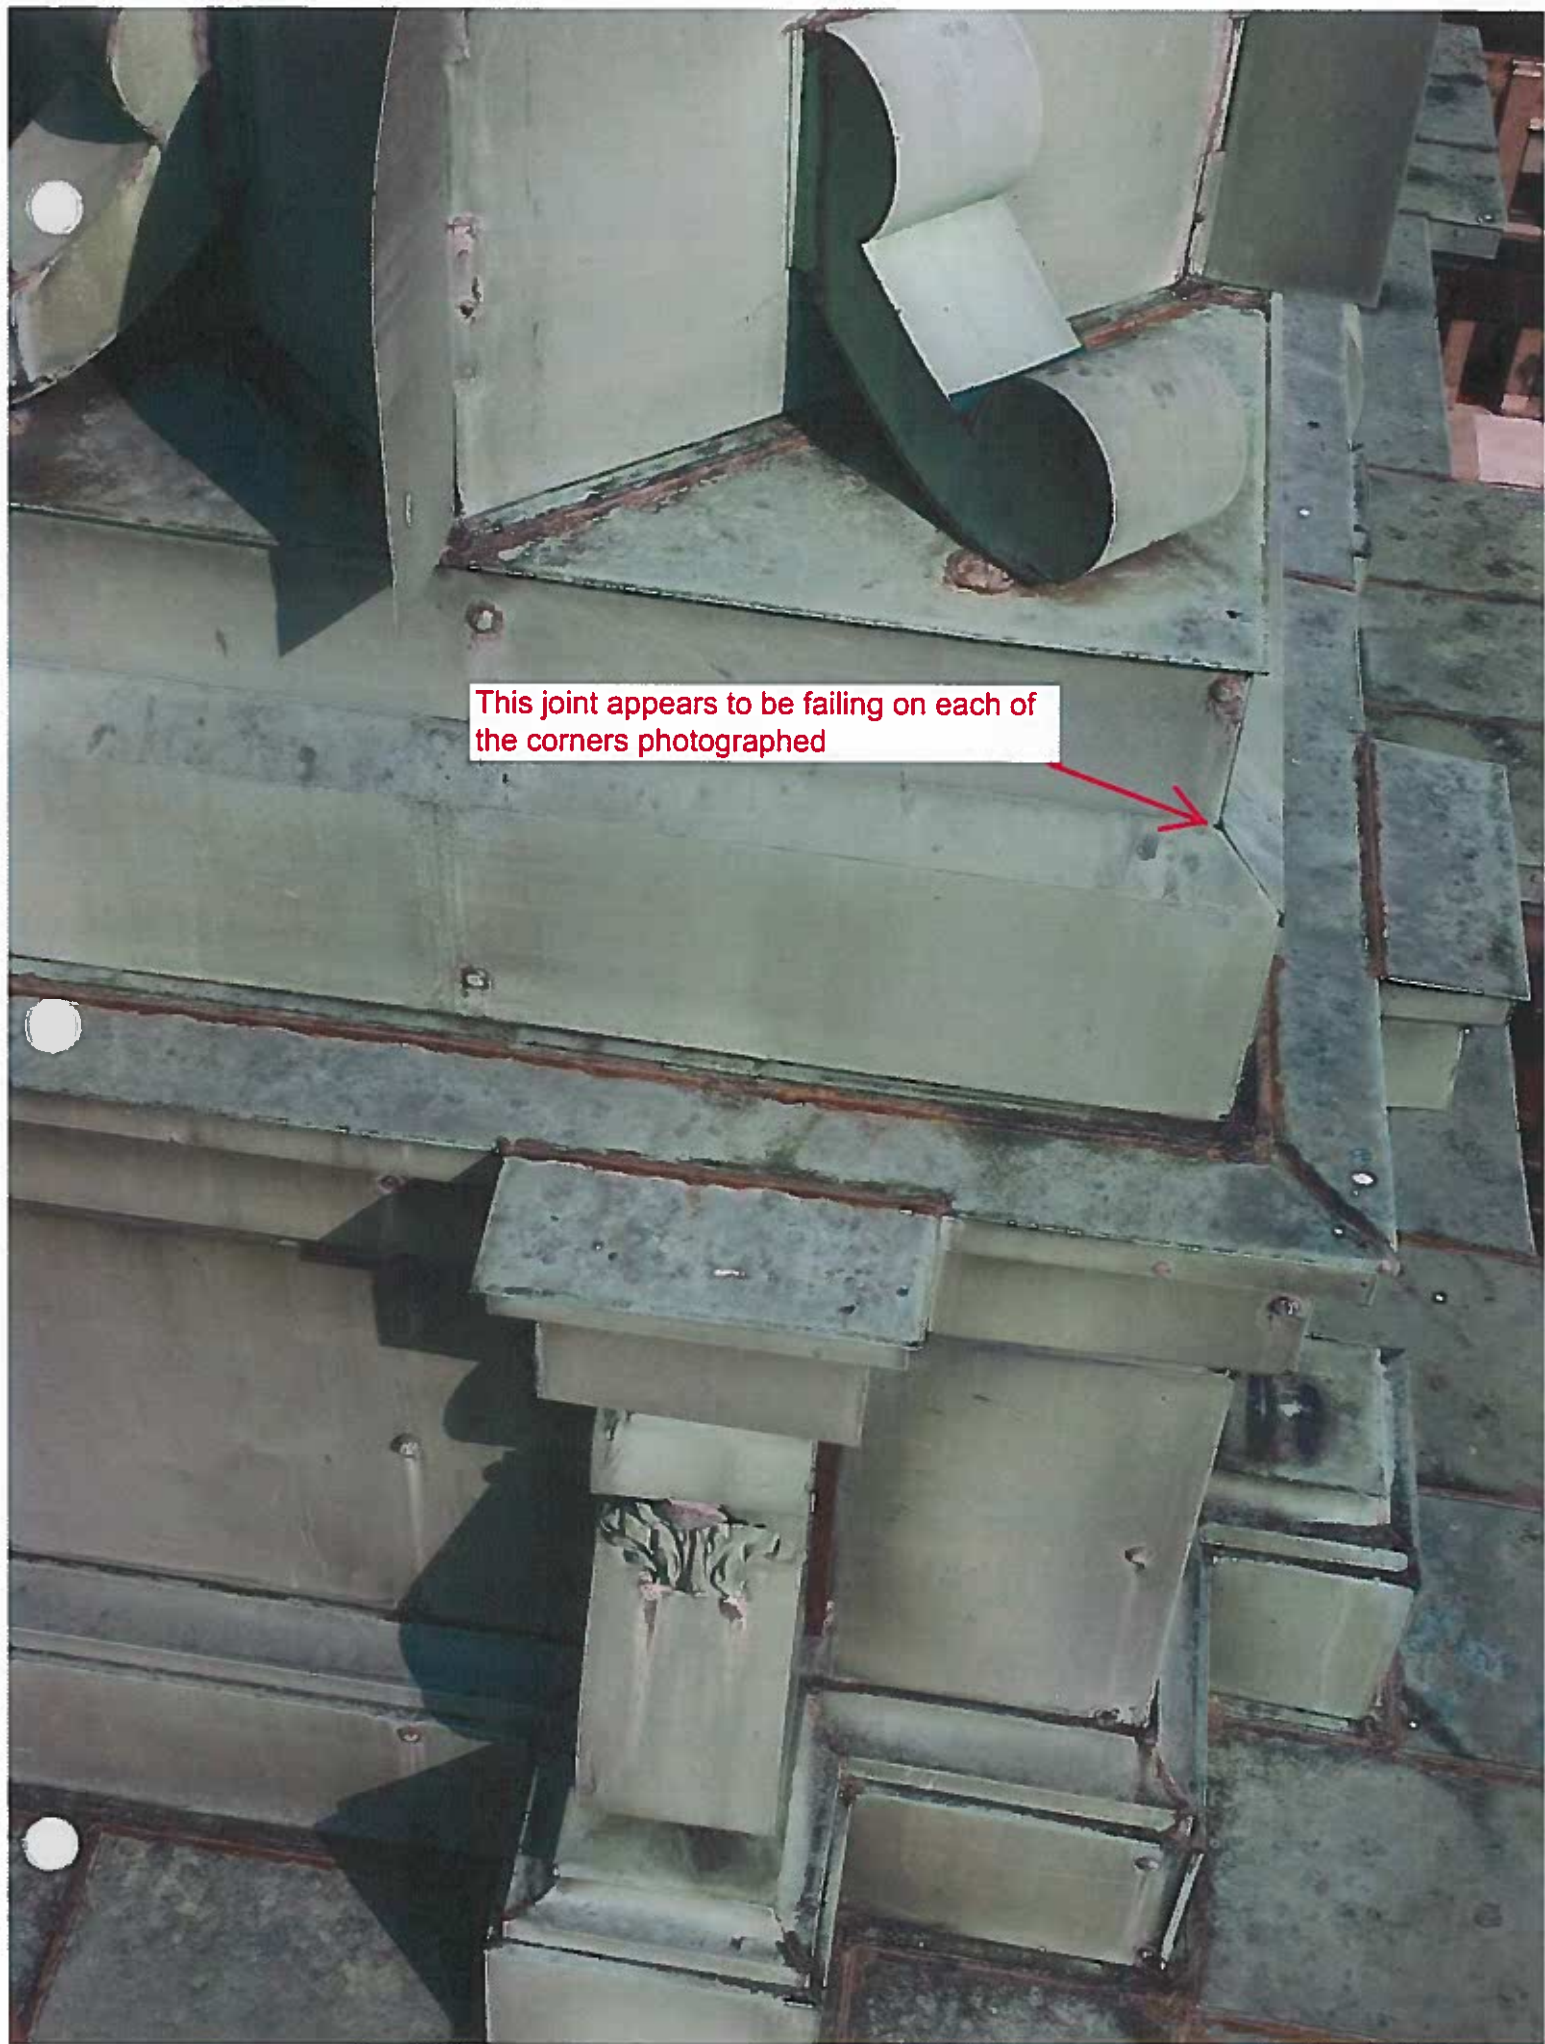
This joint appears to be failing on each of the corners photographed

Missing protective cap

Cracked seam

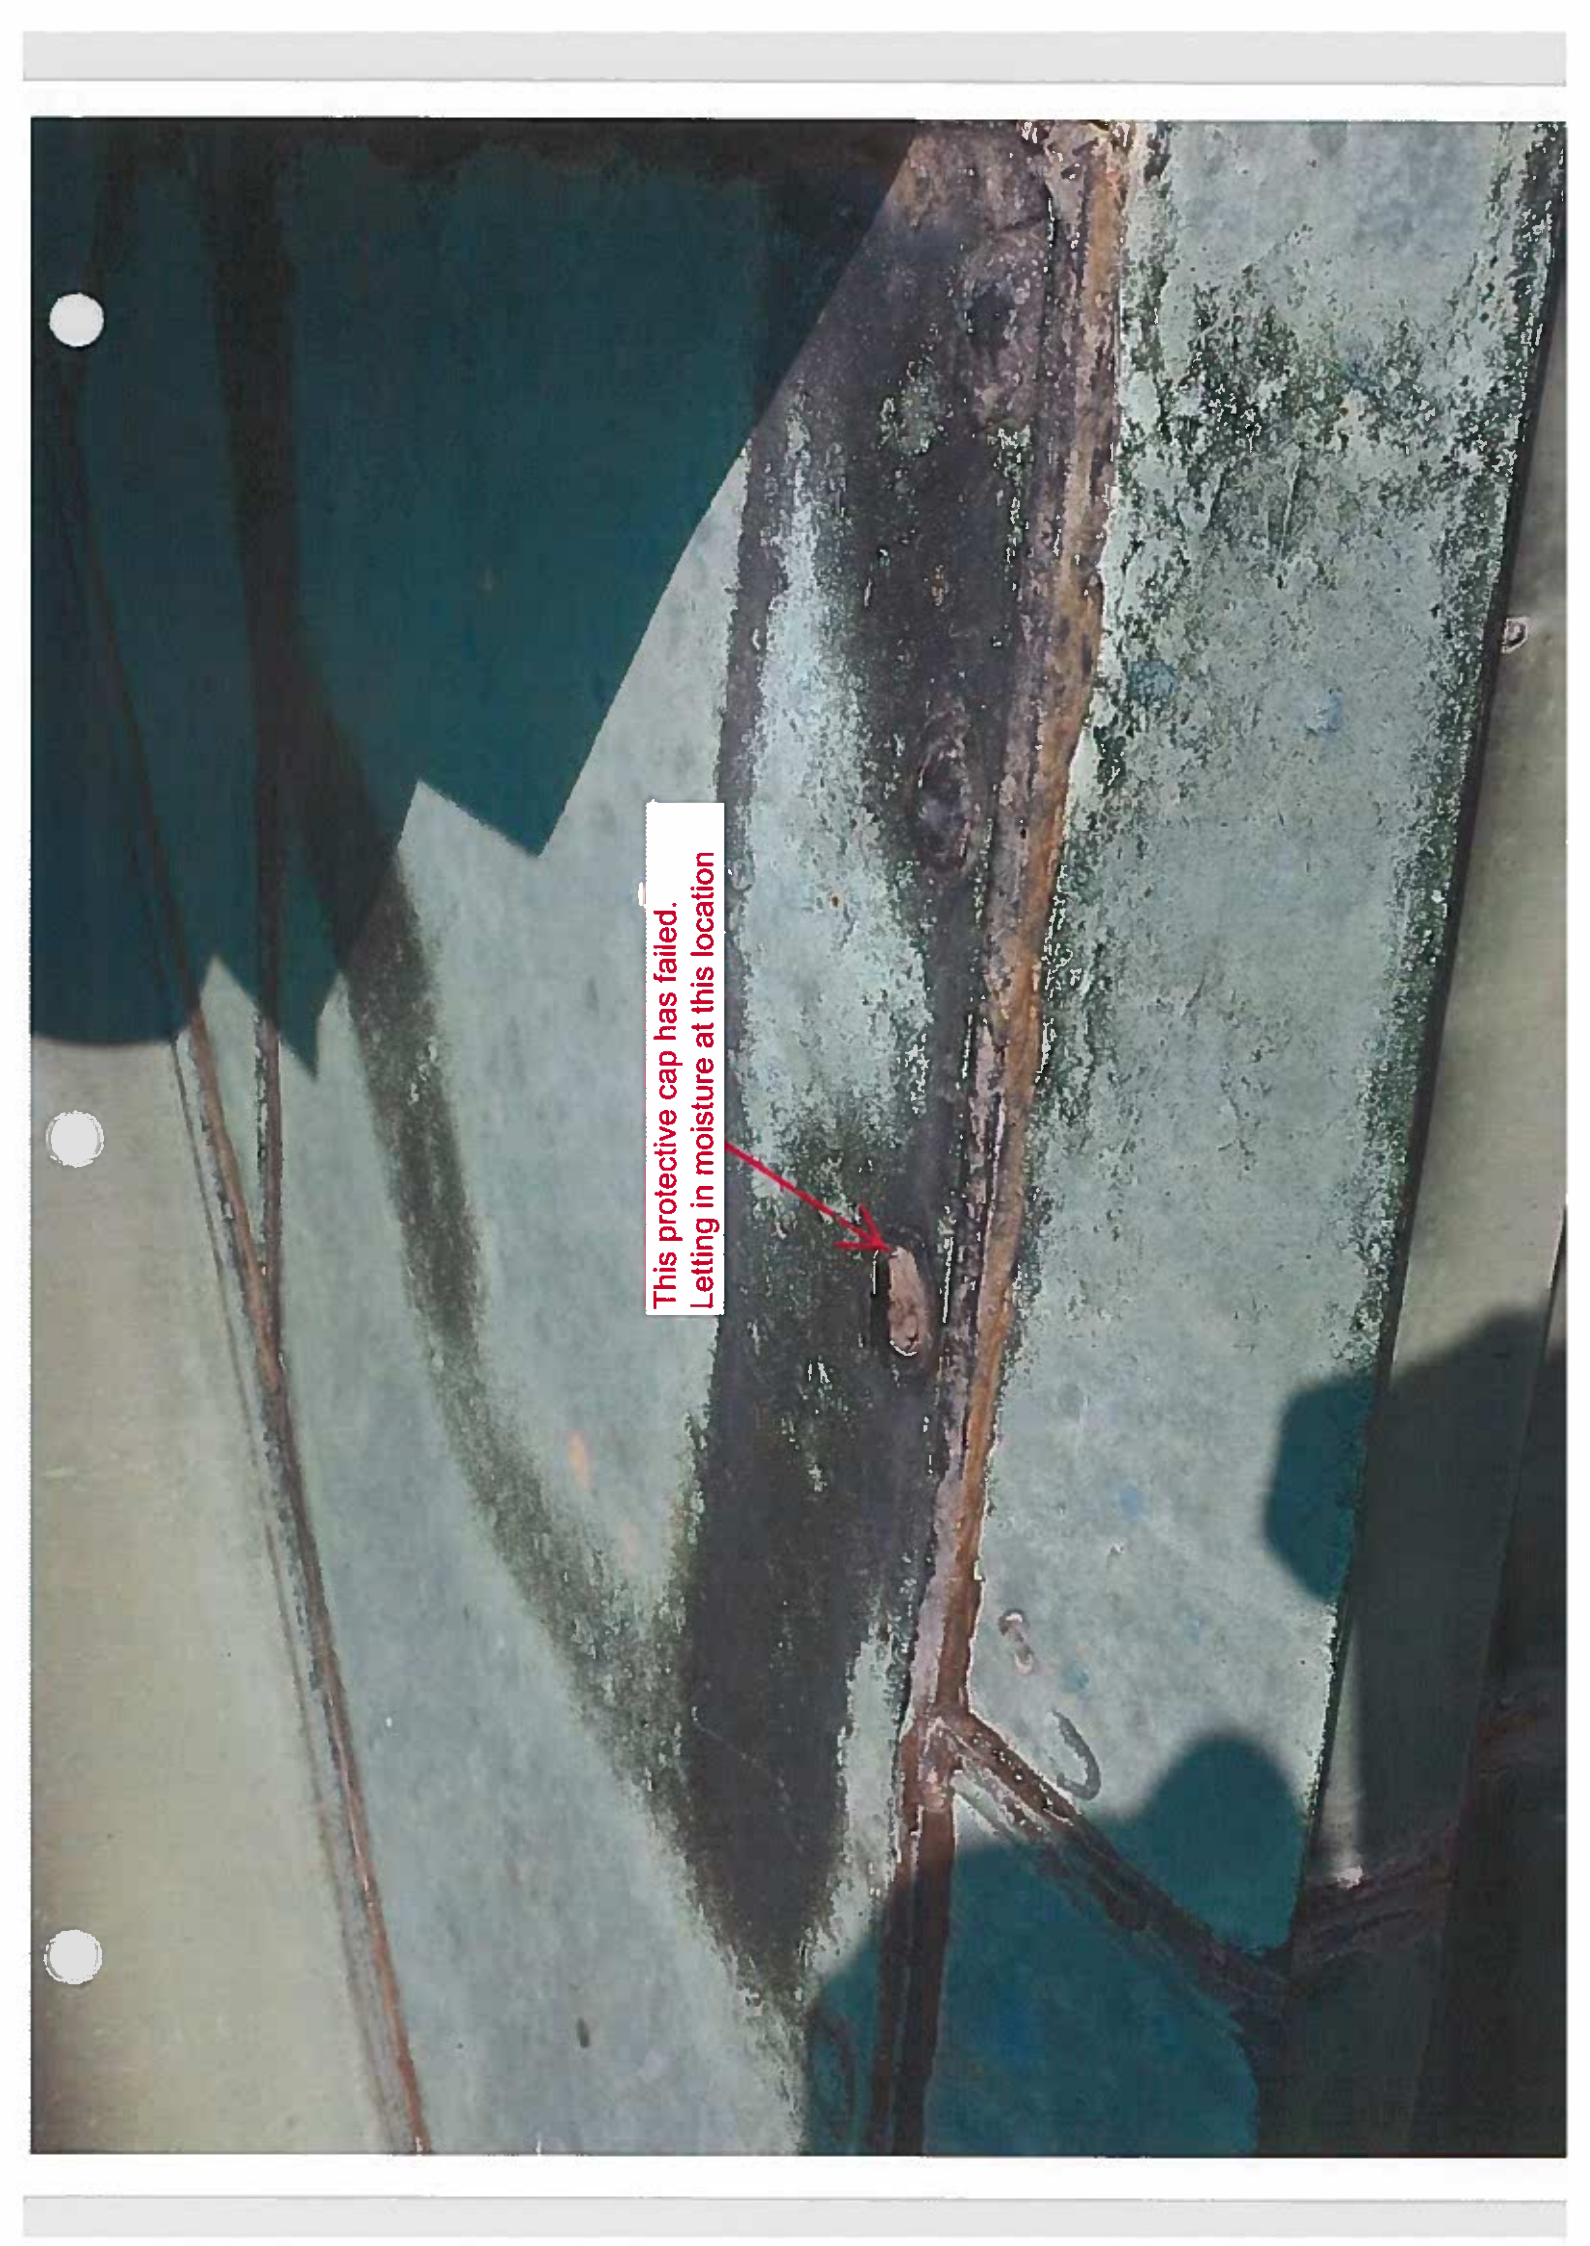
This protective cap has failed.  
Letting in moisture at this location

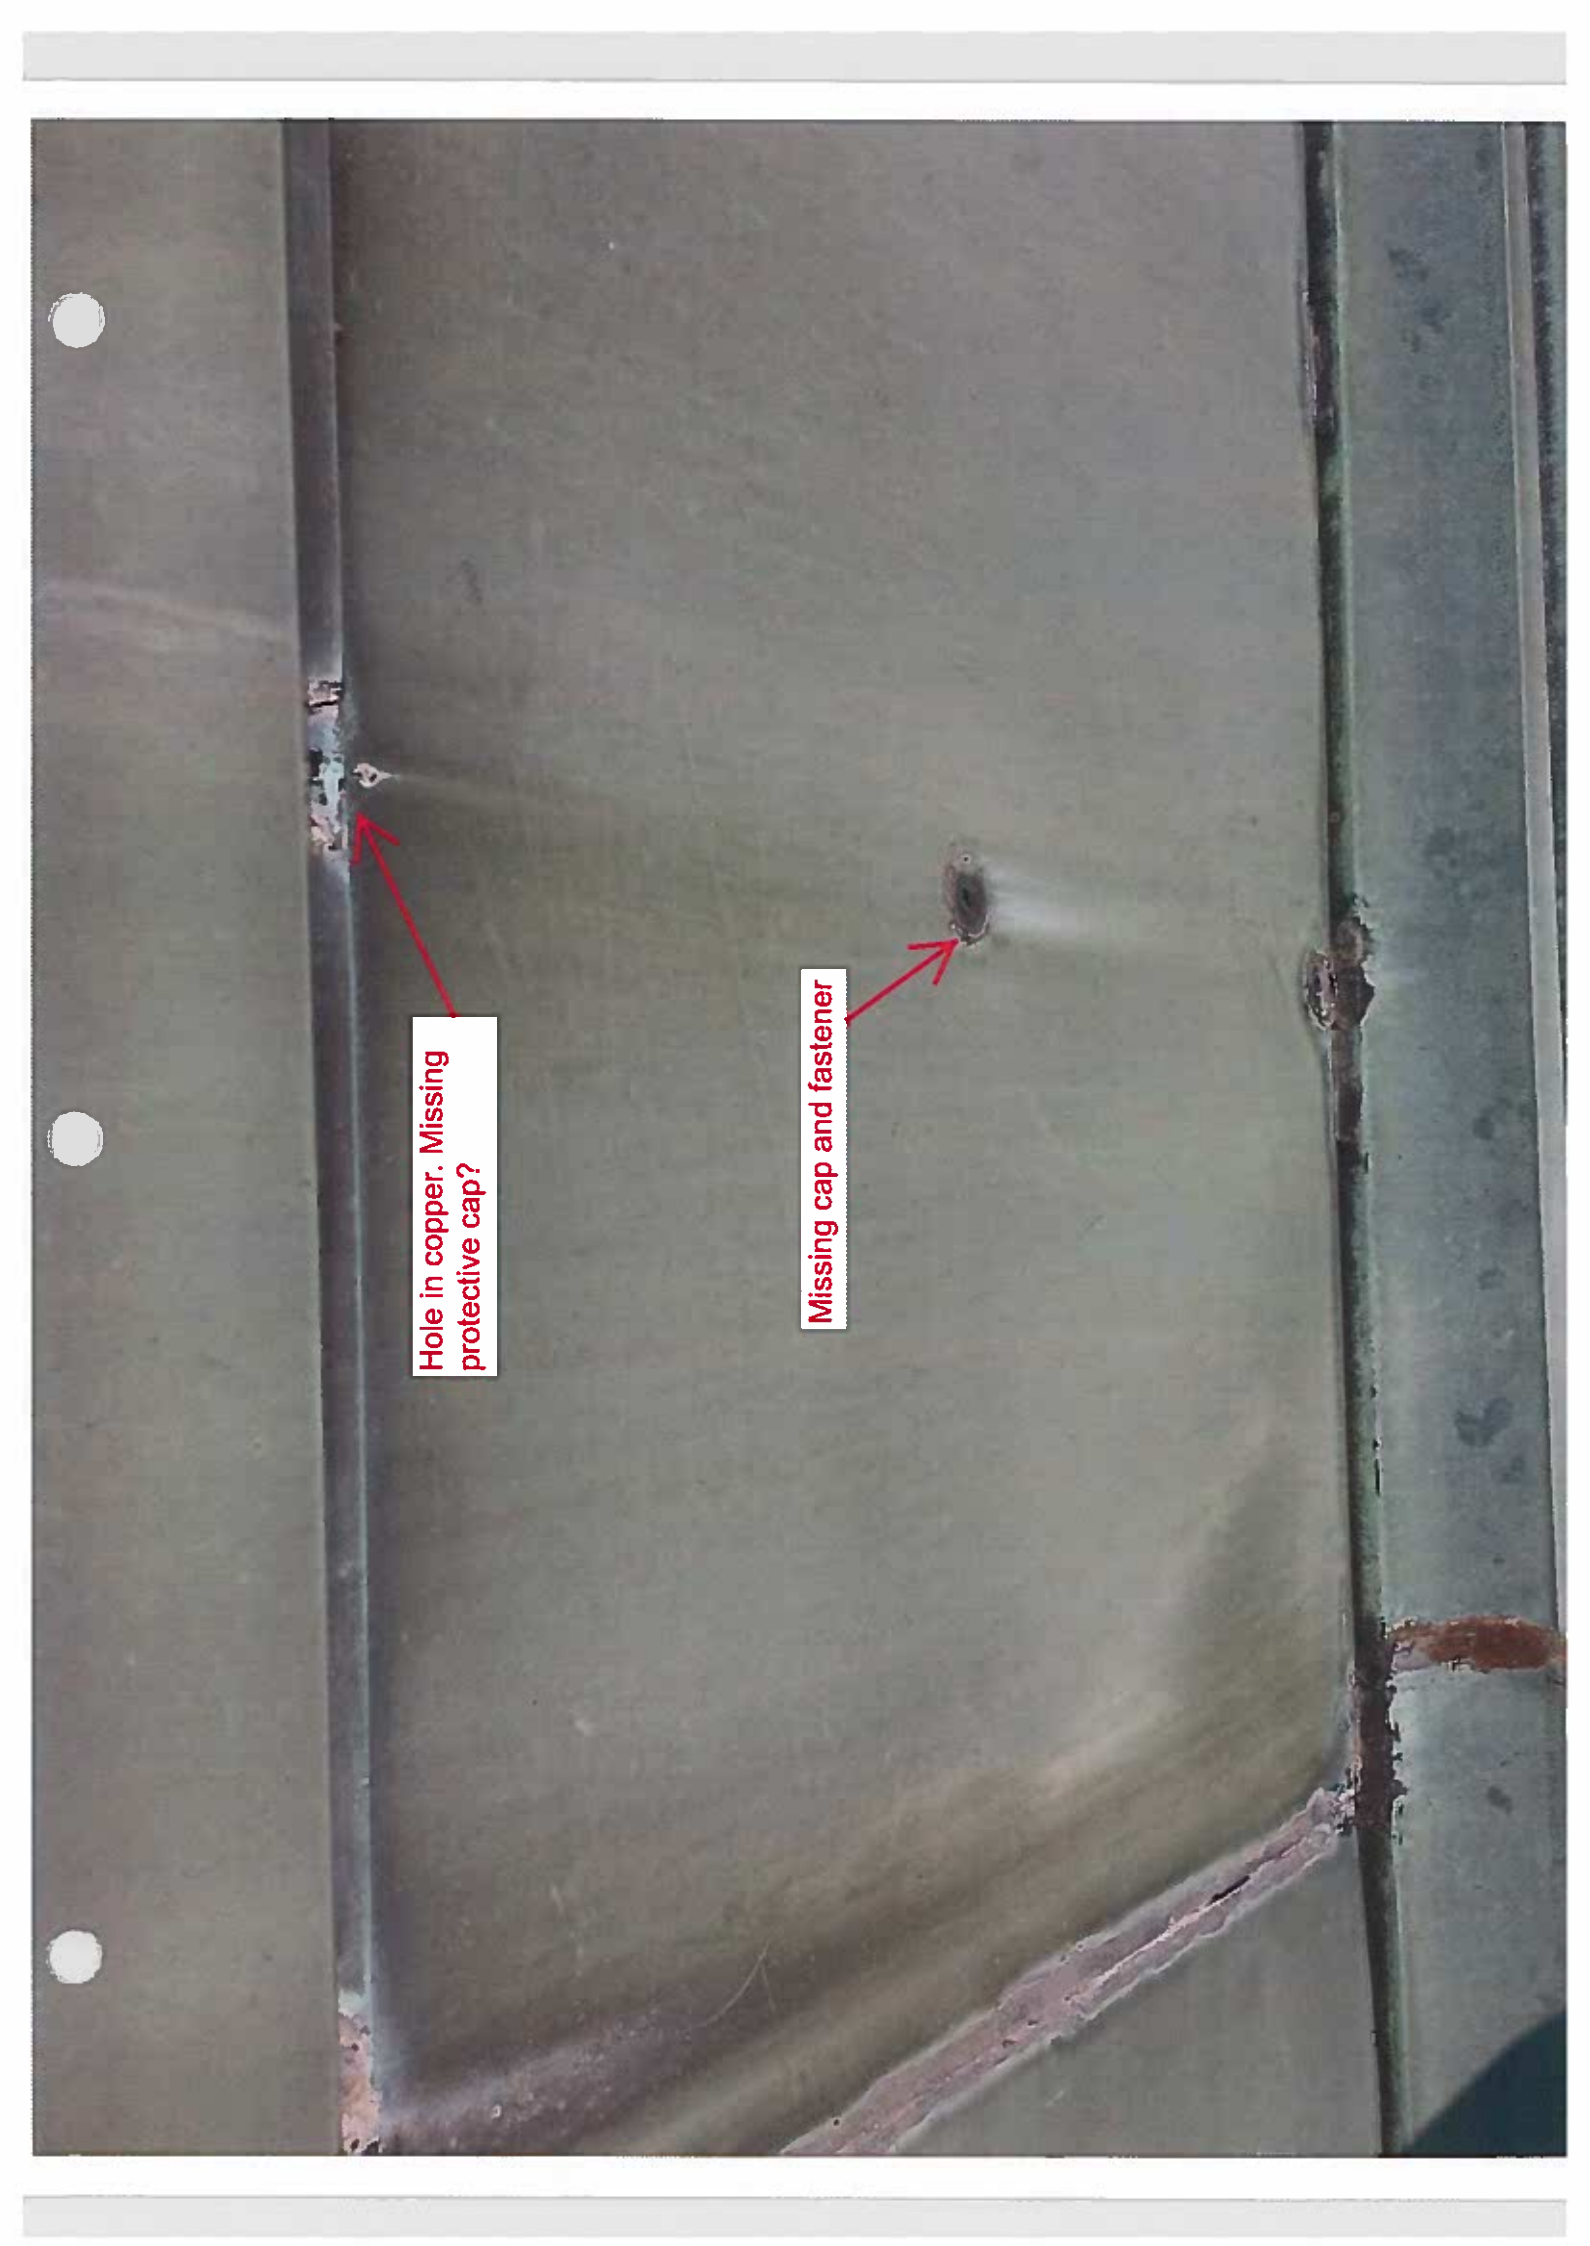
Hole in copper. Missing protective cap?

Missing cap and fastener

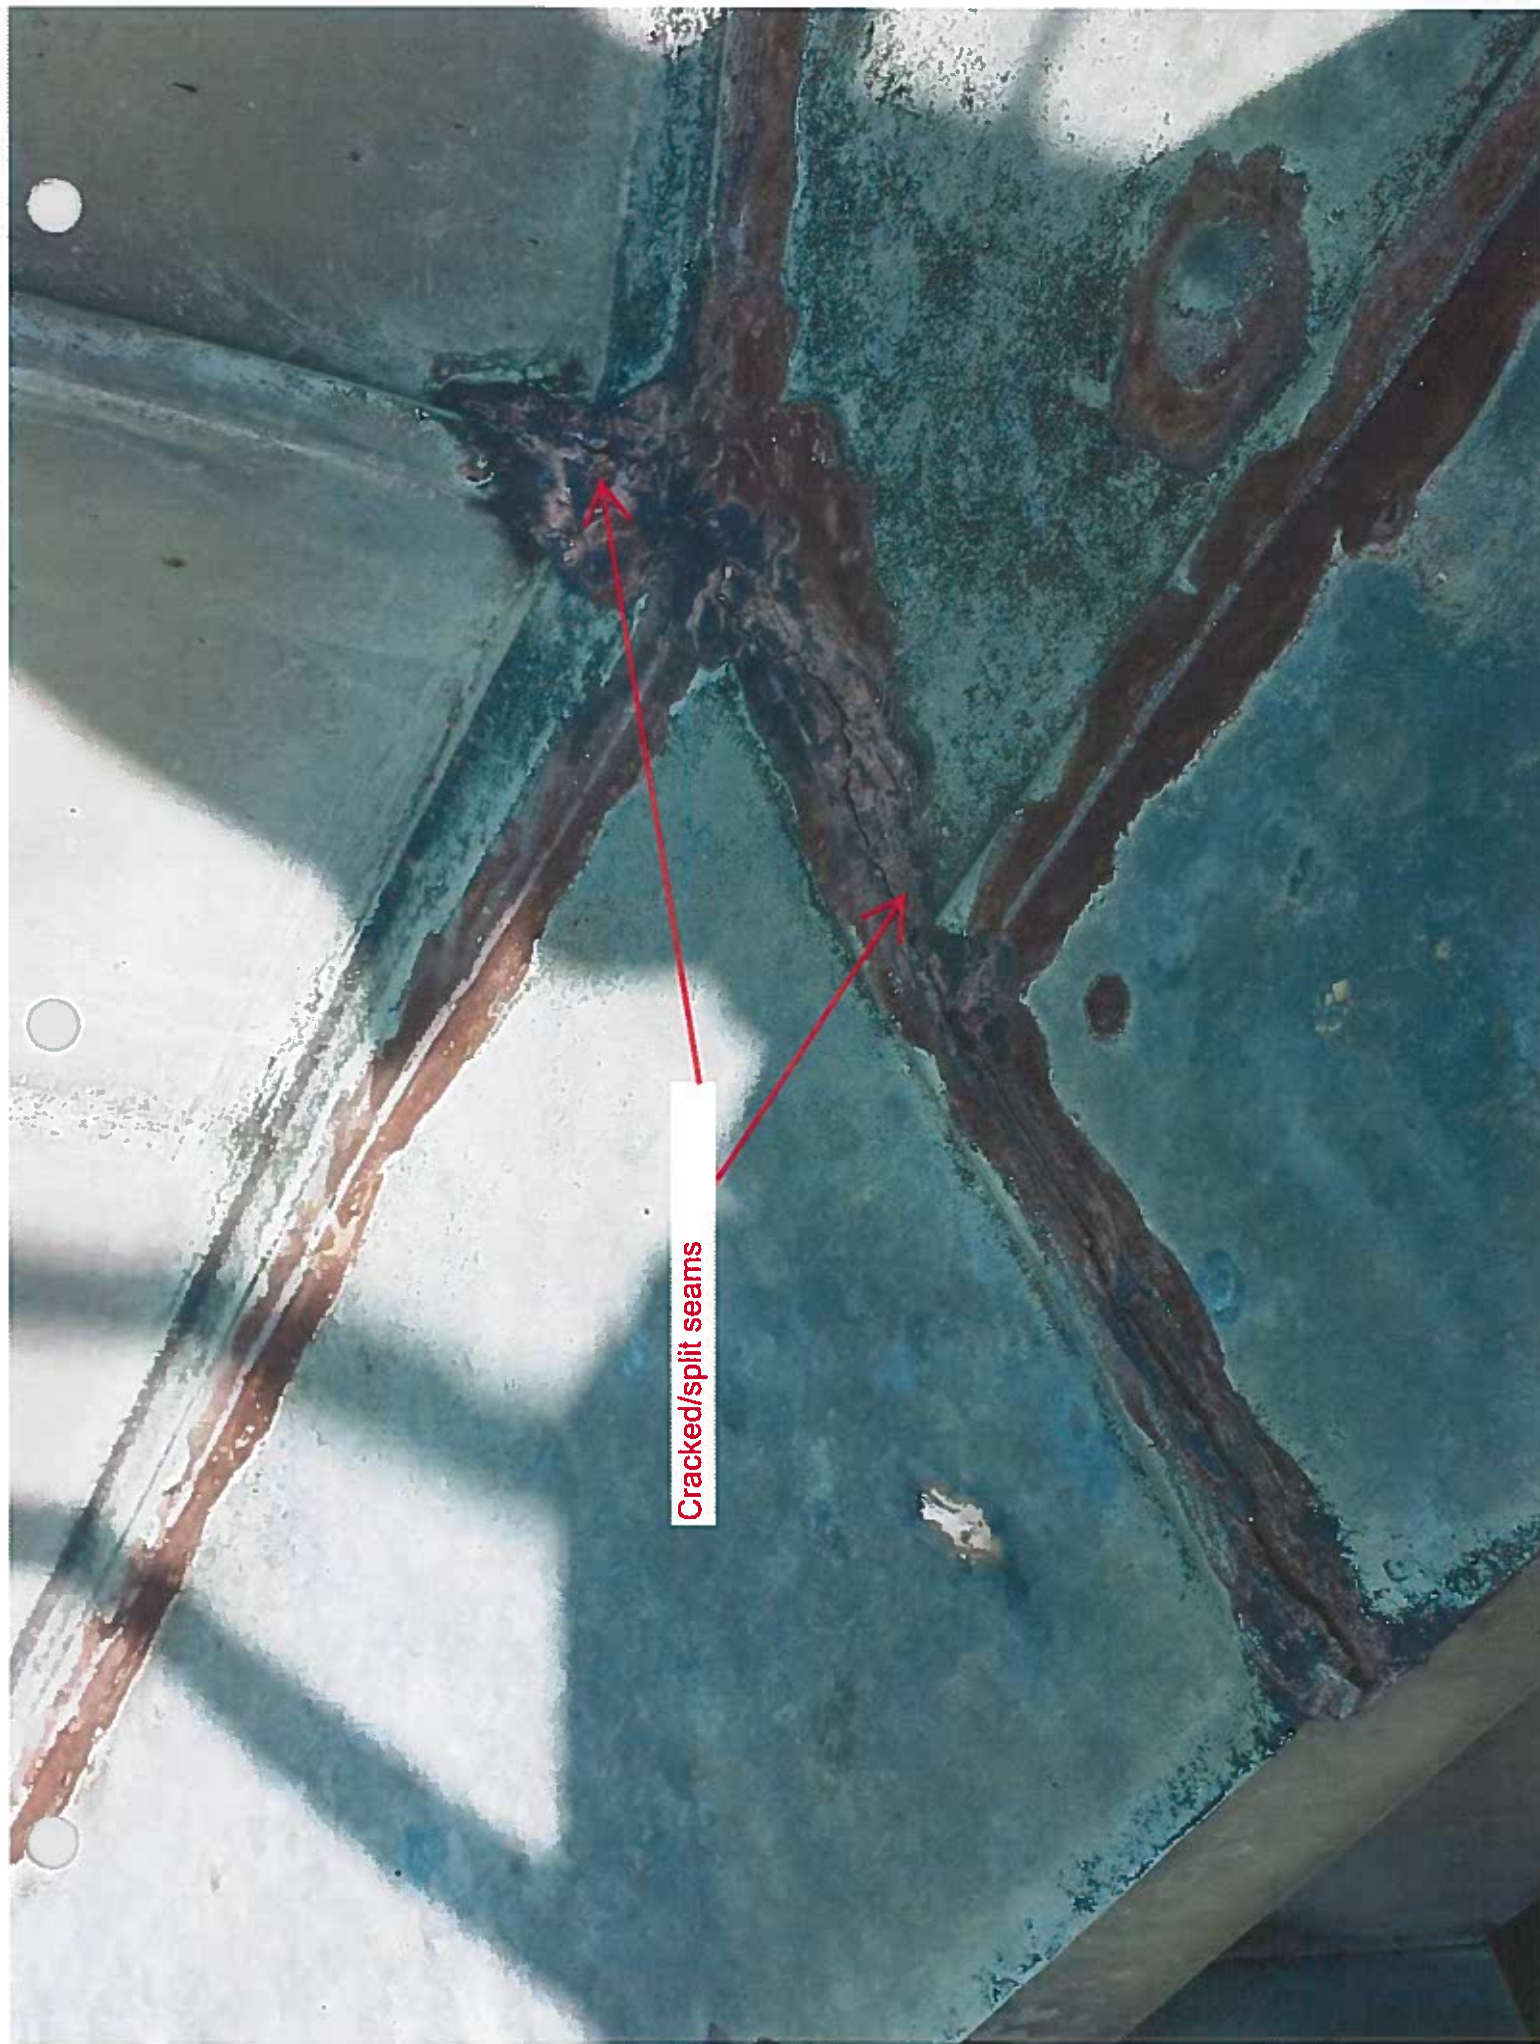
Cracked/split seams

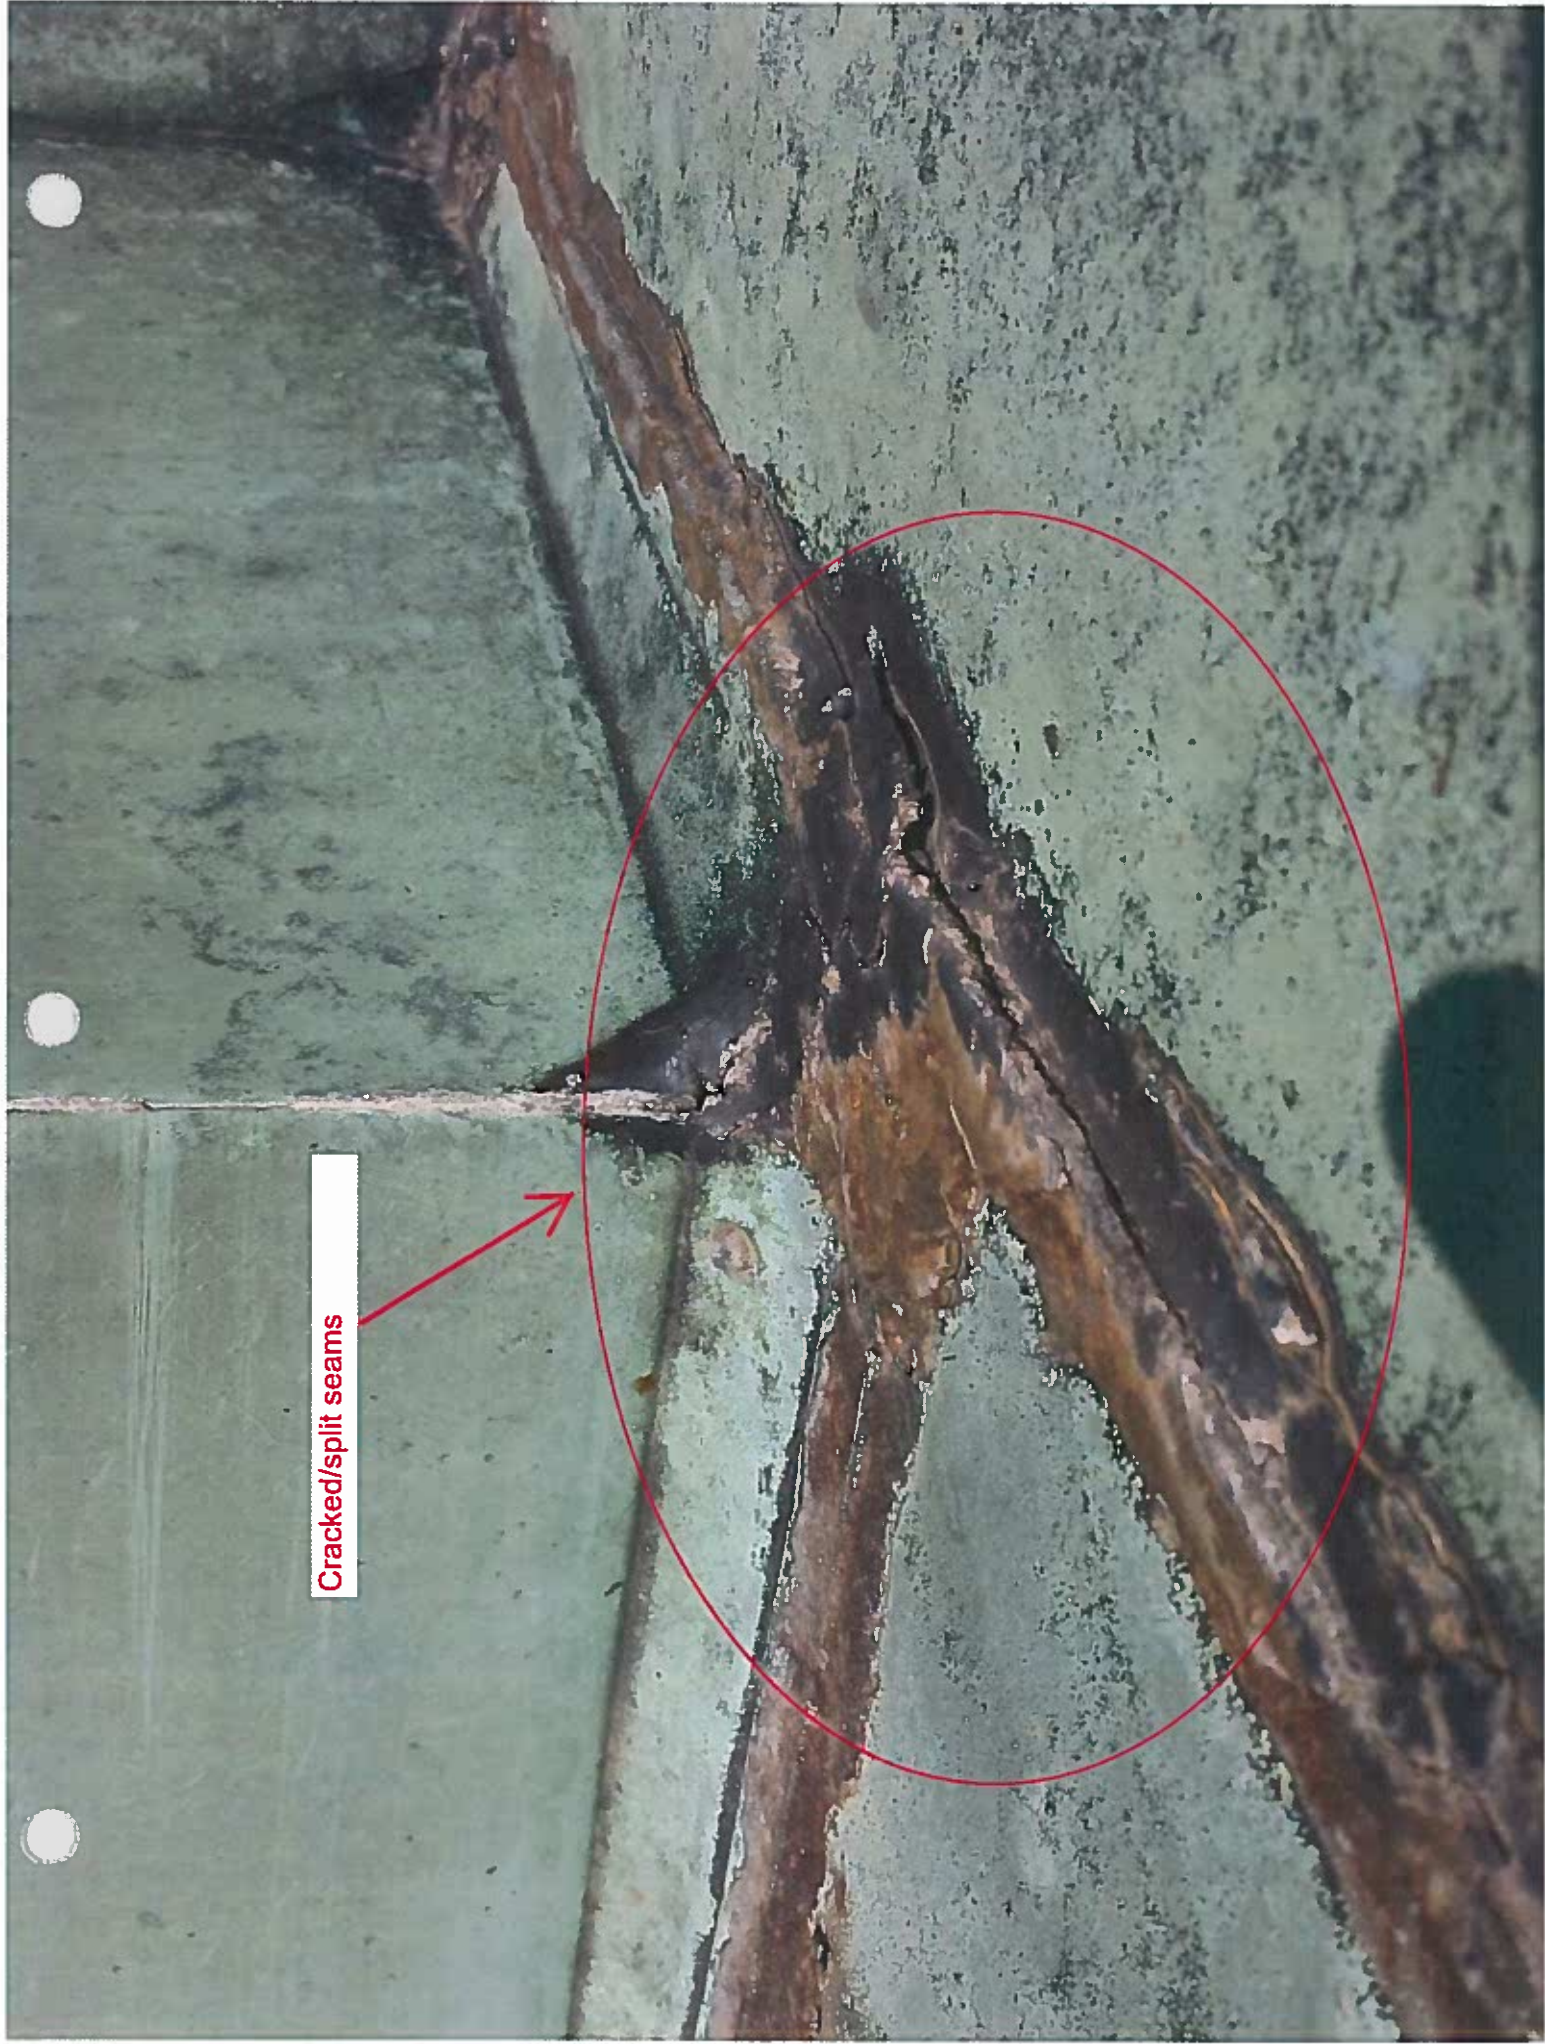
Cracked/split seams

Tear in the copper
