# Upper Ledge/ Base of Dome

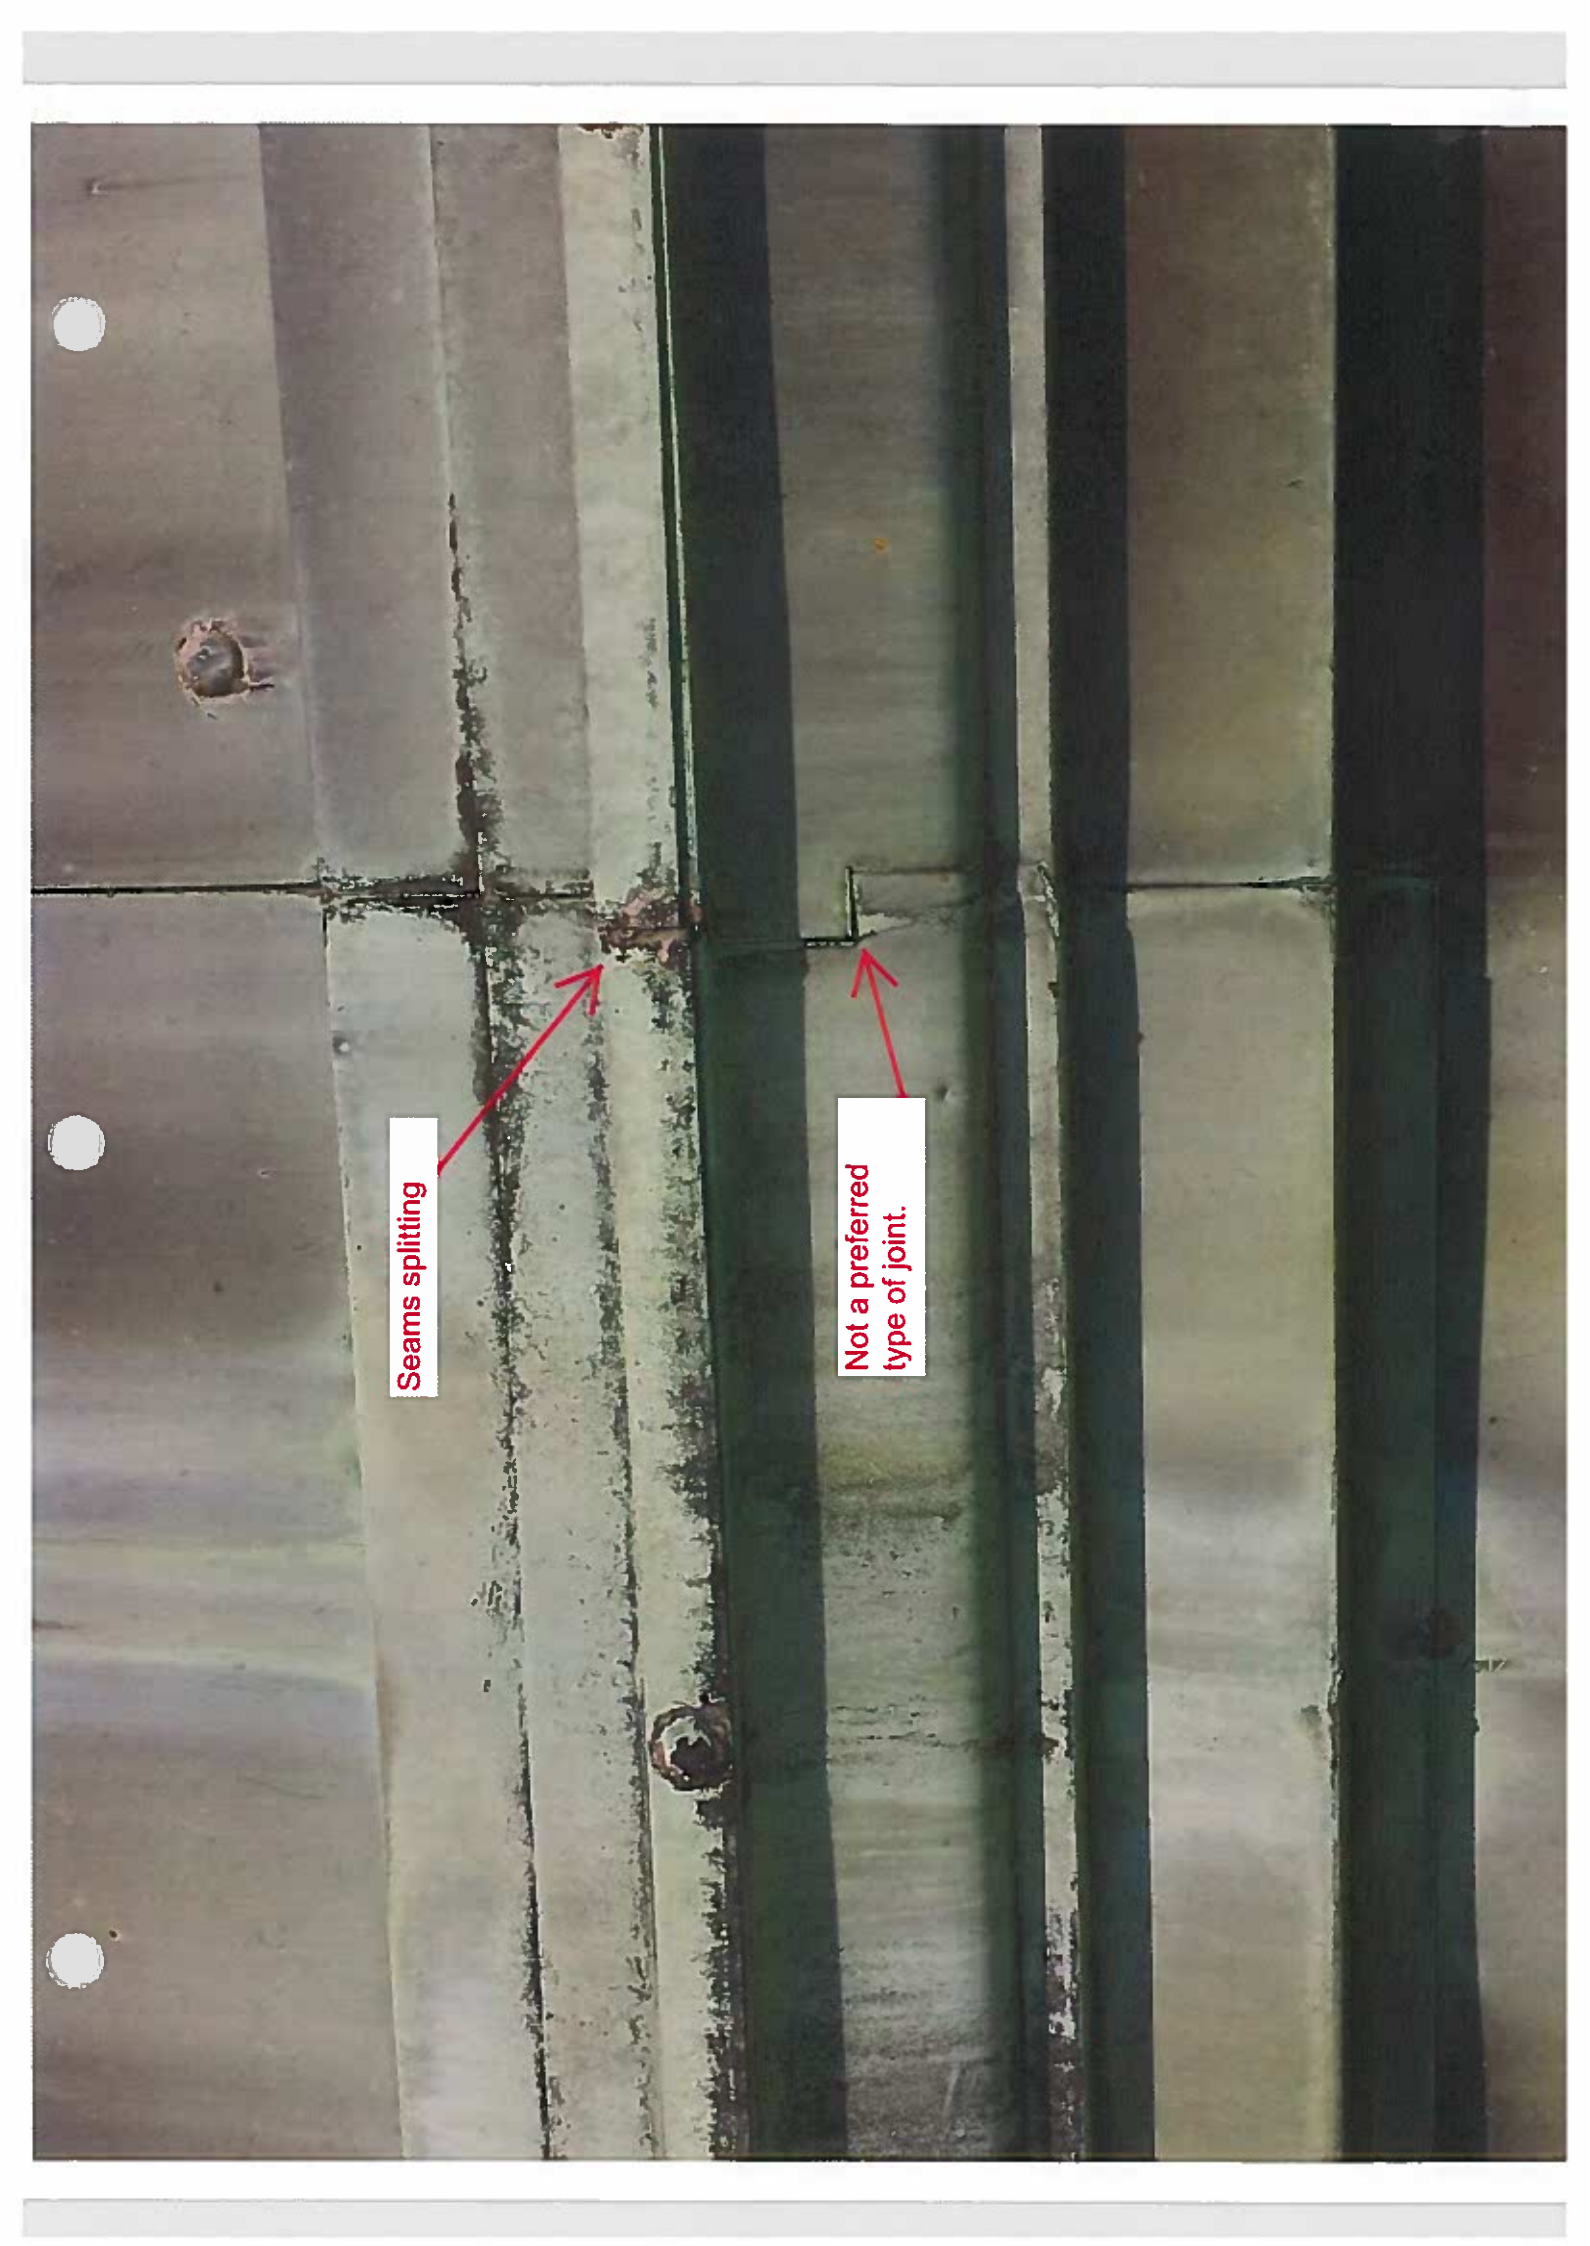
Seams splitting

Not a preferred  
type of joint.

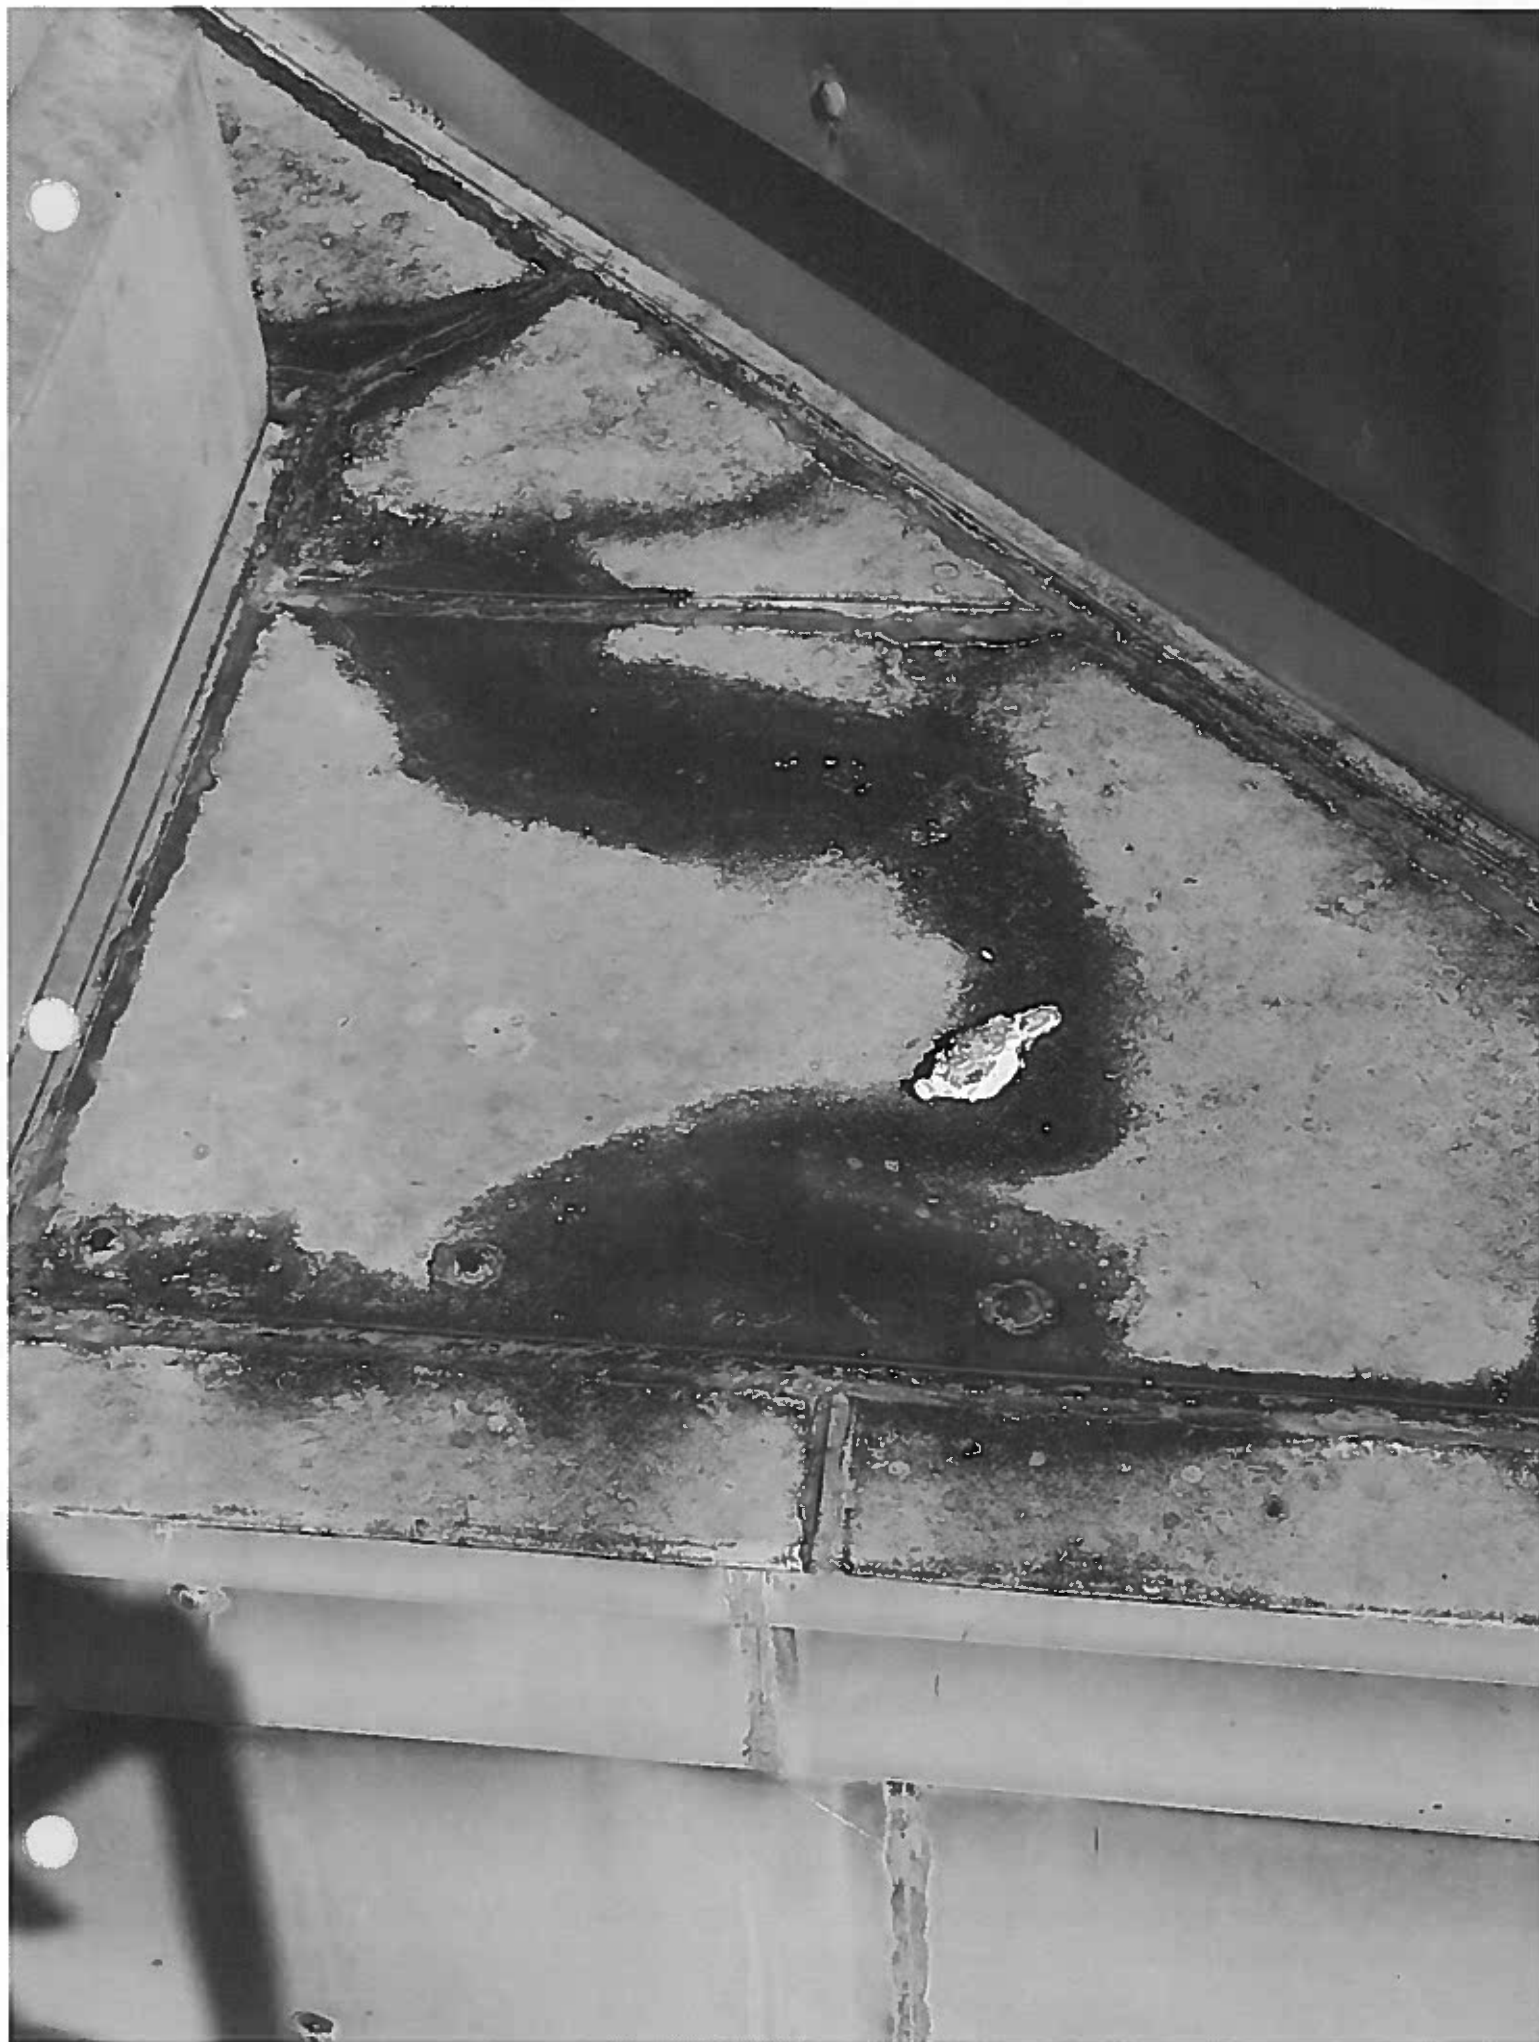
Cracked/split seam

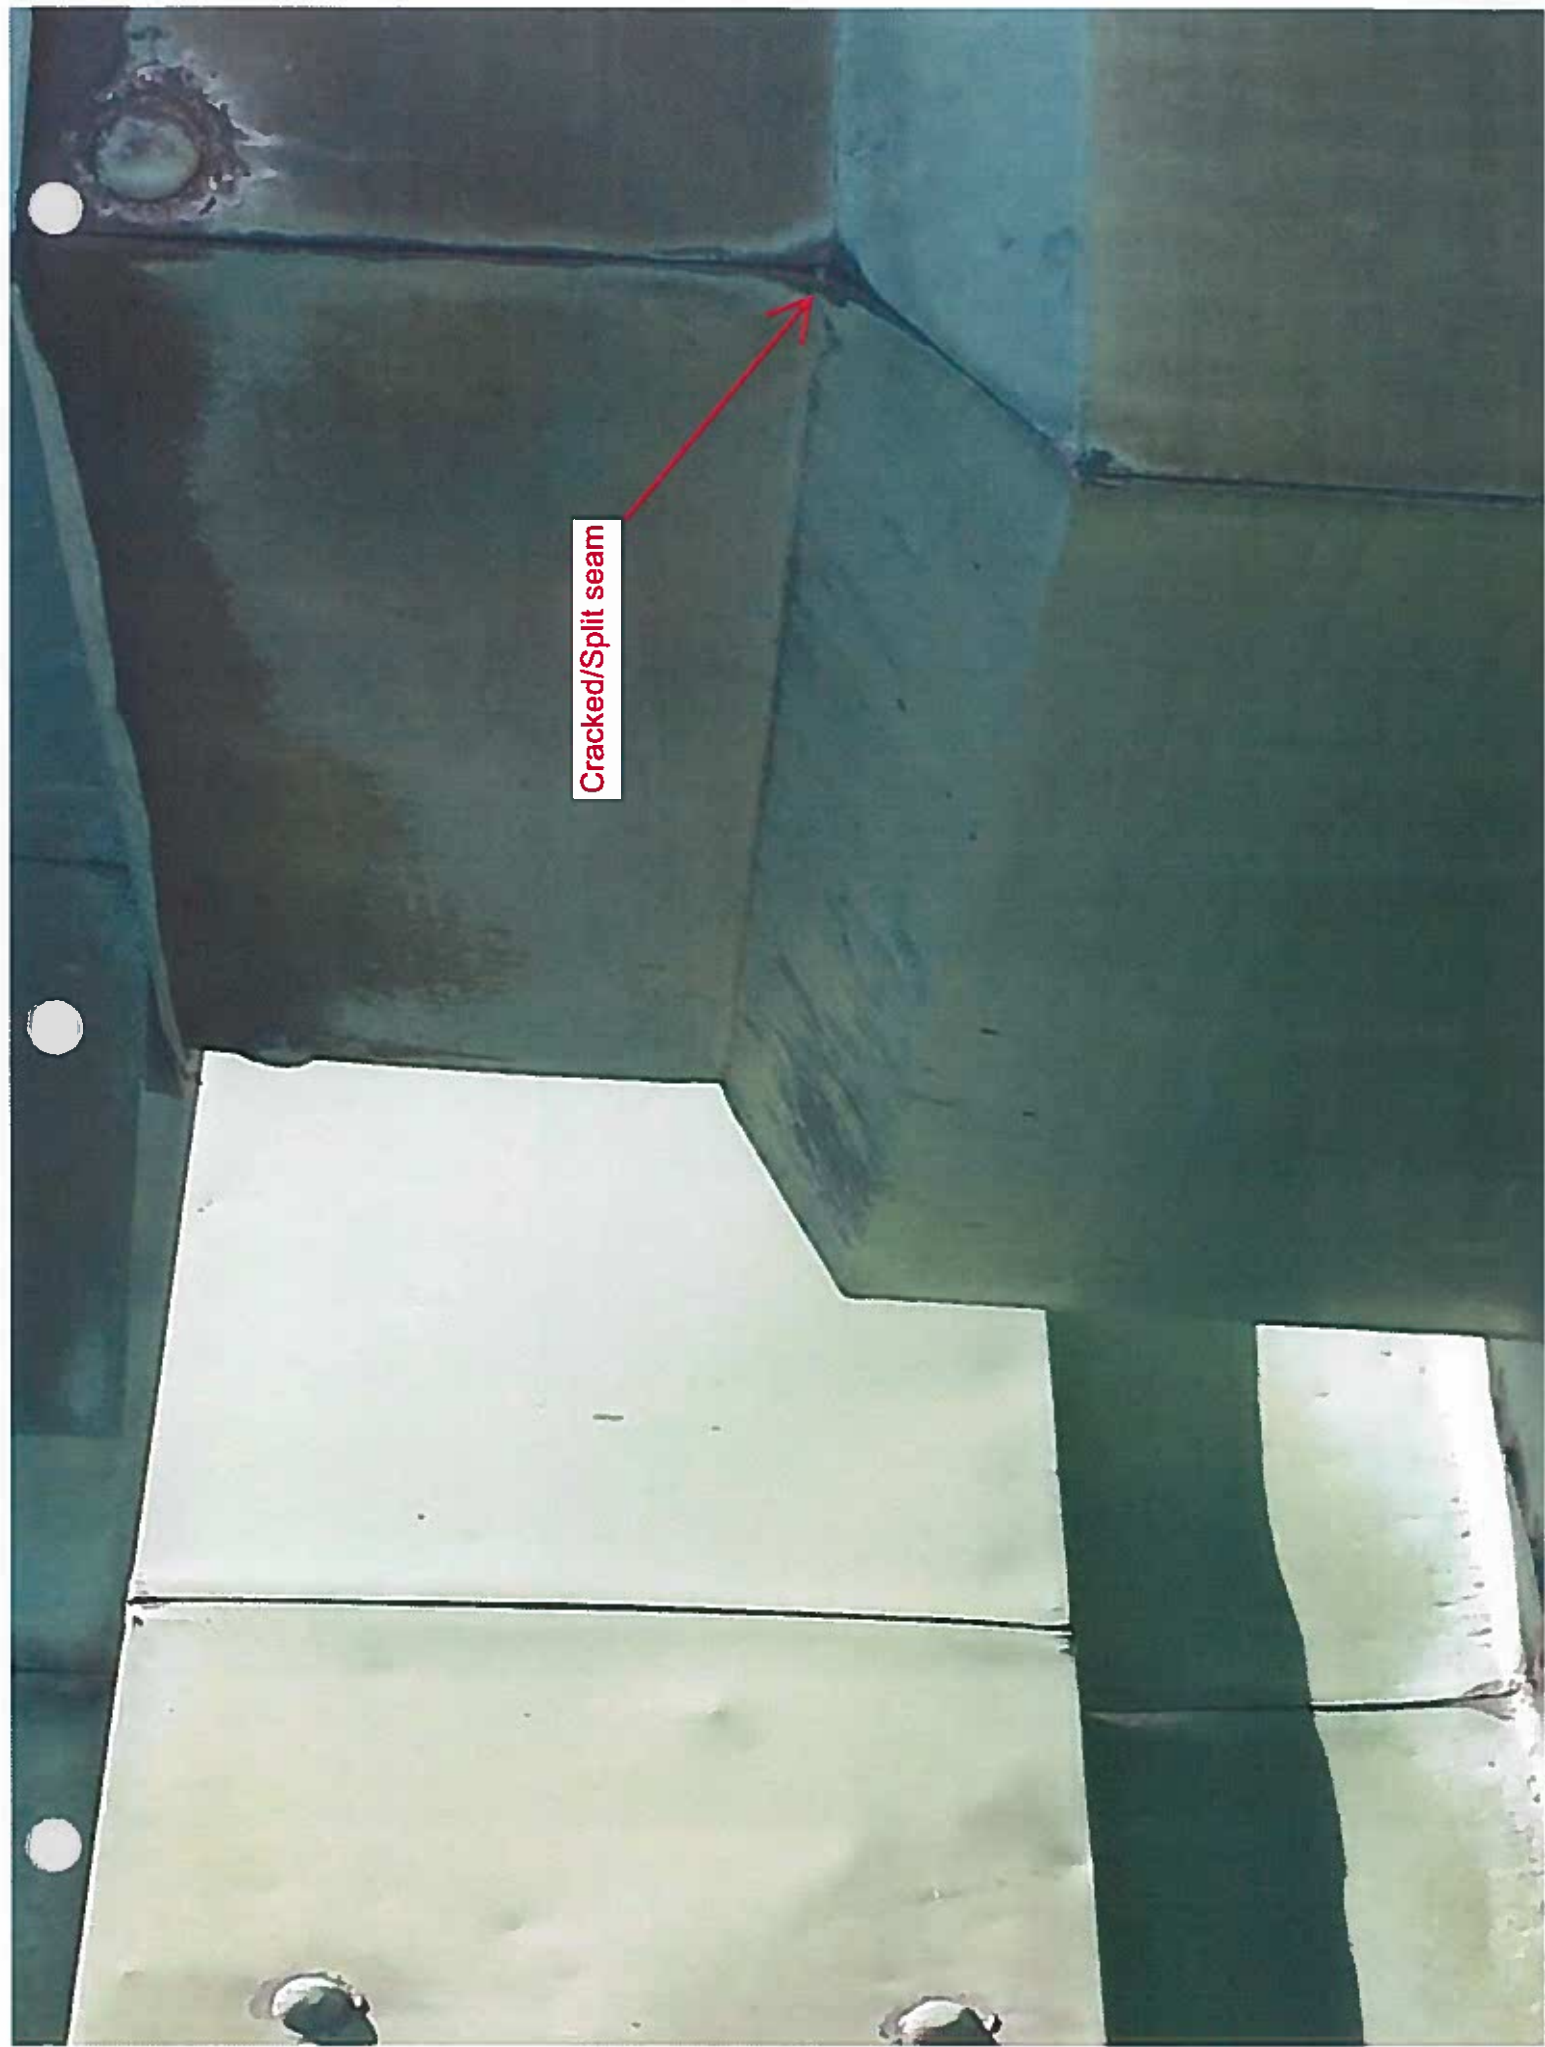
Cracked/Split seam

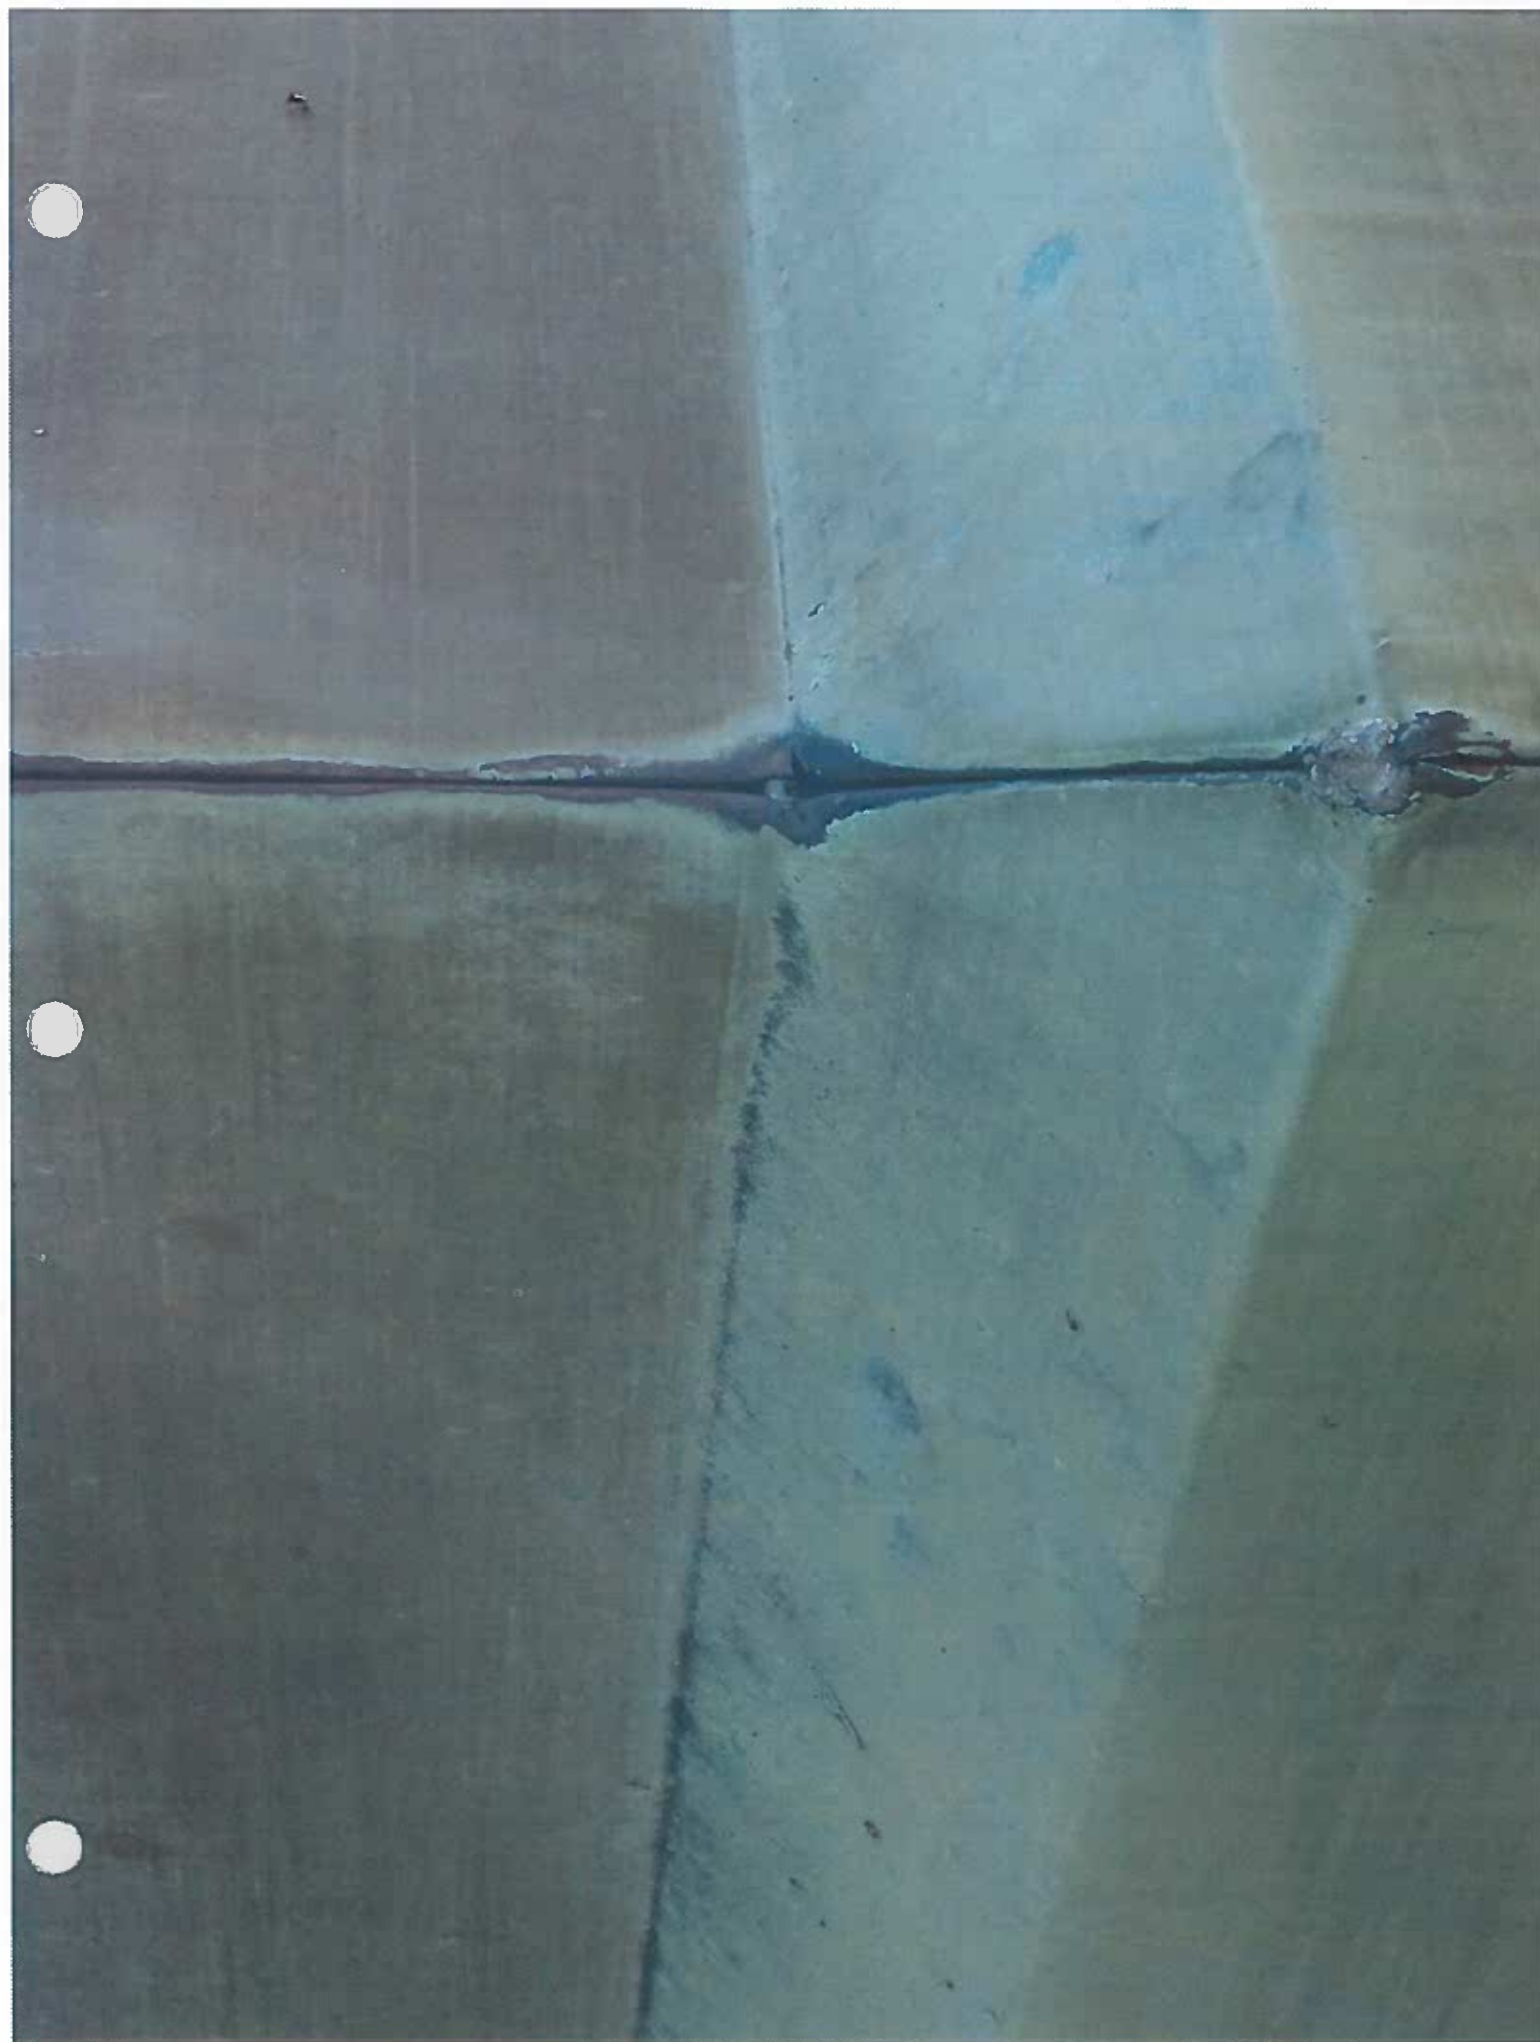
Cracked/split seam
