# Clerestory Photos

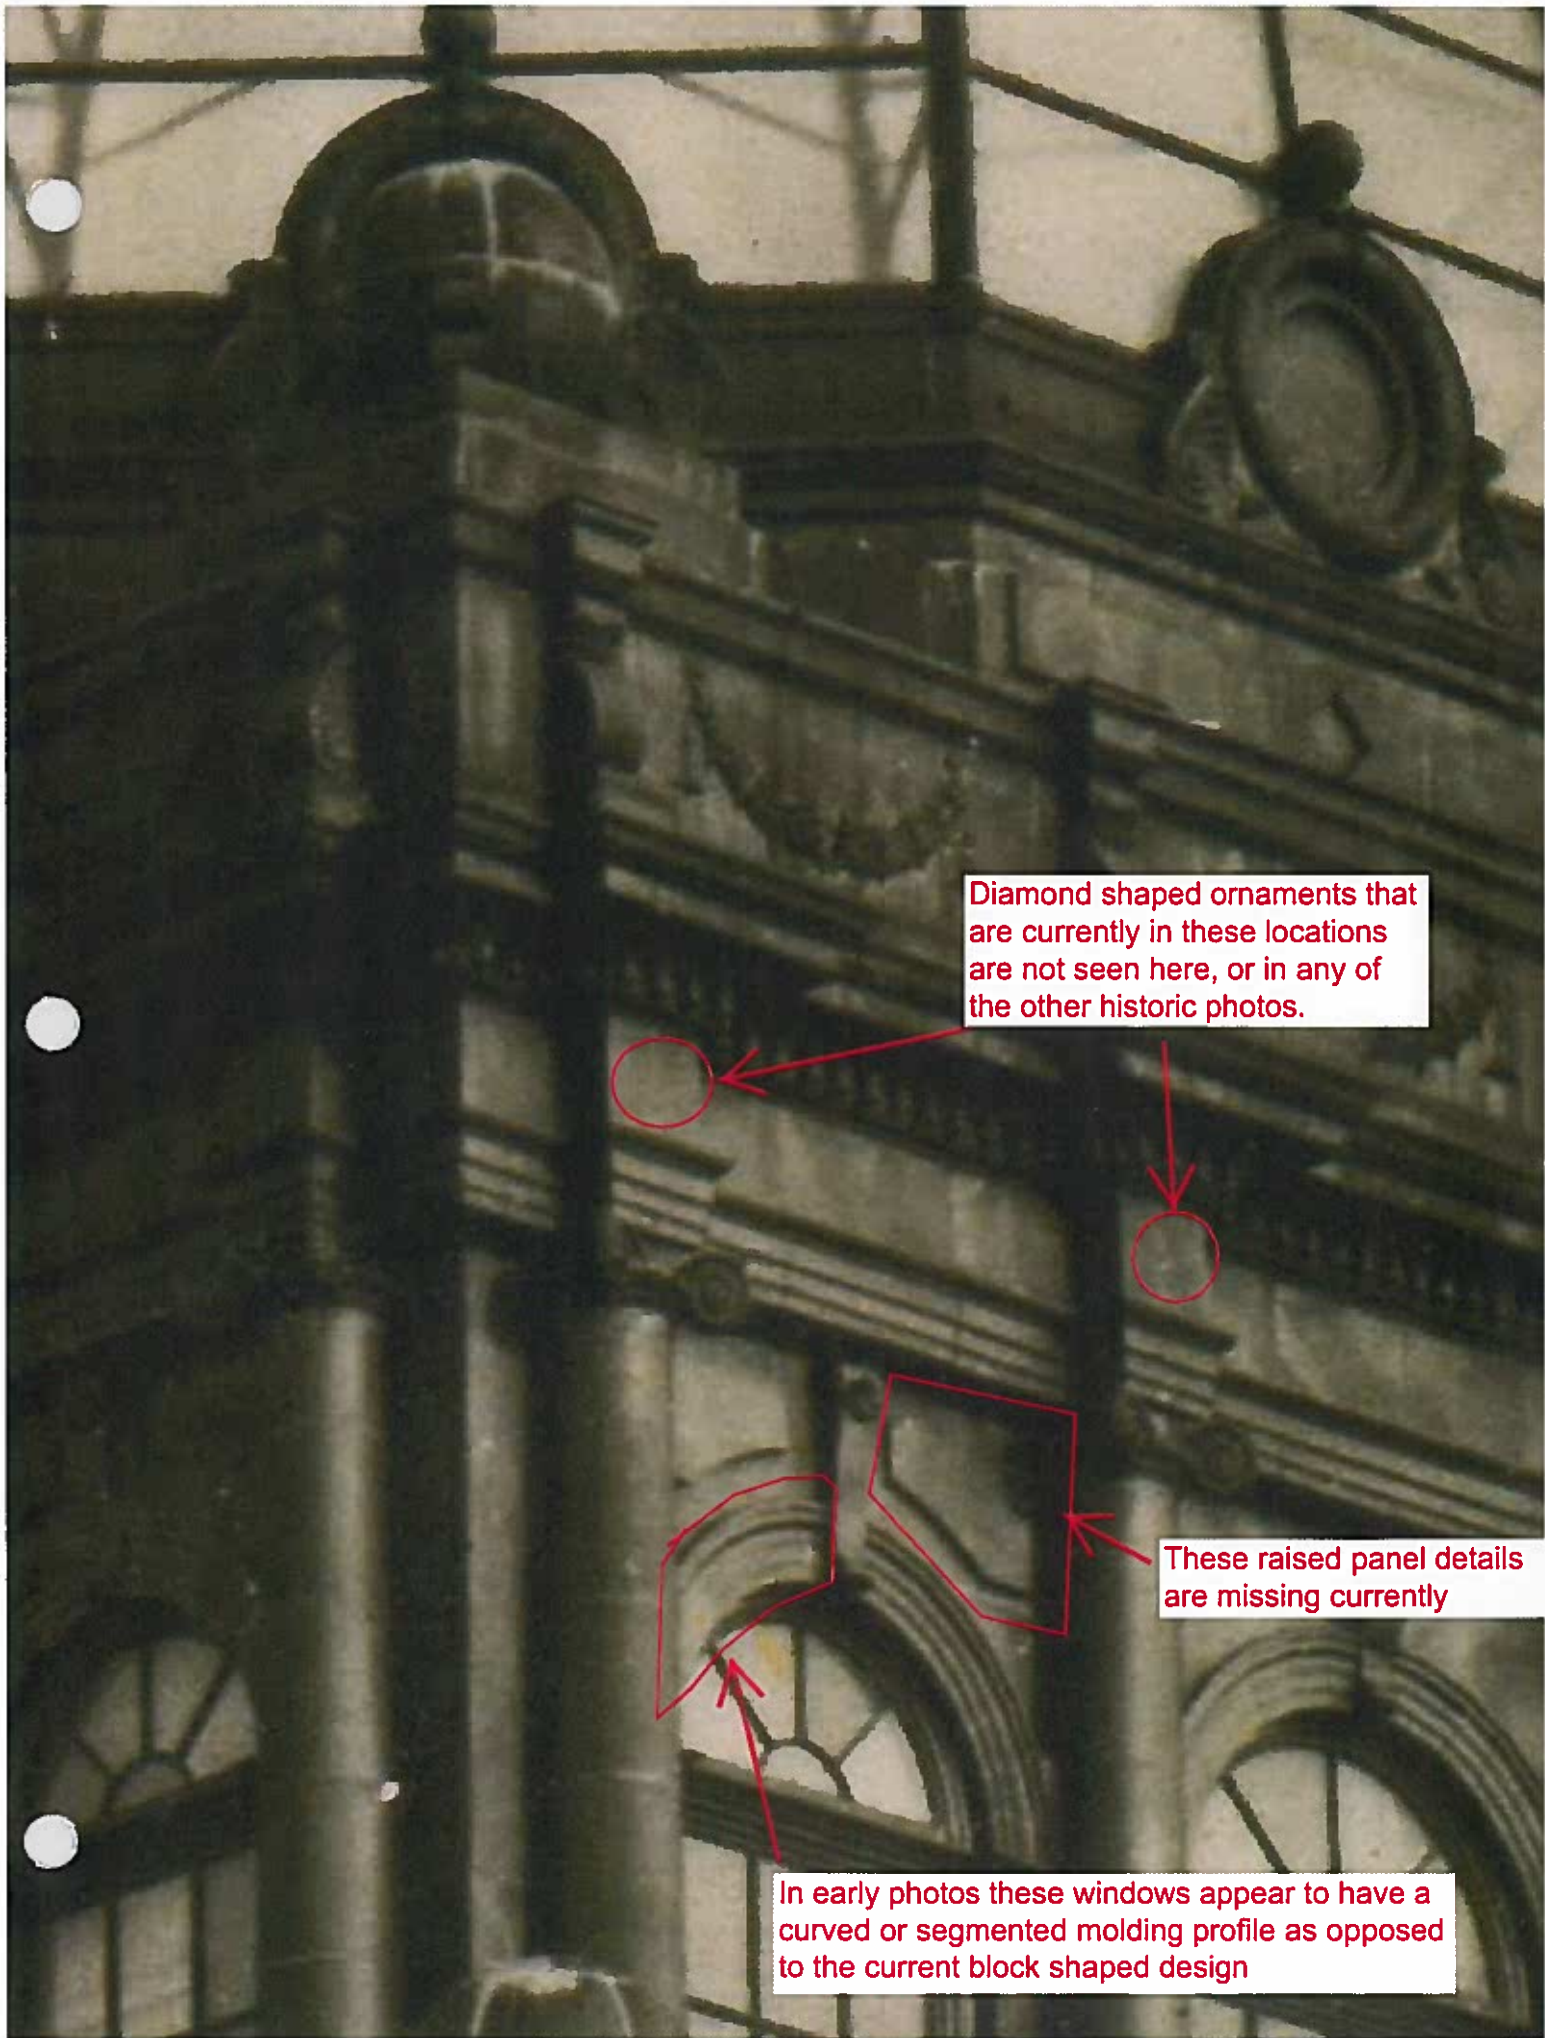
Diamond shaped ornaments that are currently in these locations are not seen here, or in any of the other historic photos.

These raised panel details are missing currently

In early photos these windows appear to have a curved or segmented molding profile as opposed to the current block shaped design

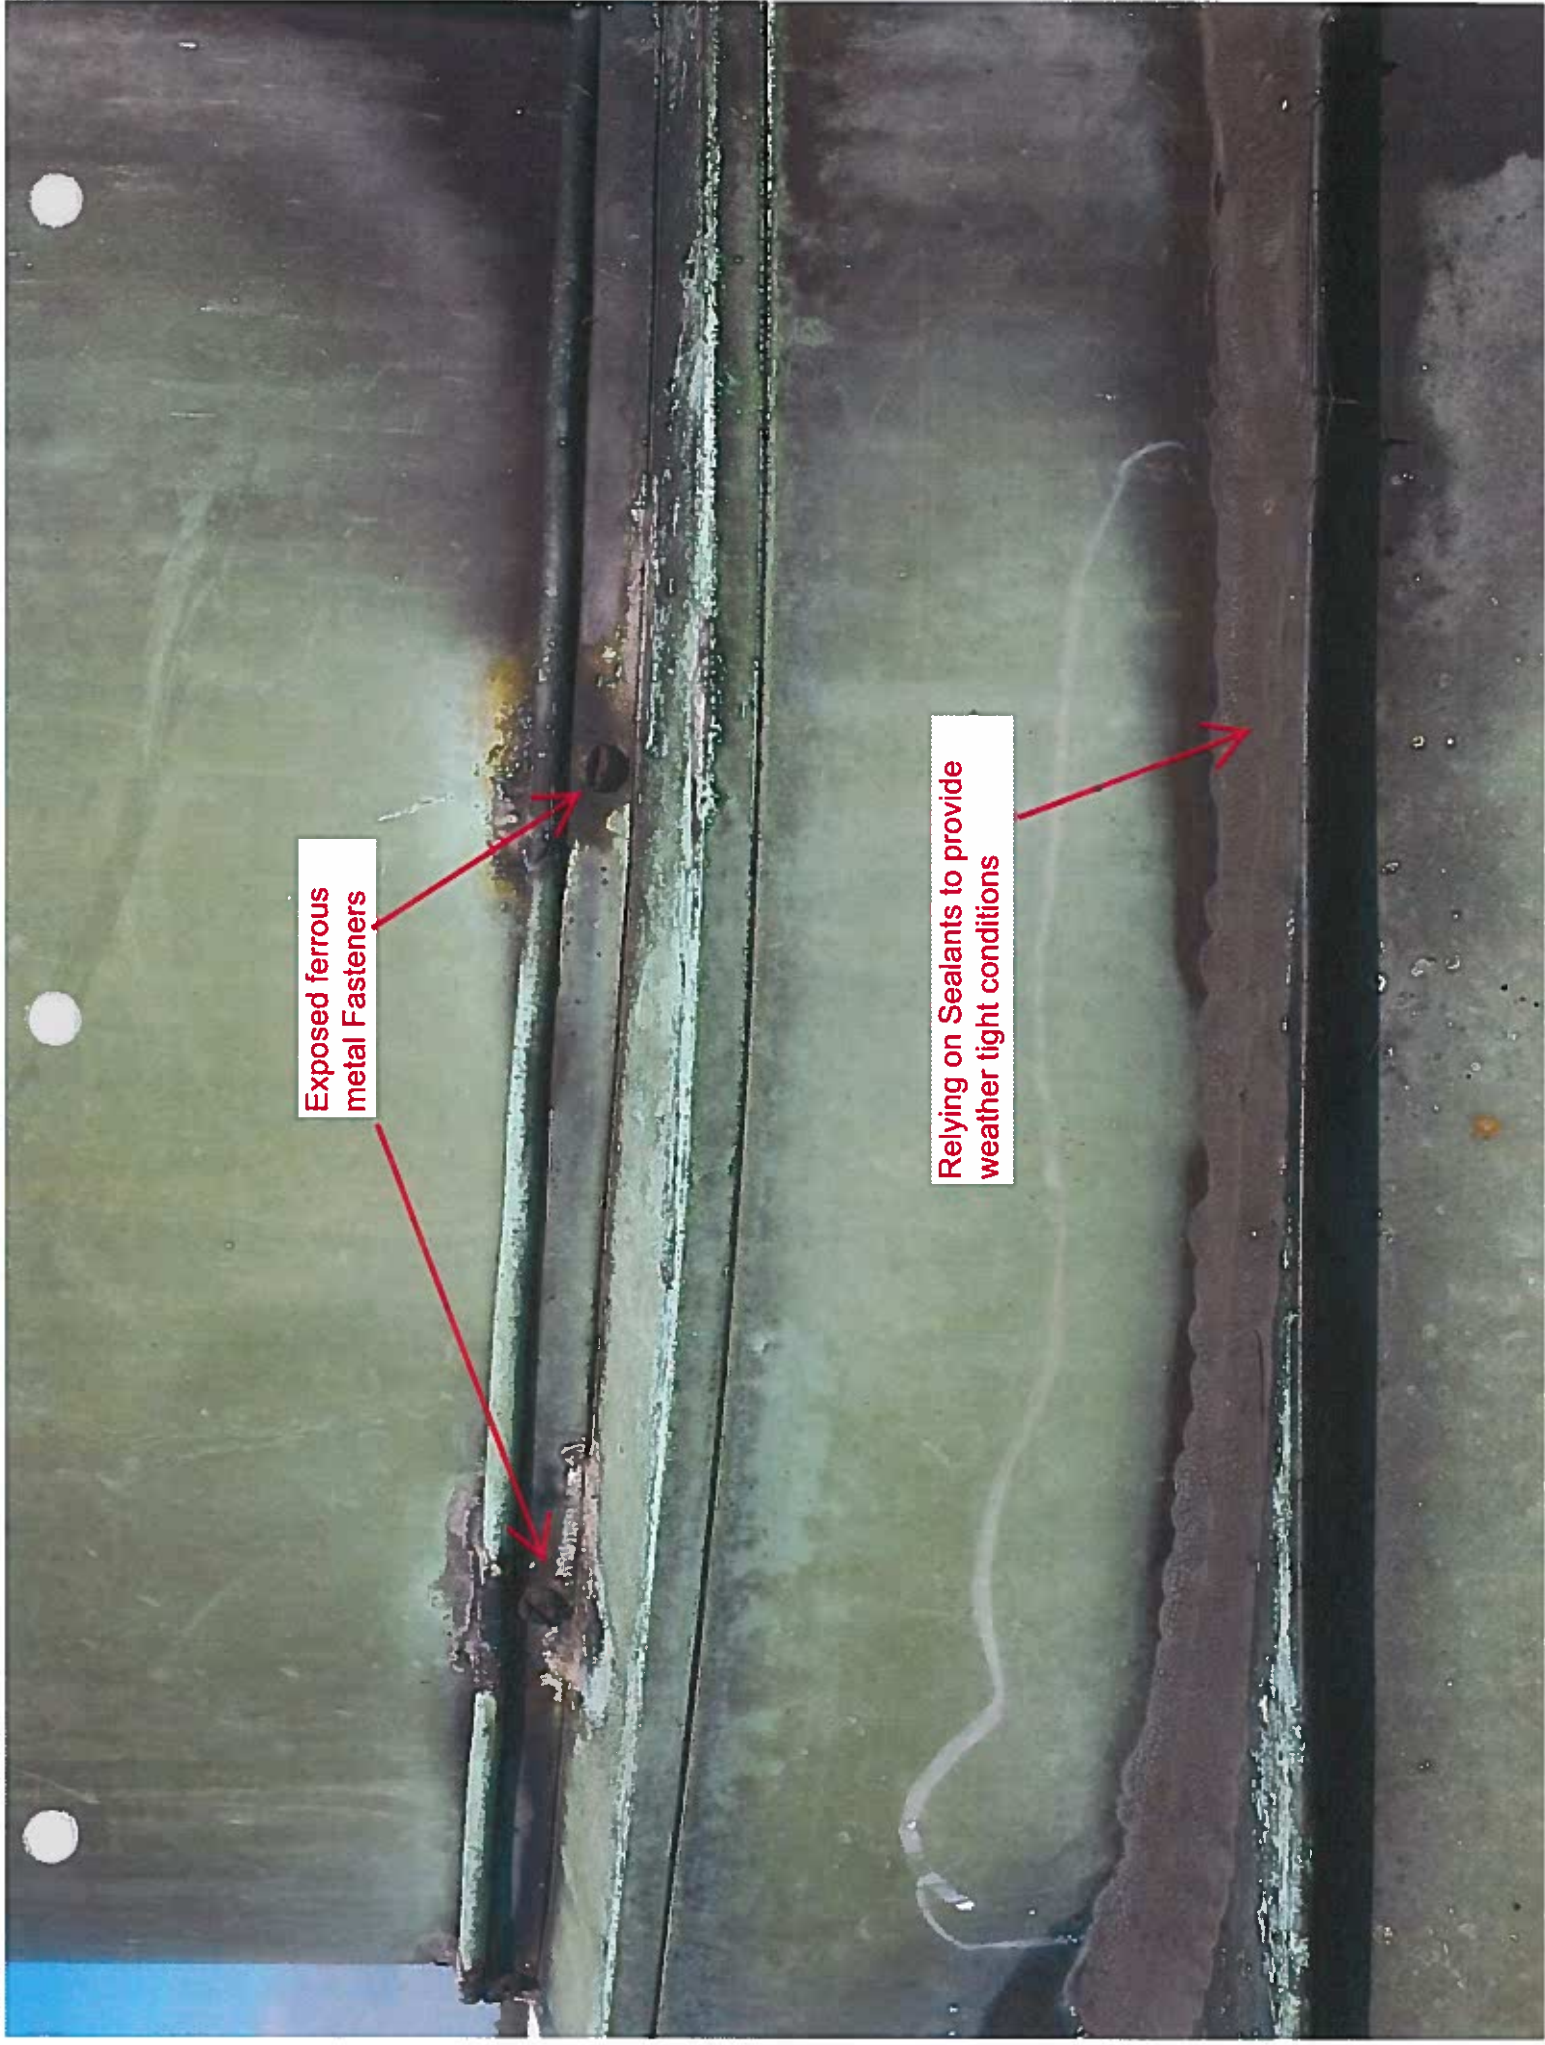
Relying on Sealants to provide  
weather tight conditions

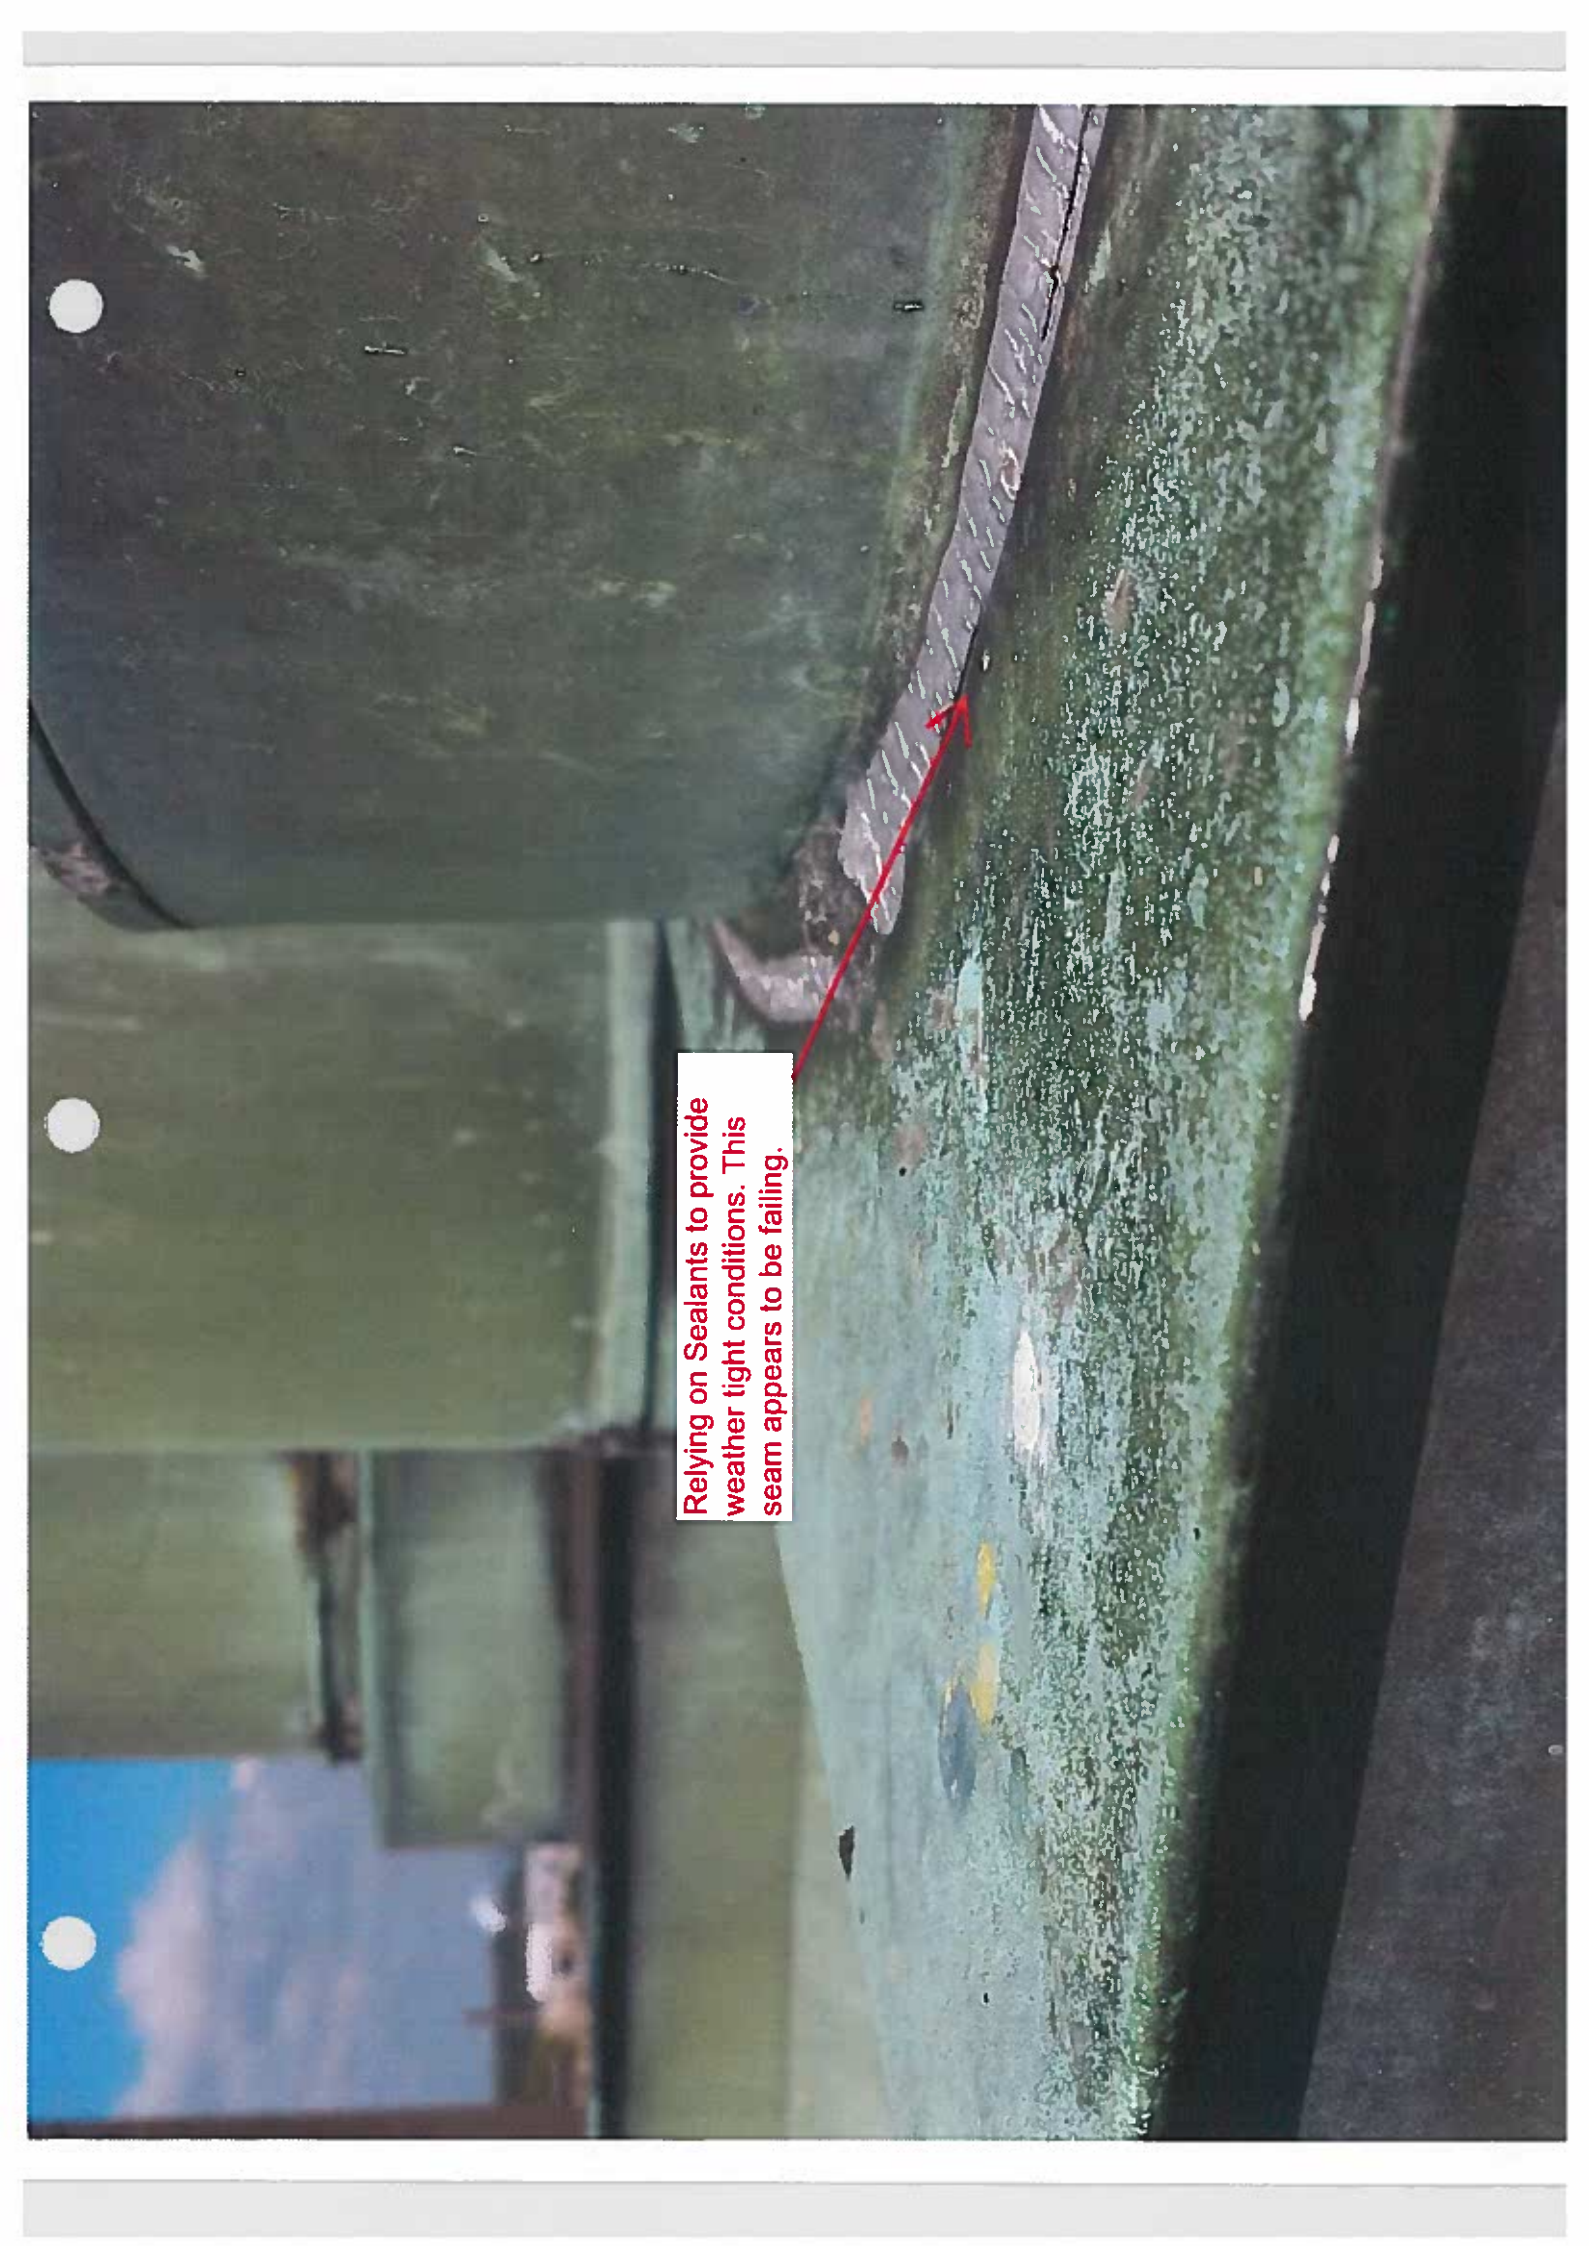
Relying on Sealants to provide weather tight conditions. This seam appears to be failing.

Relying on Sealants to provide  
weather tight conditions

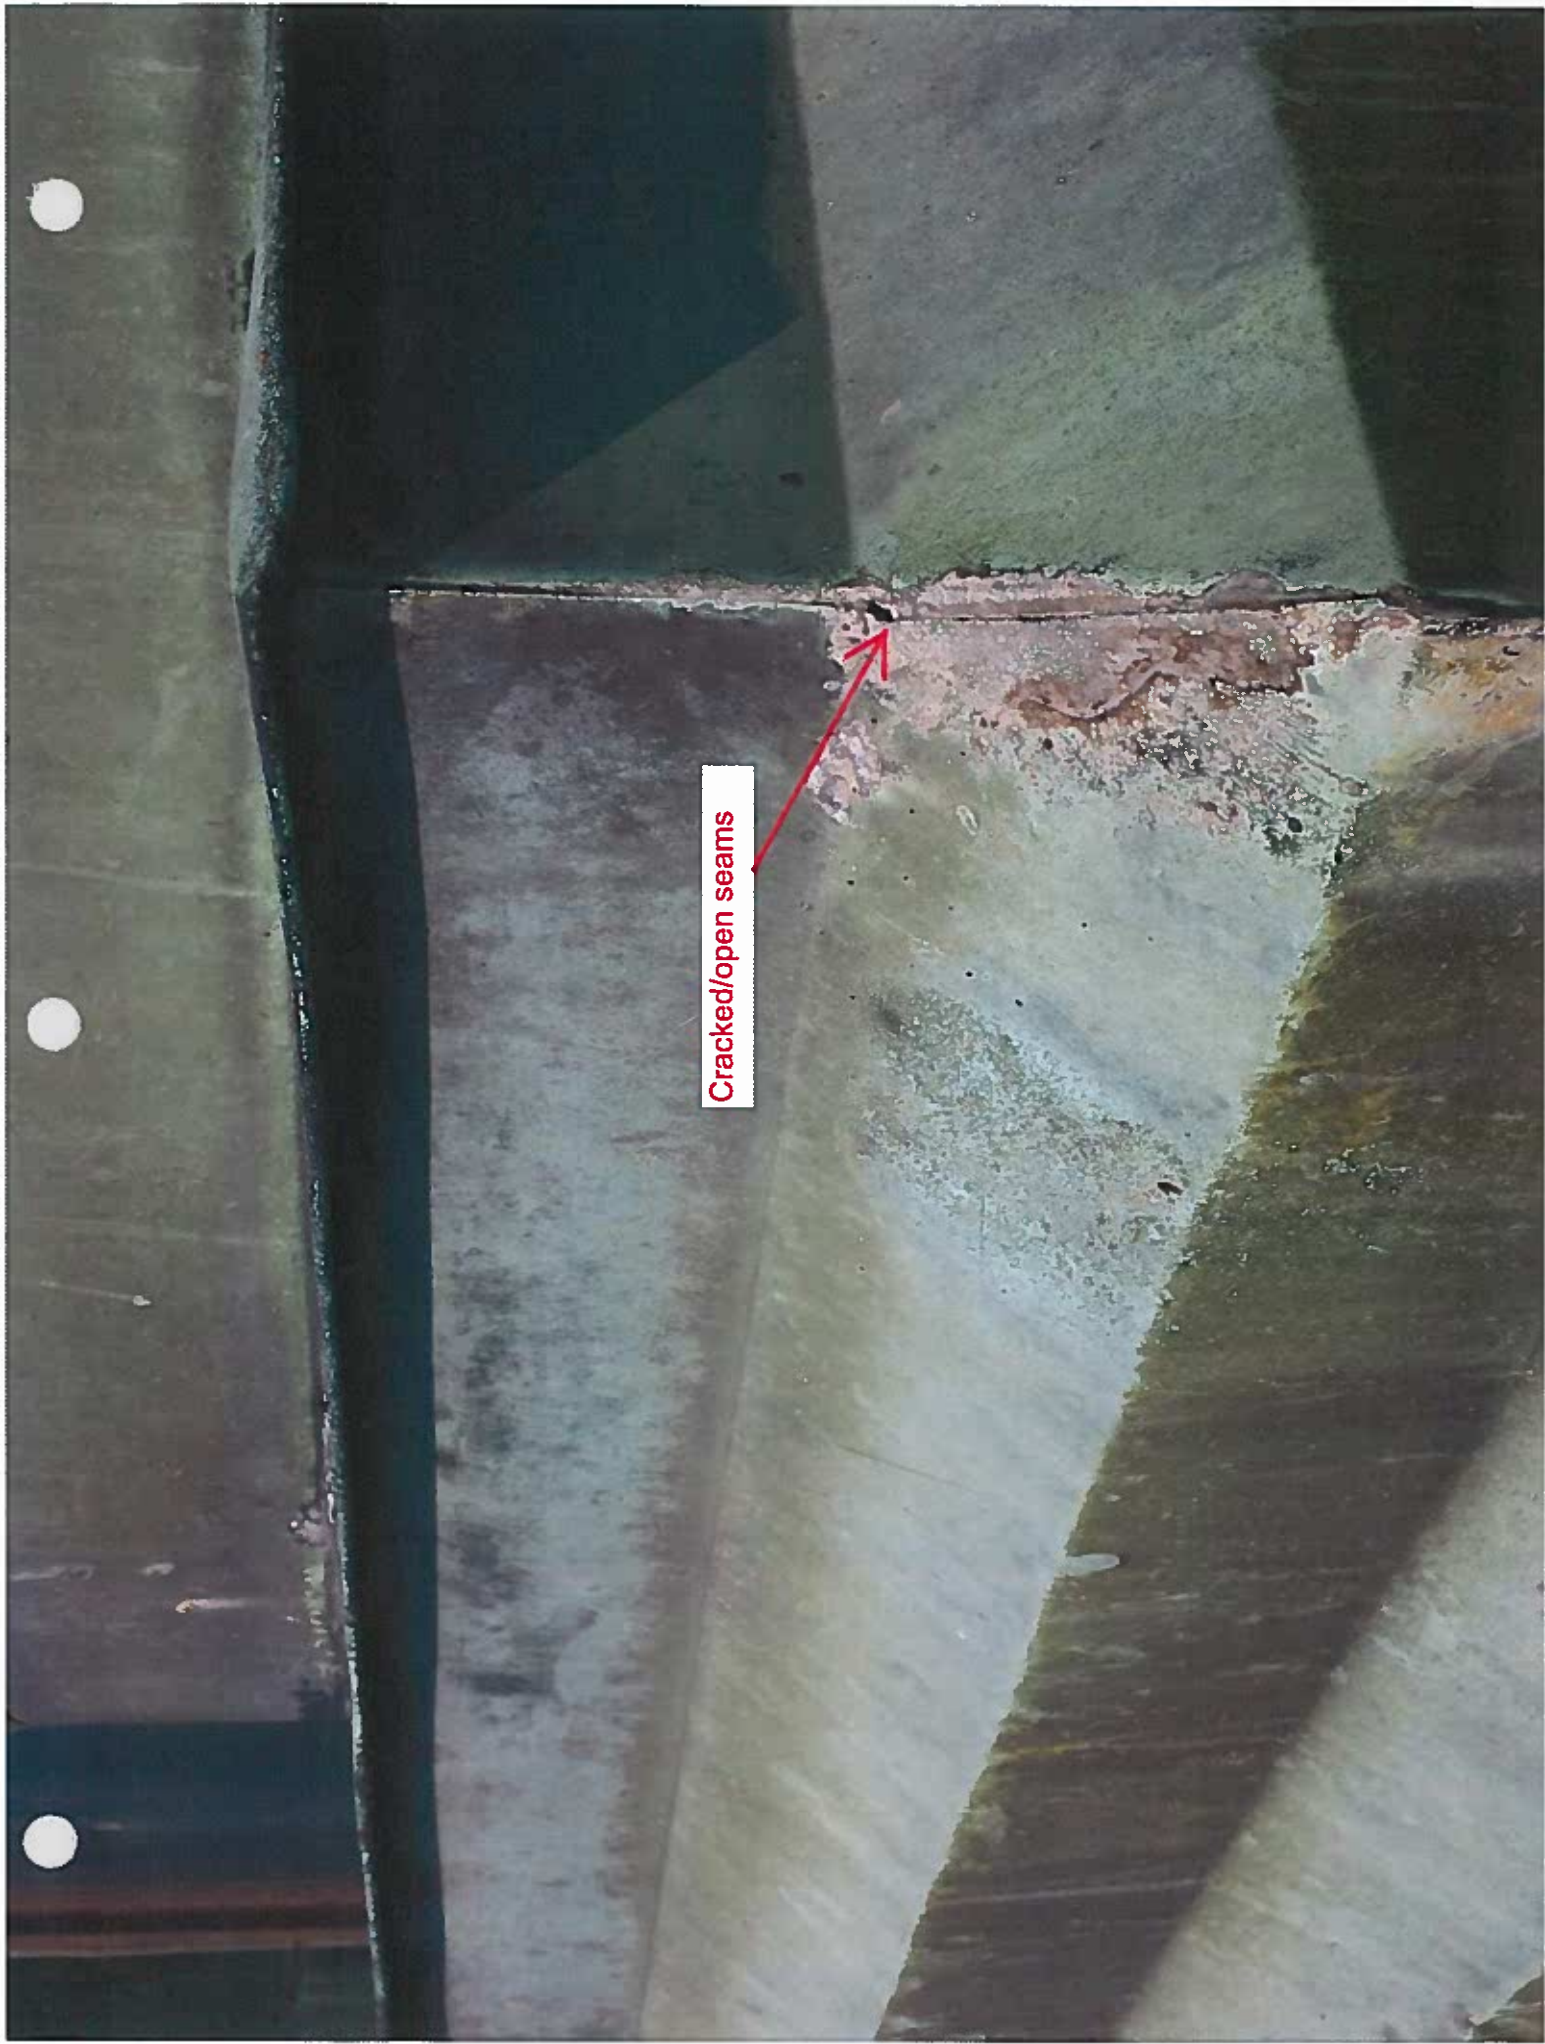
Cracked/open seams

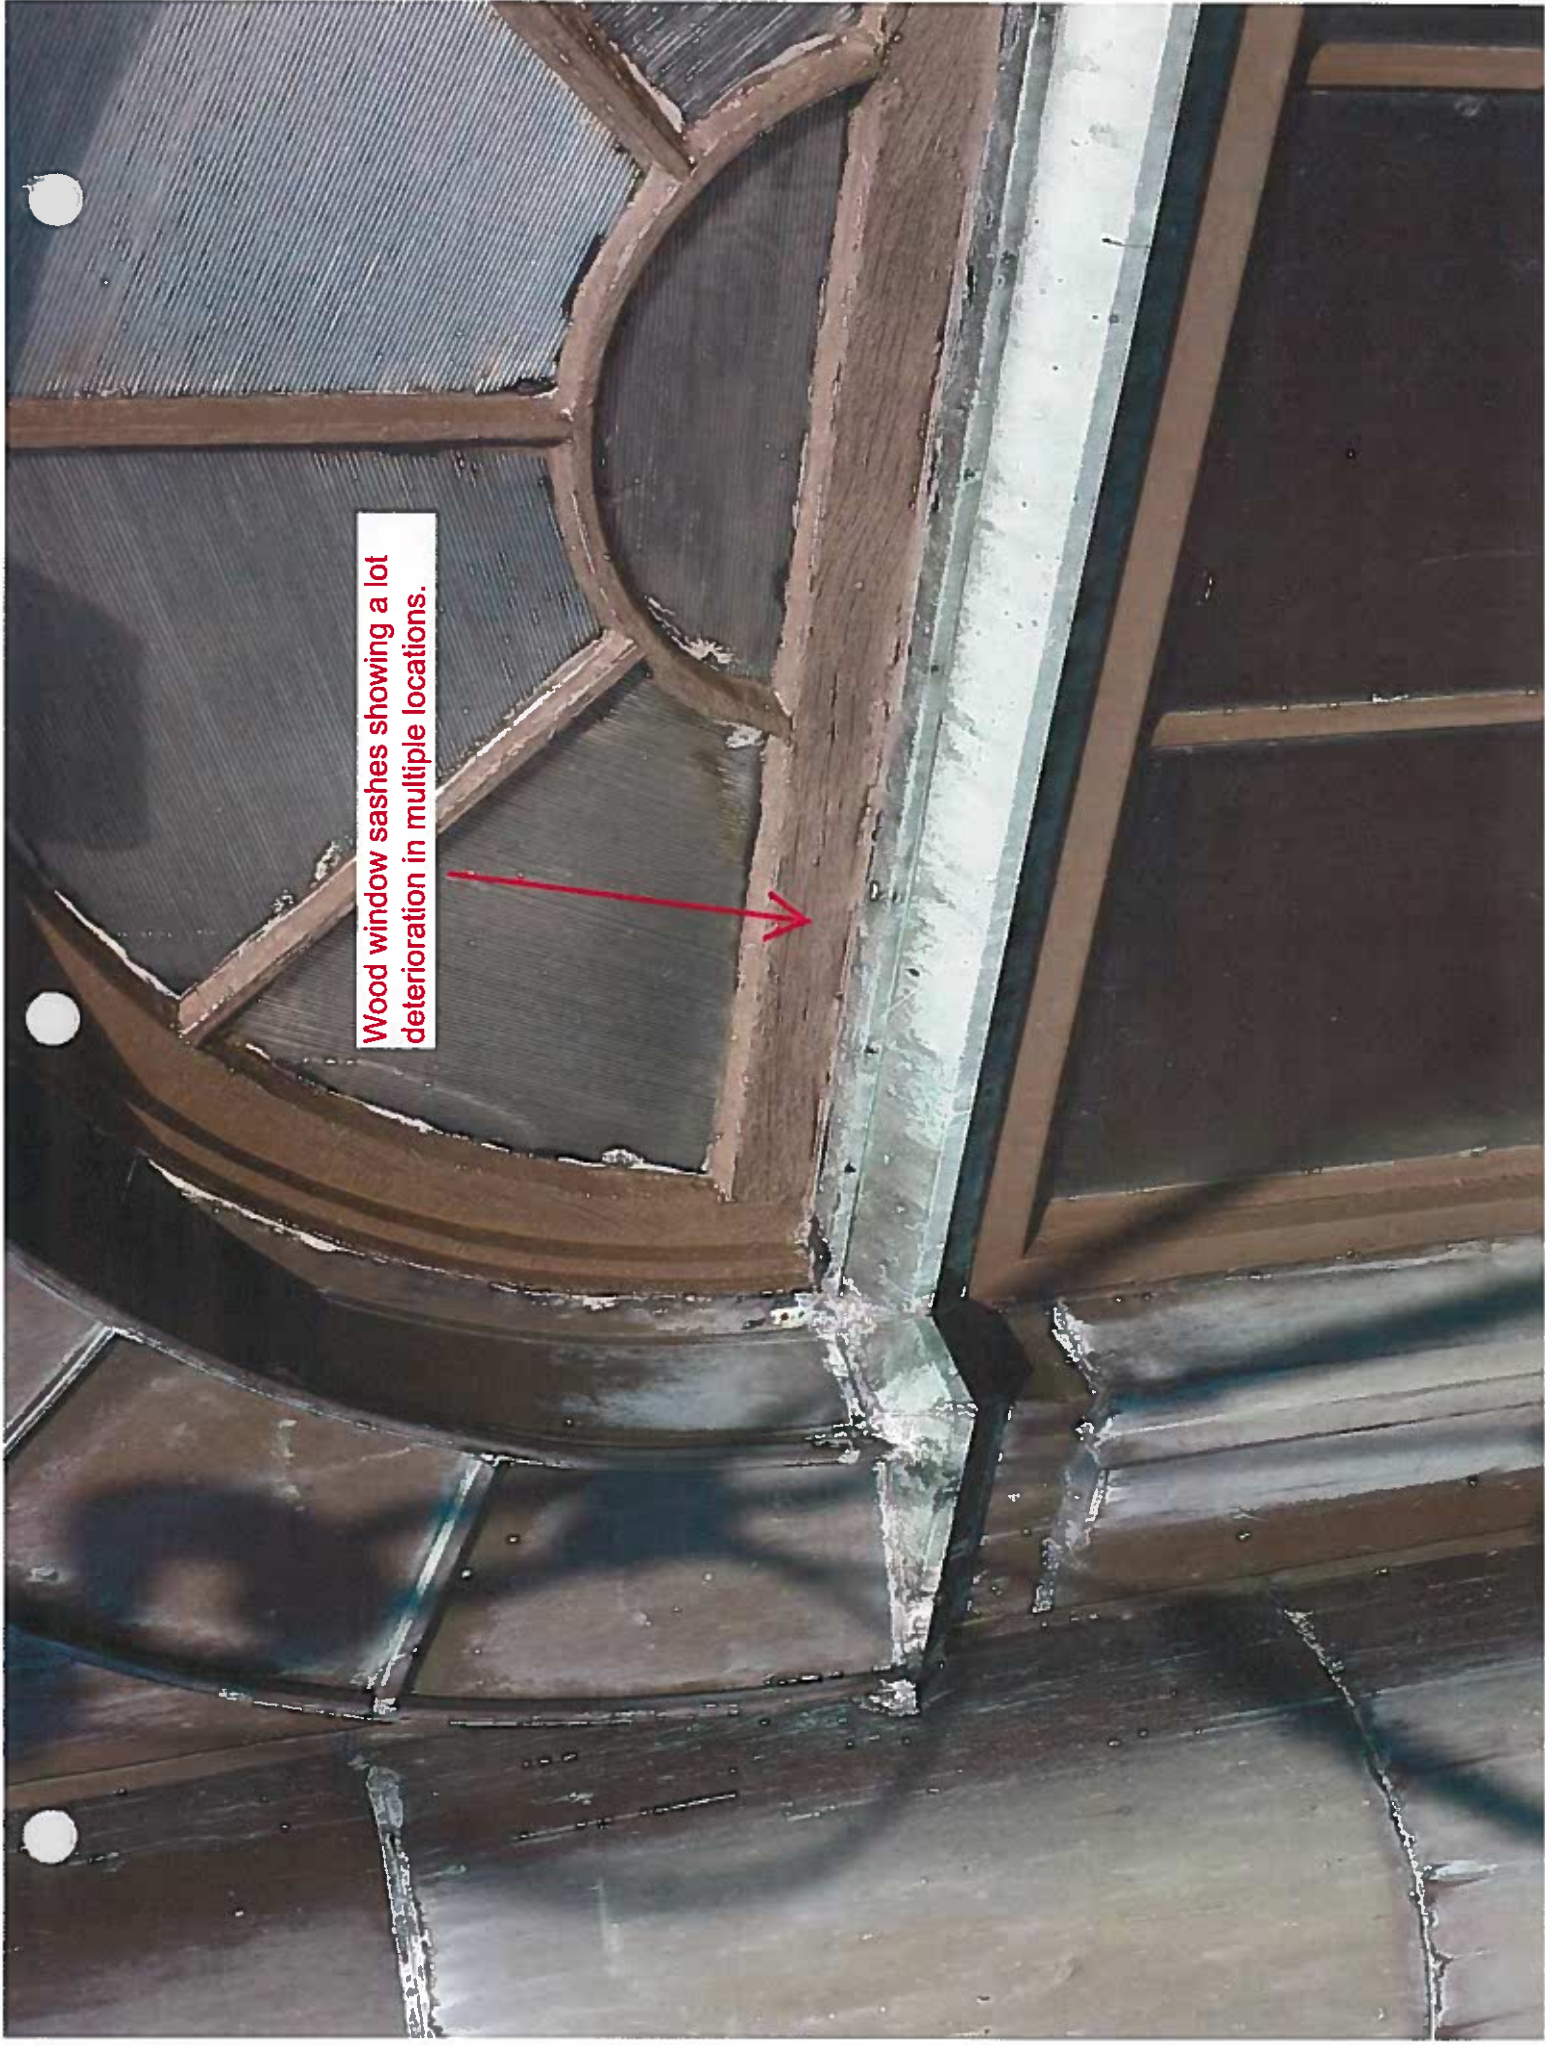
Wood window sashes showing a lot deterioration in multiple locations.

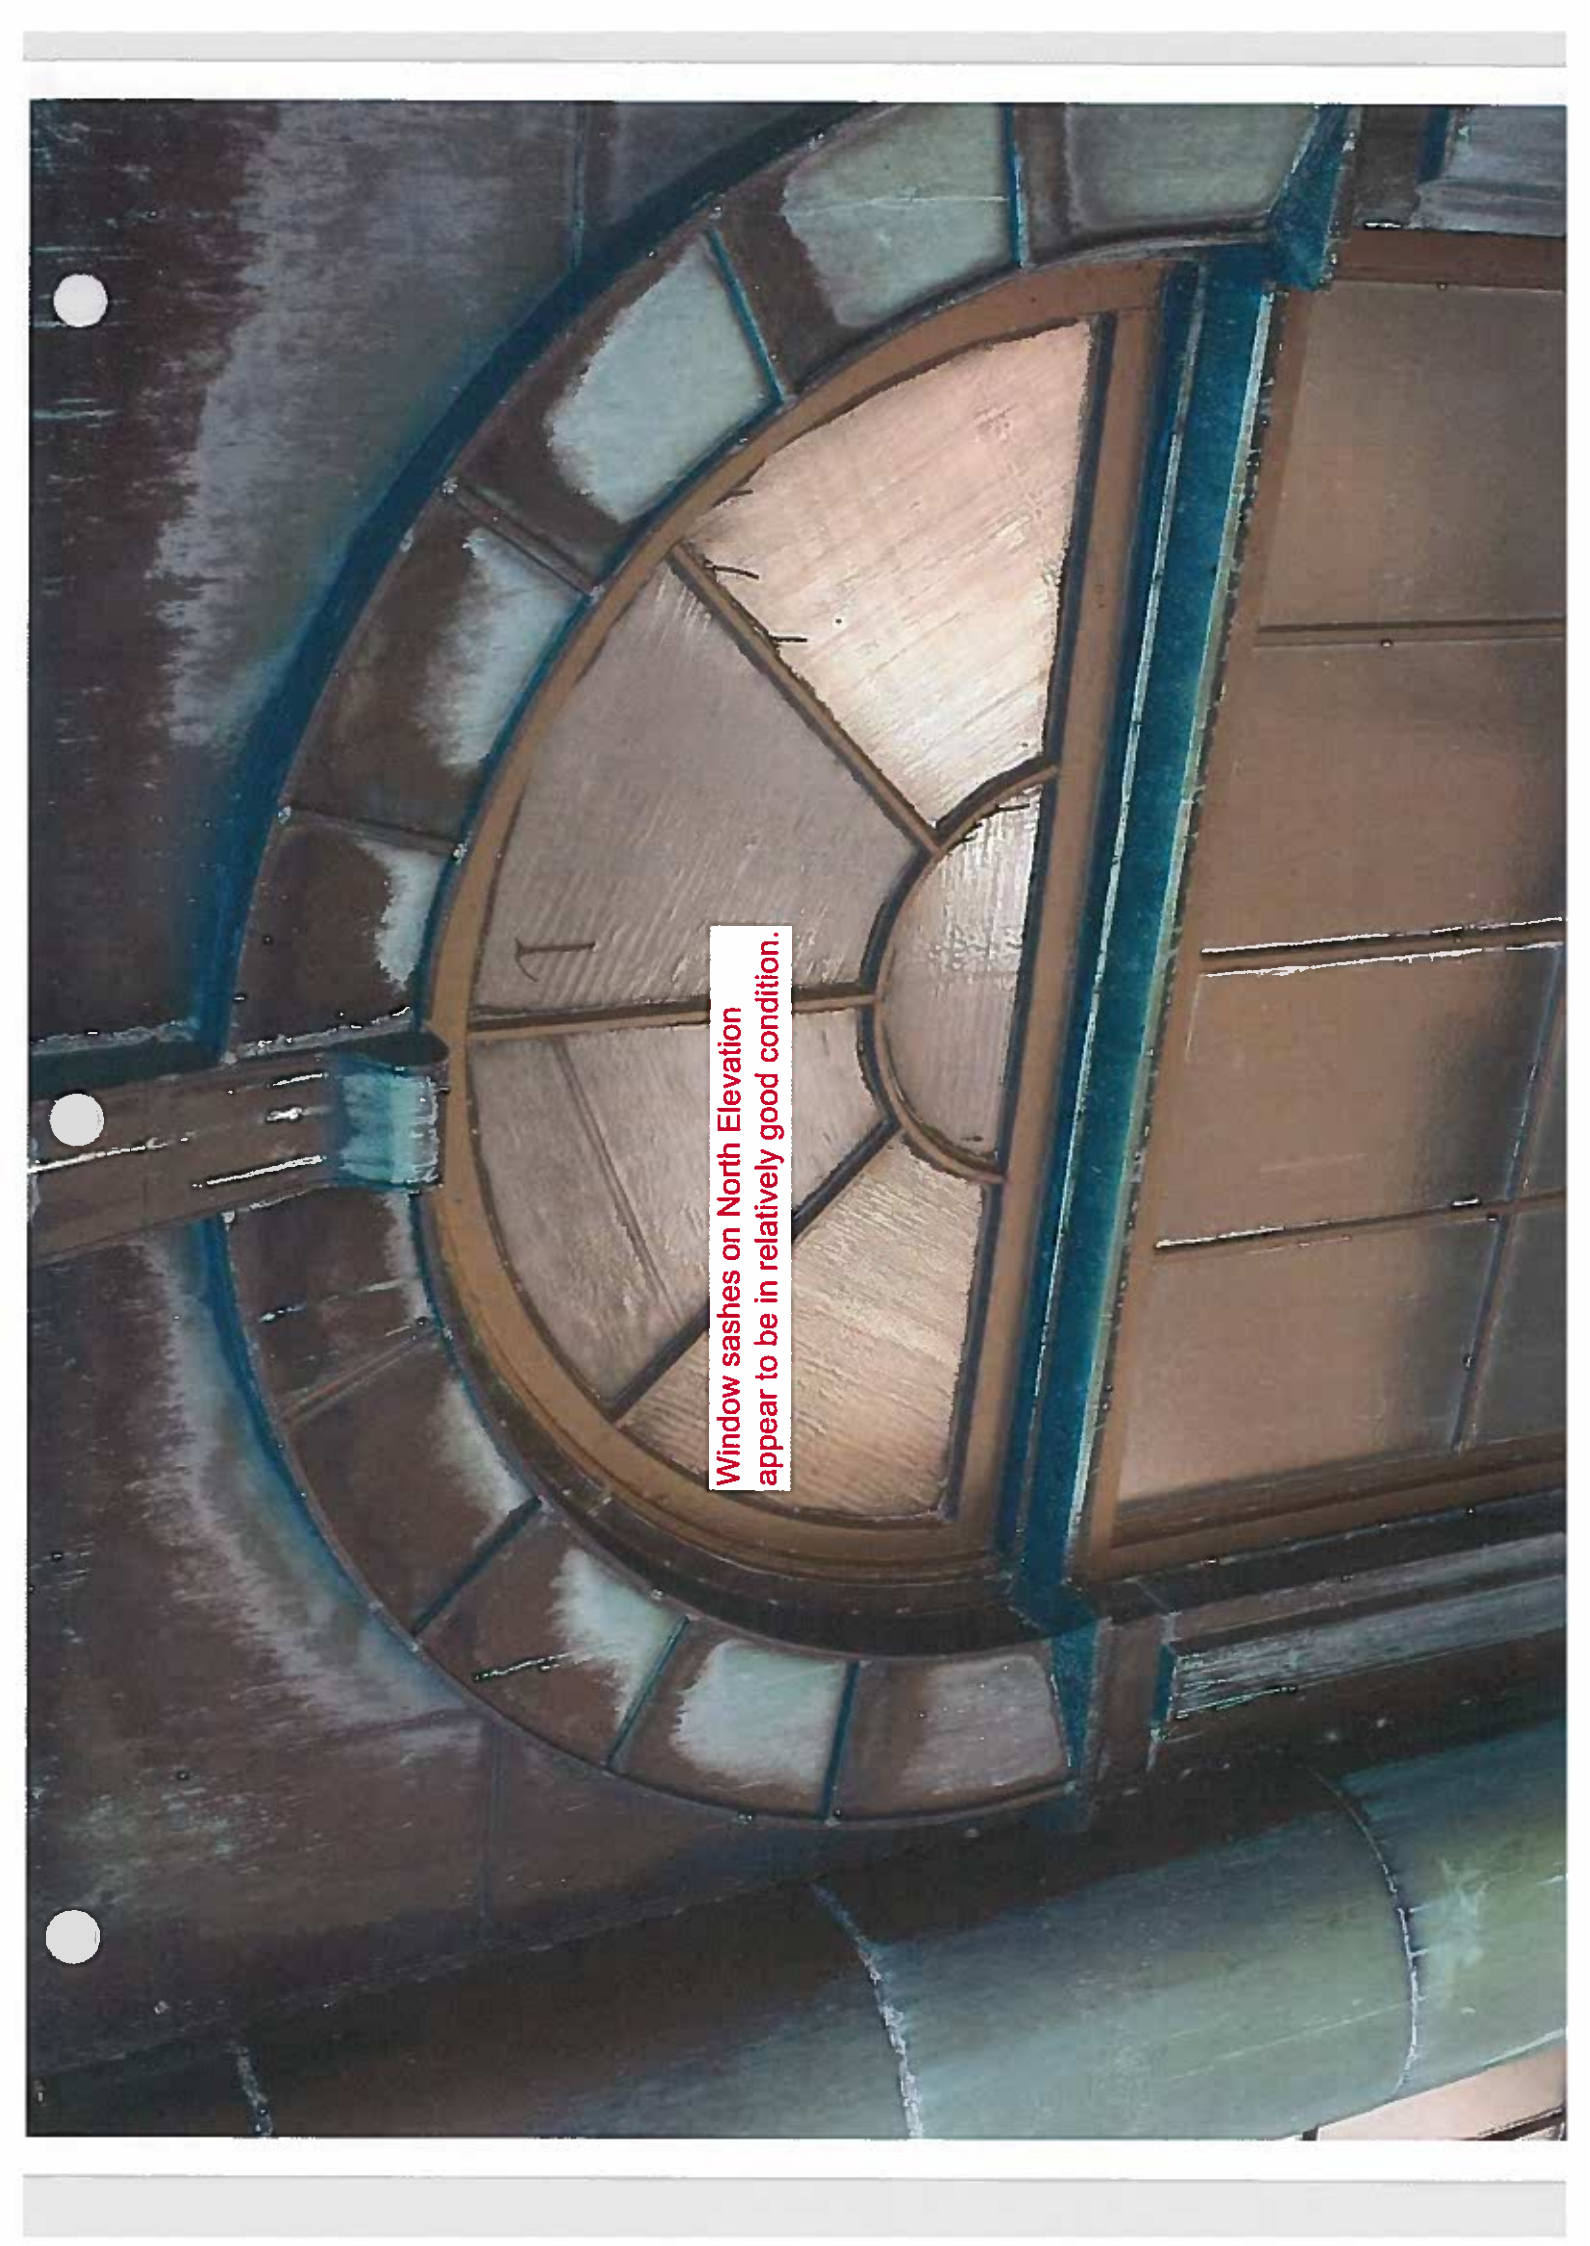
Window sashes on North Elevation appear to be in relatively good condition.
