# Clerestory Photos

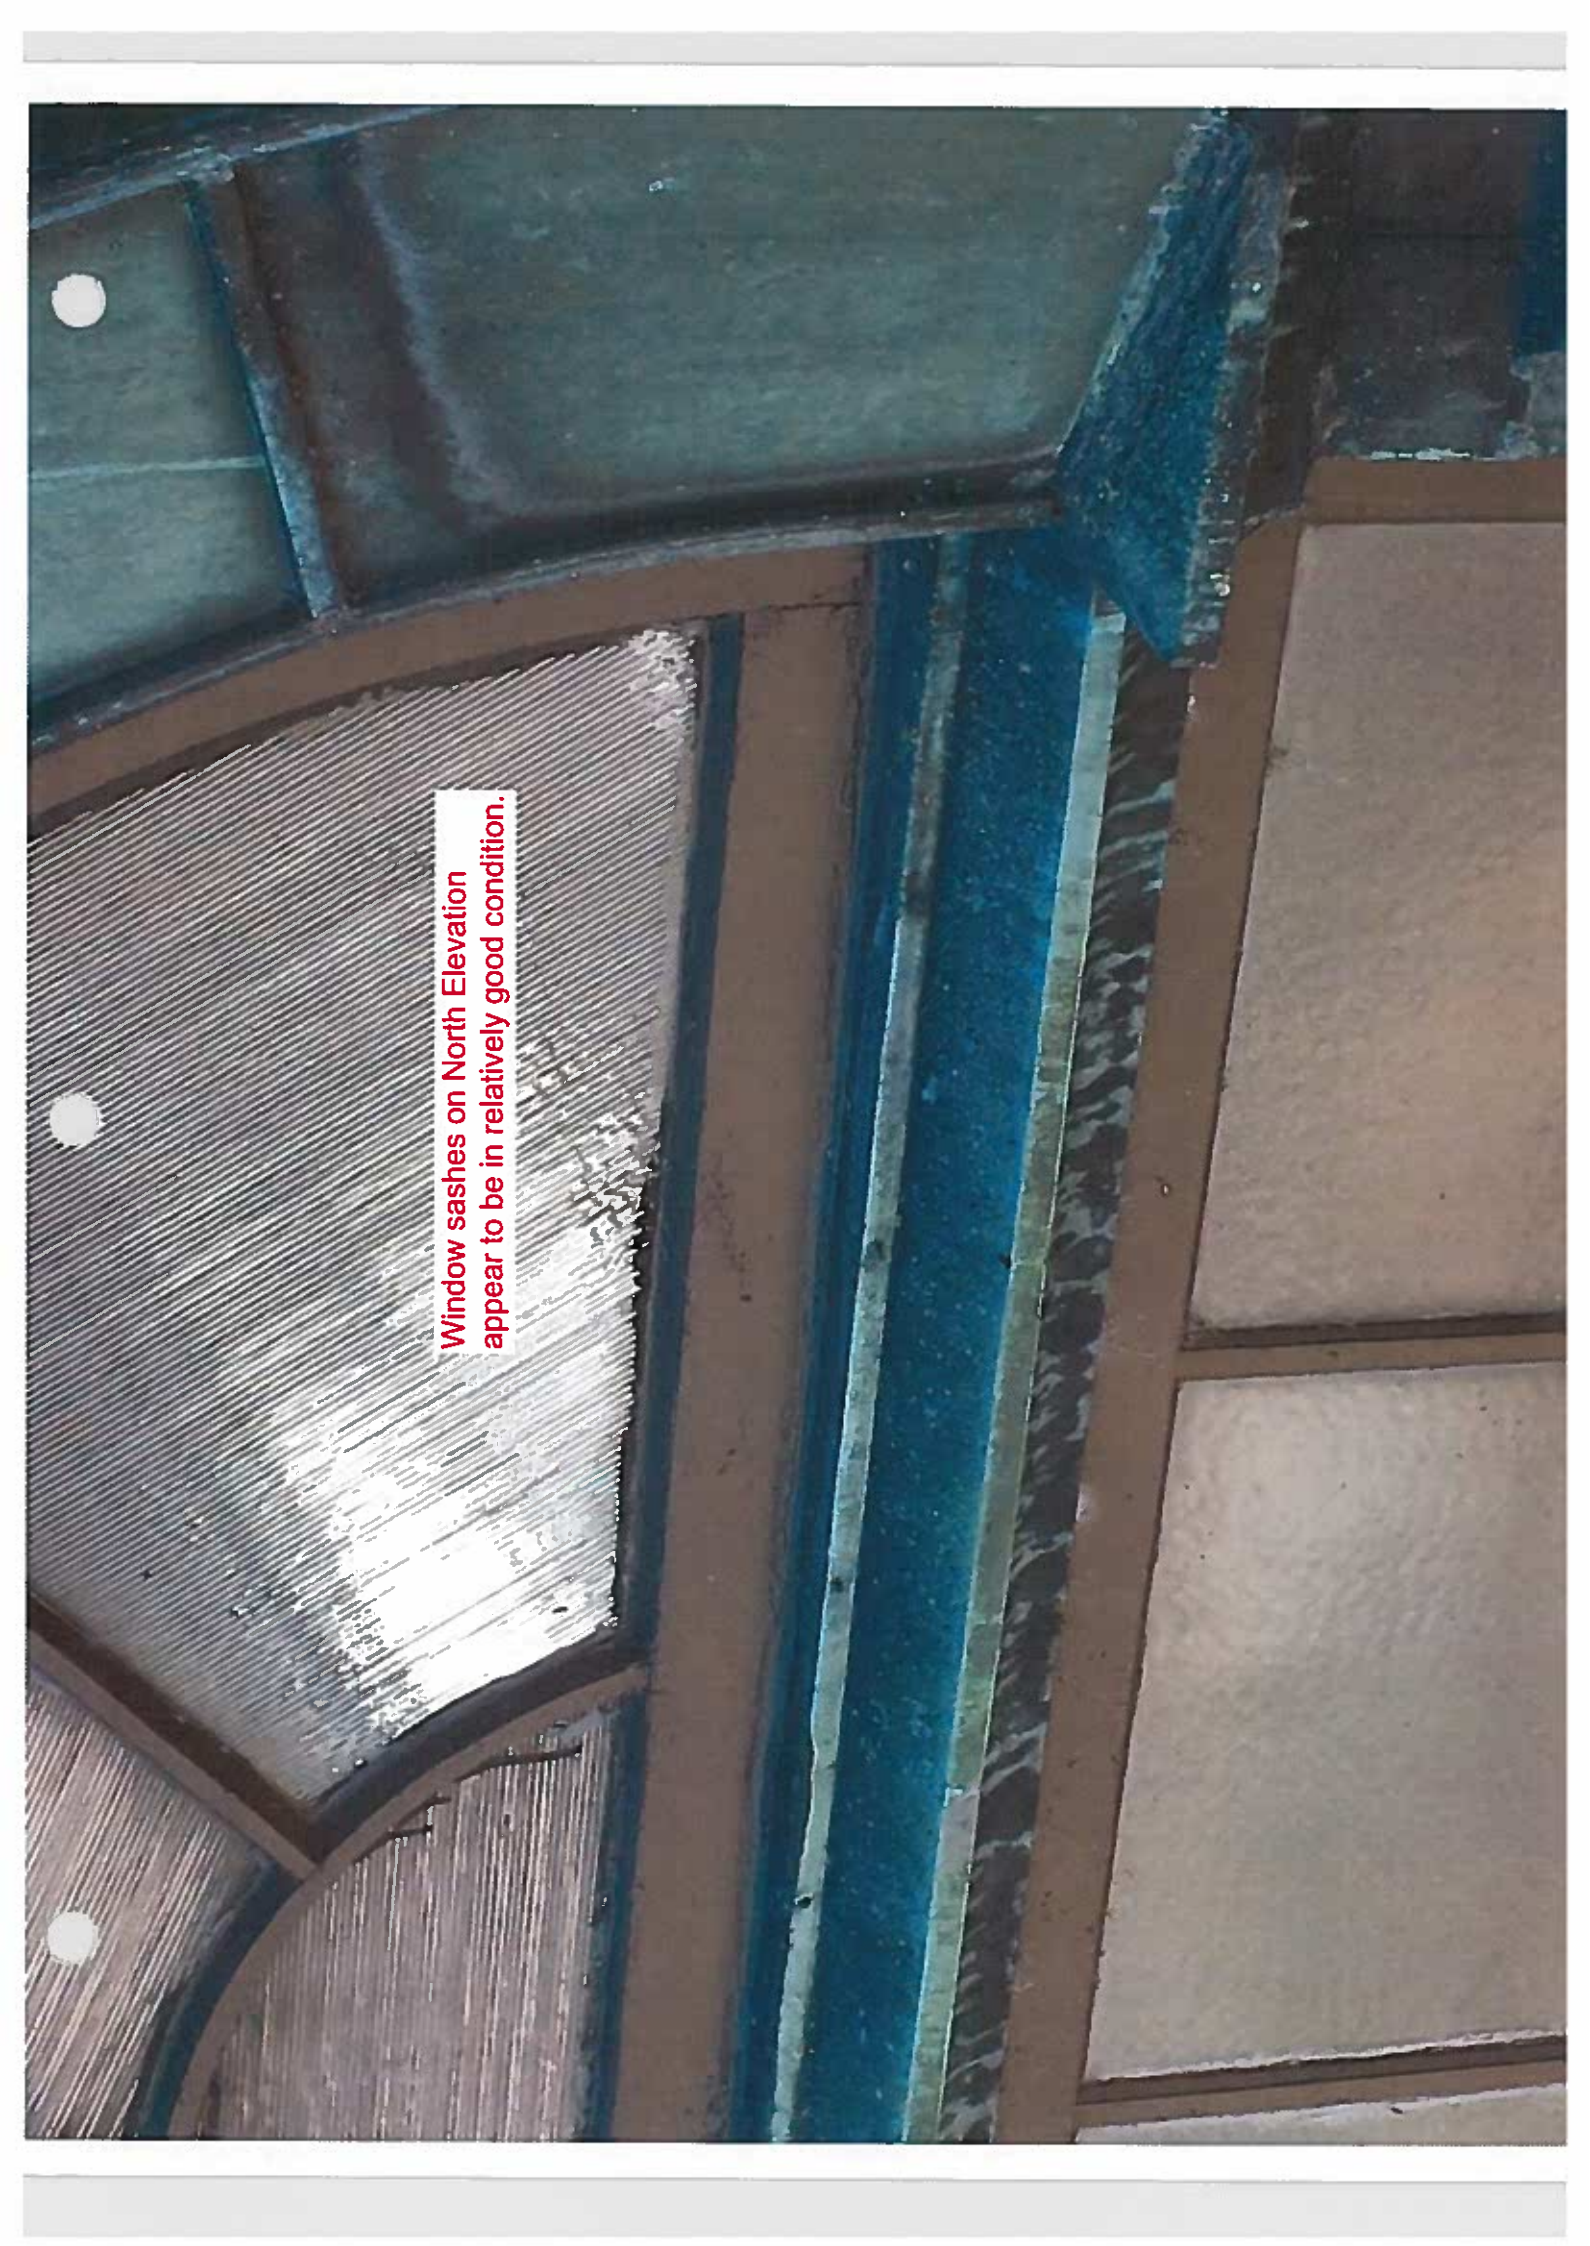
Window sashes on North Elevation appear to be in relatively good condition.

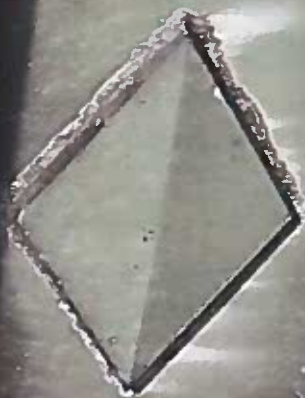
Open, allowing weather to get behind  
the decorative copper

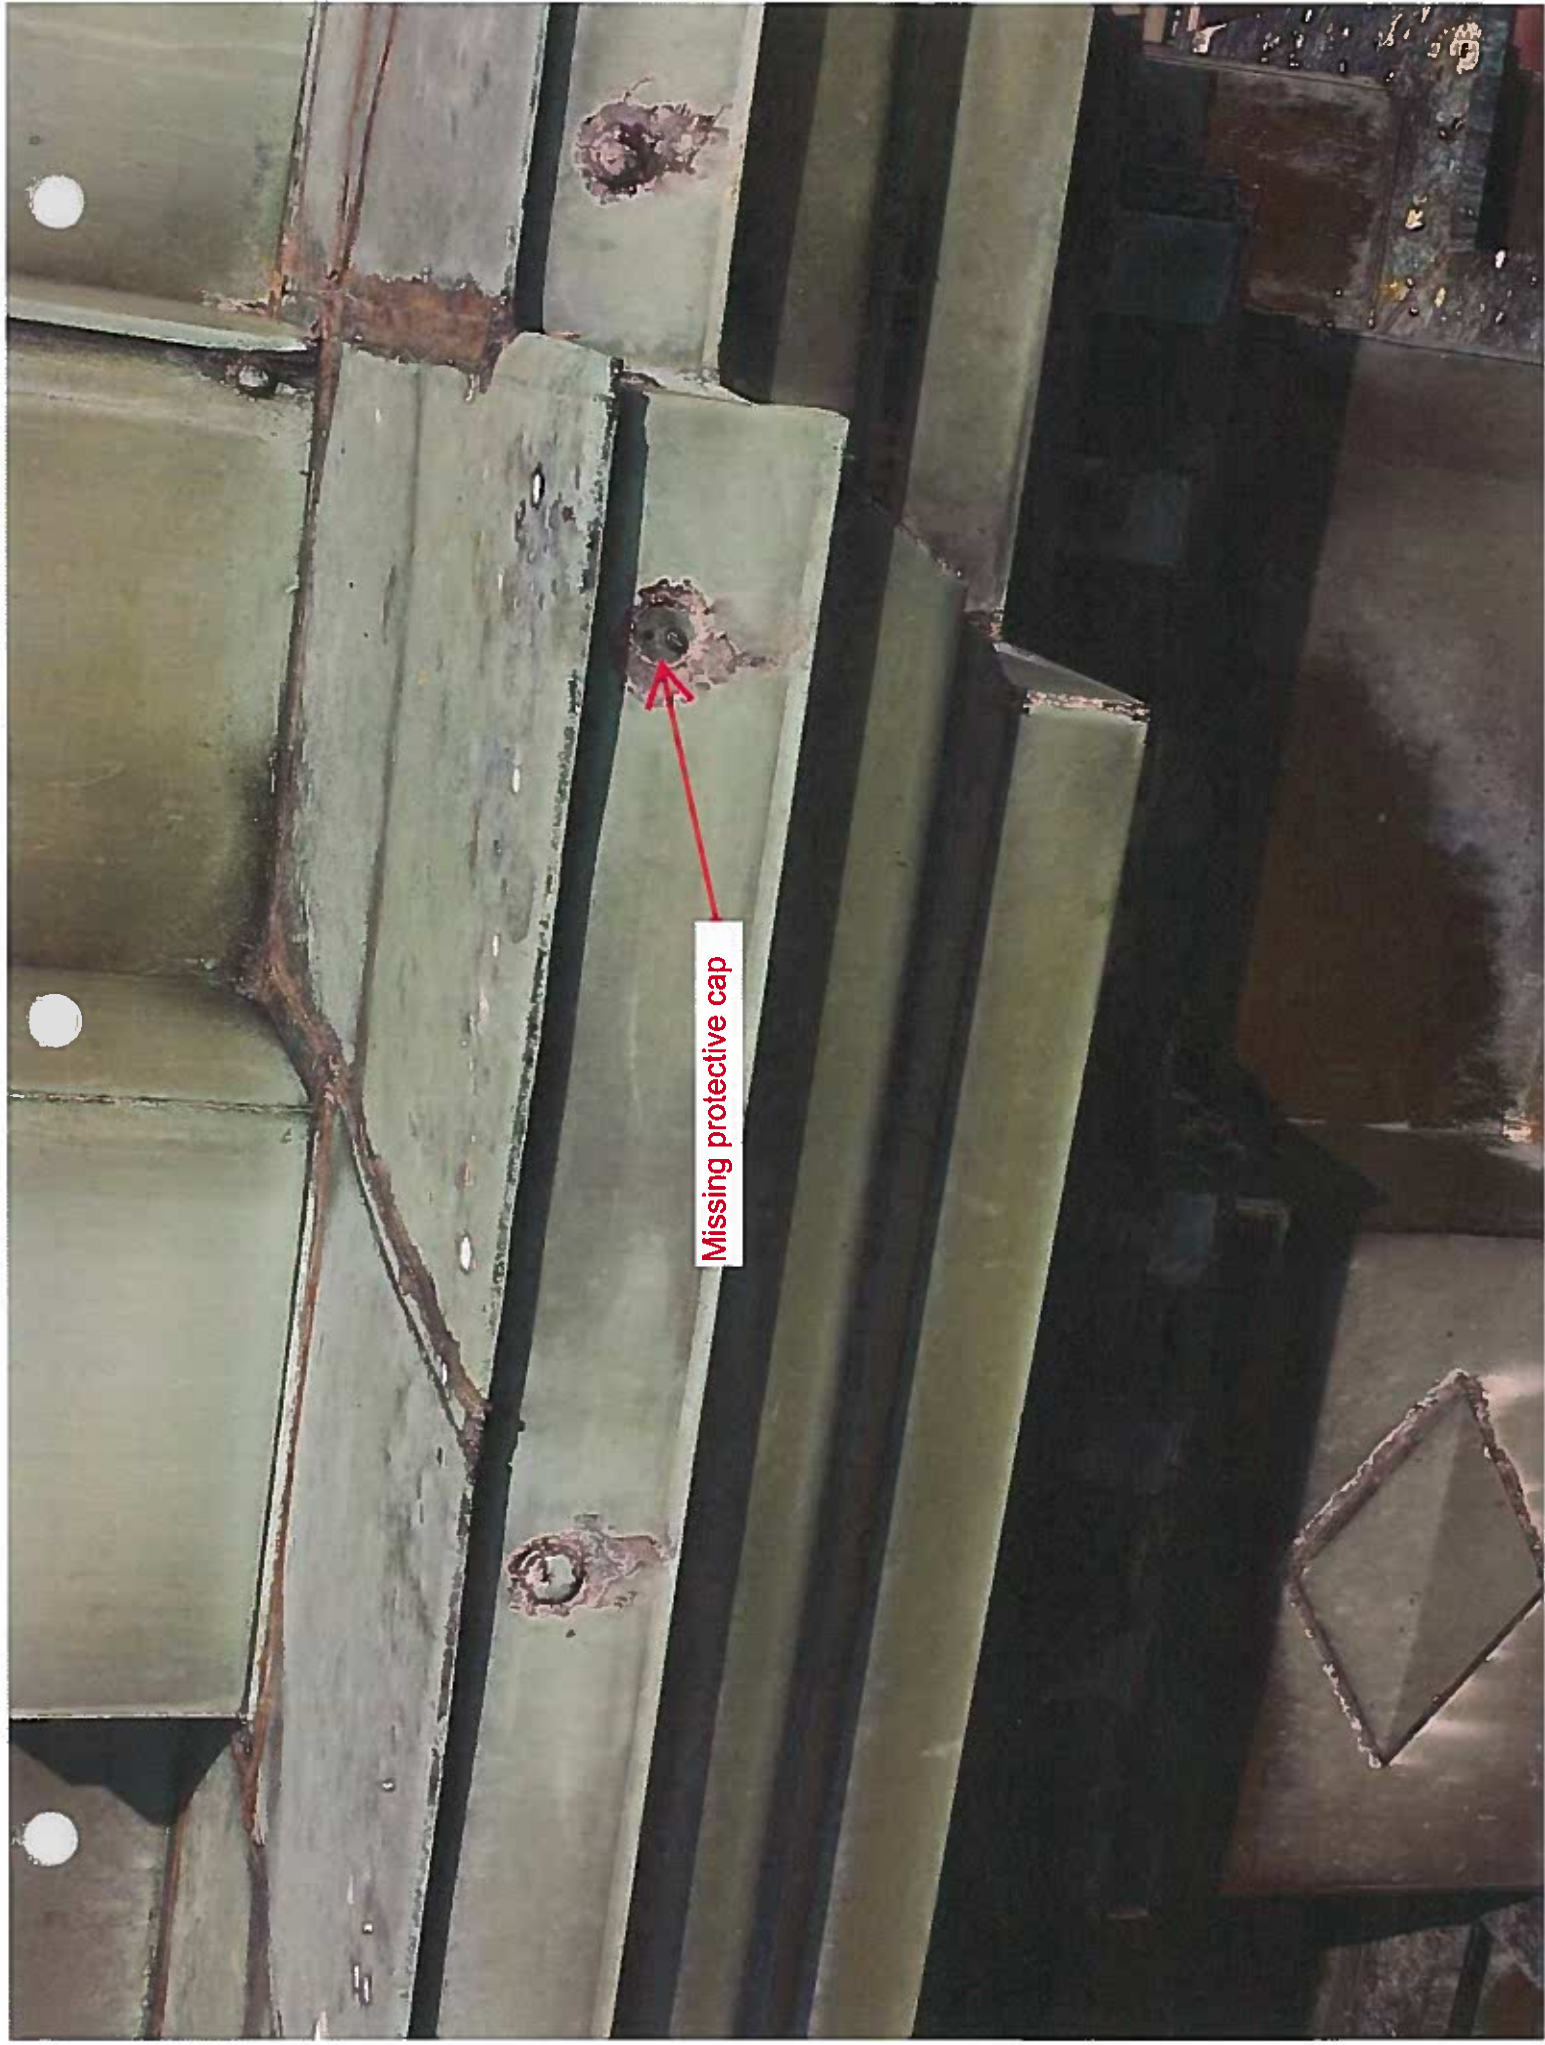
Missing protective cap

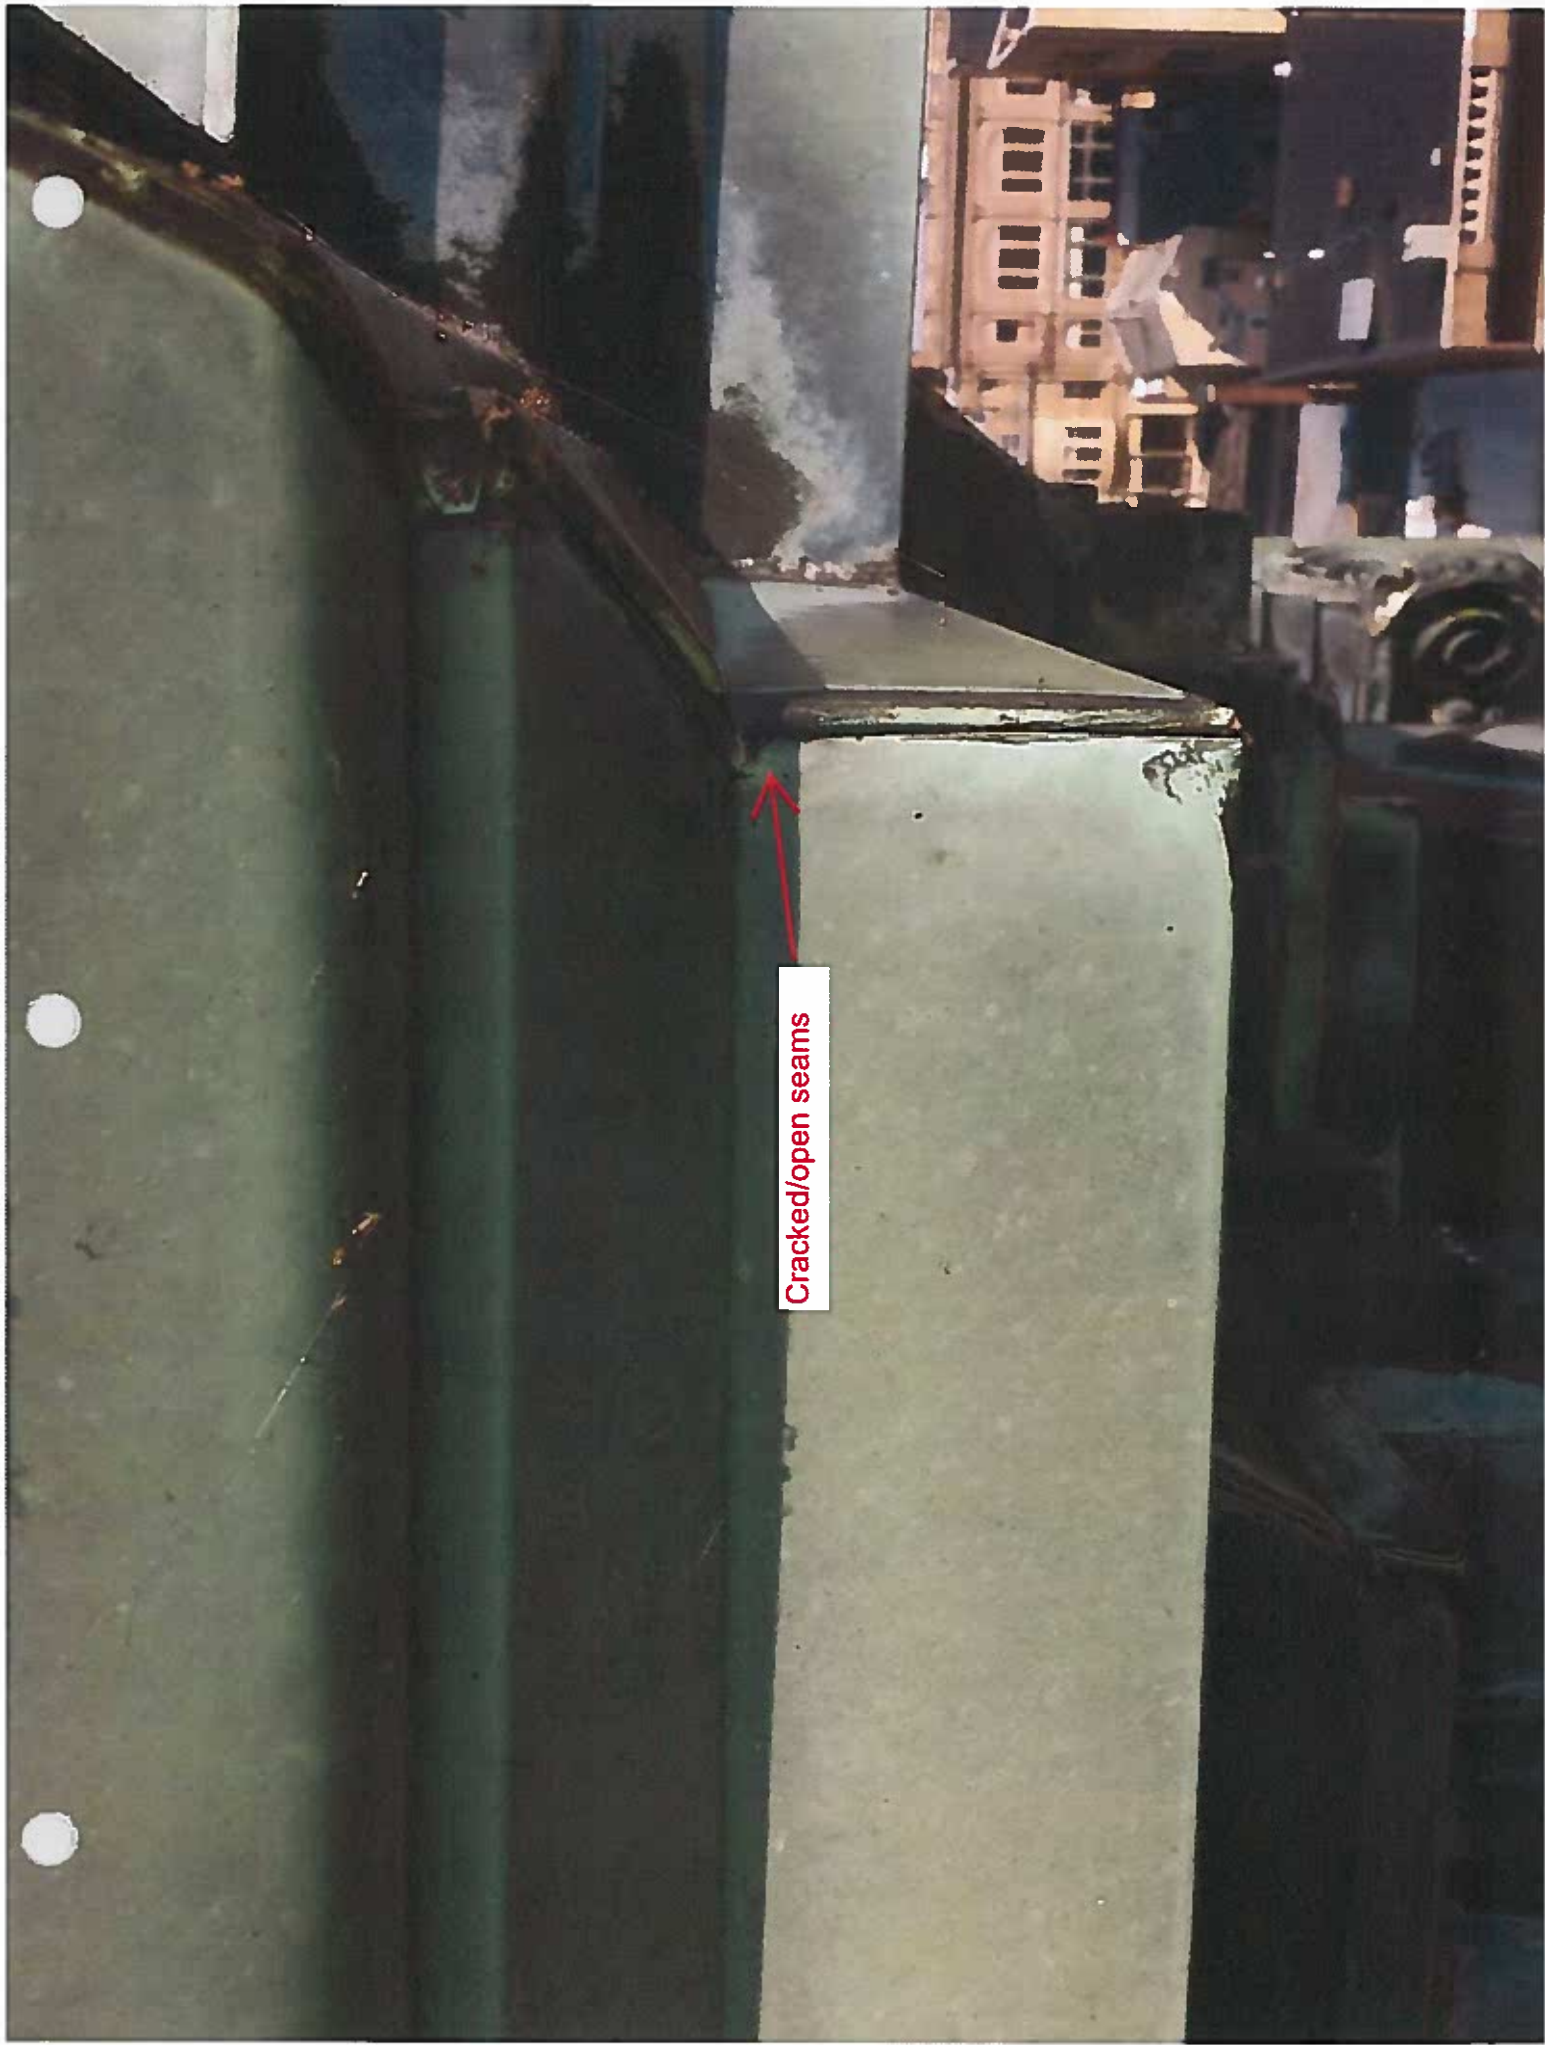
Cracked/open seams

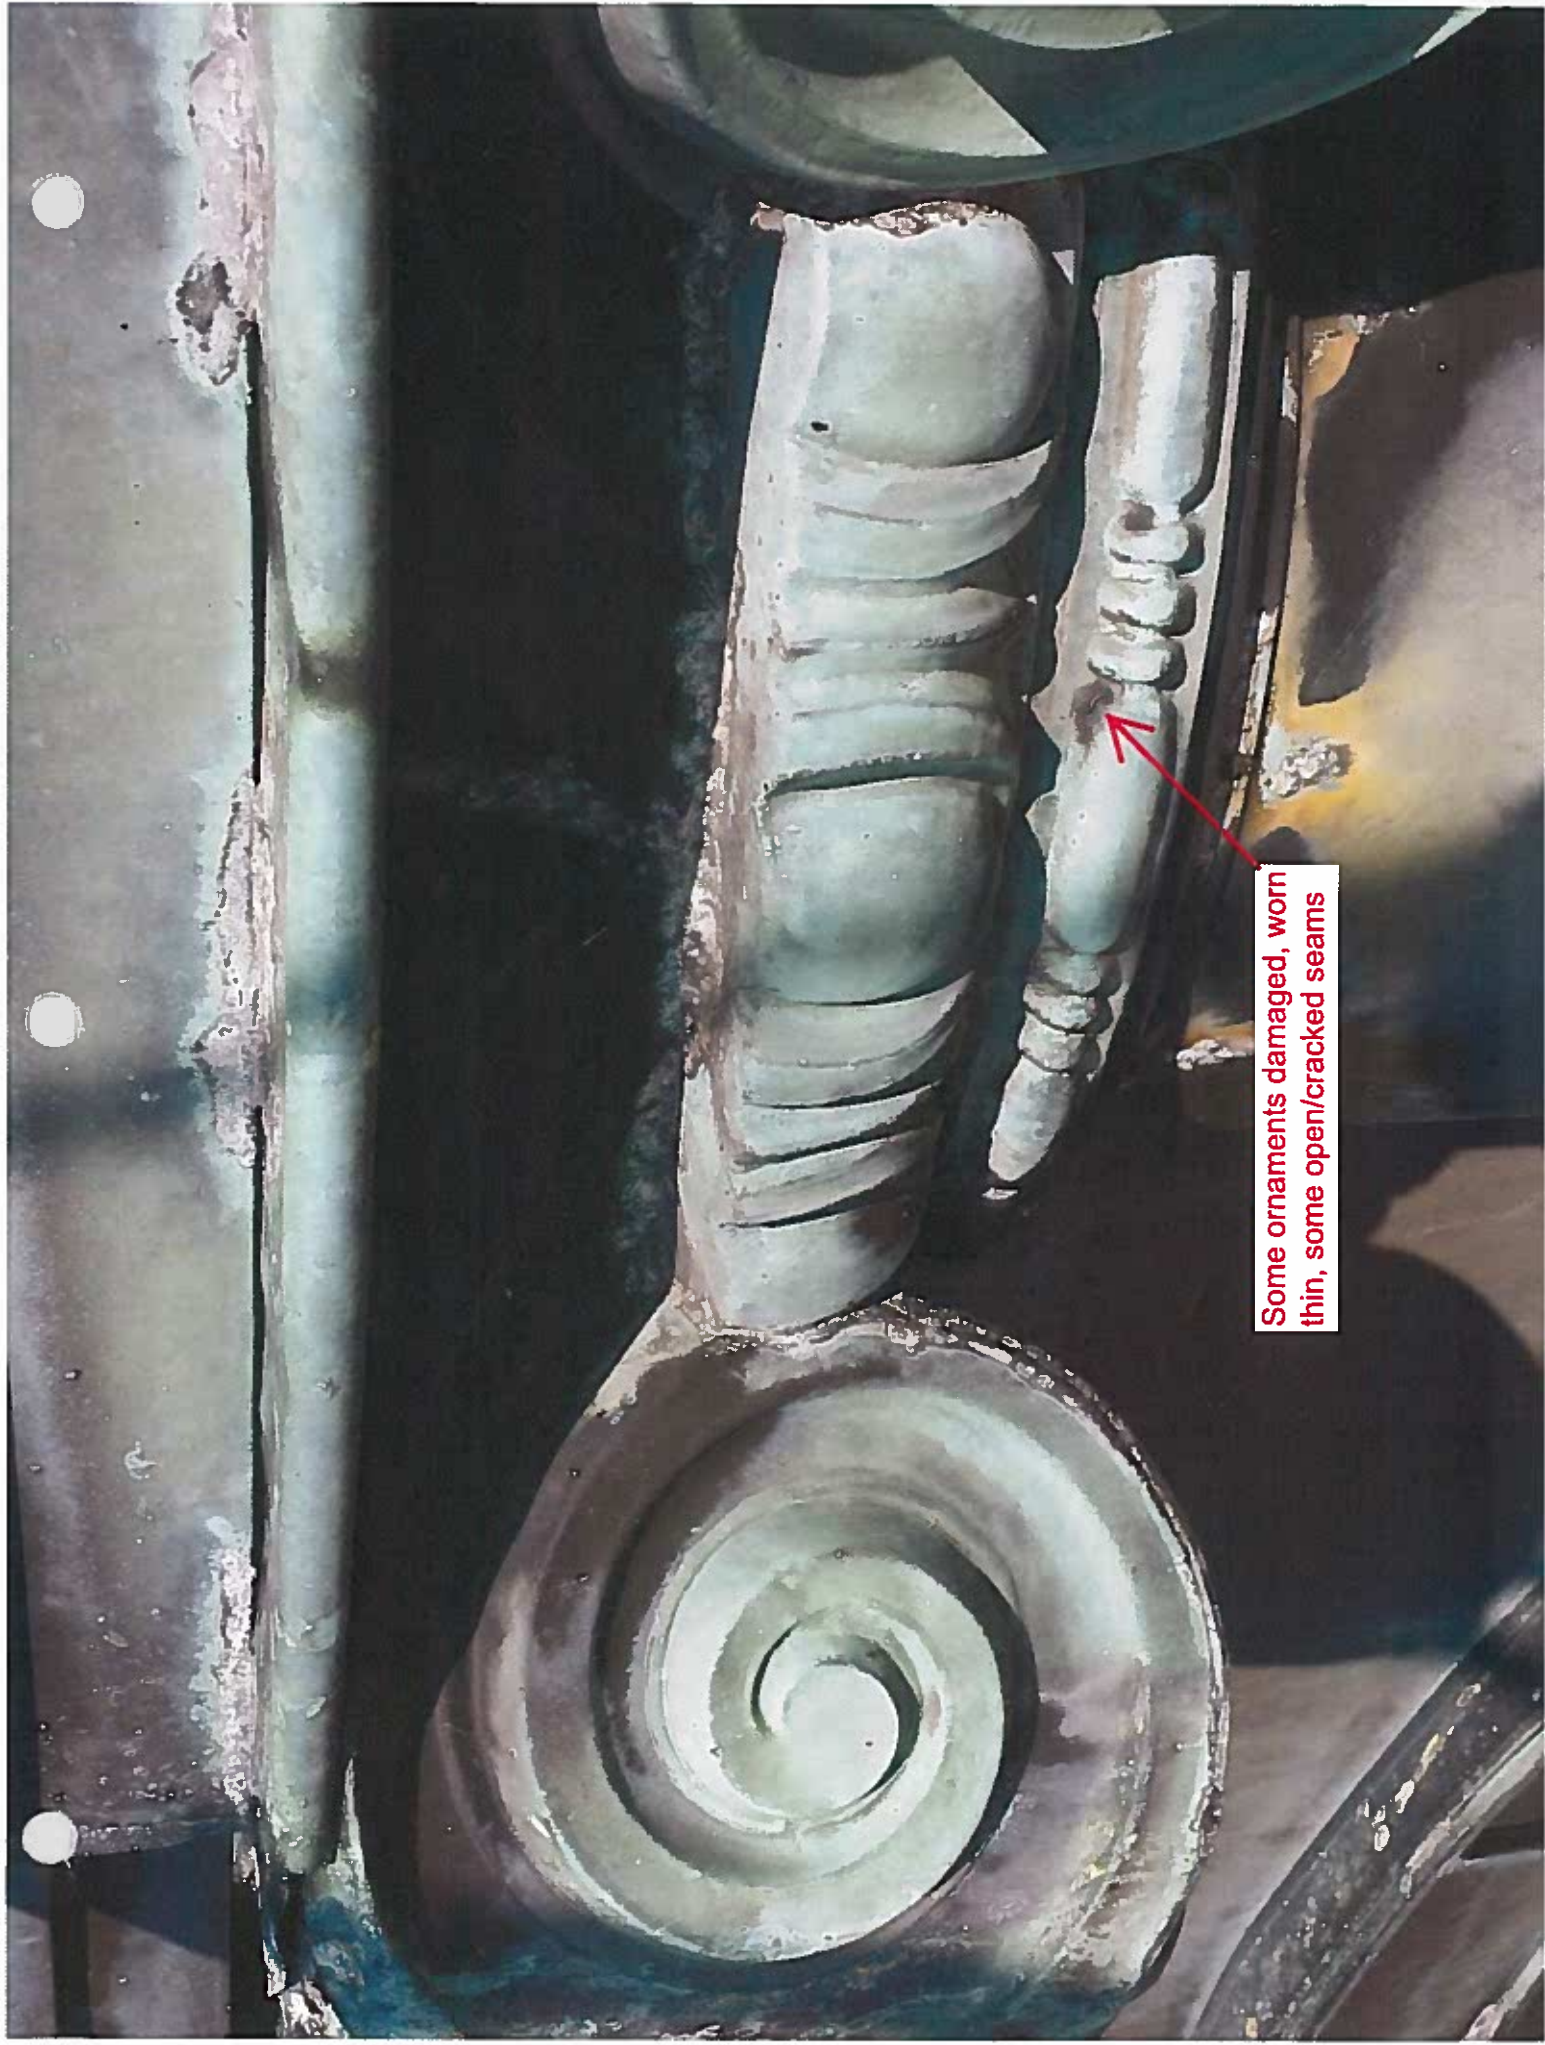
Some ornaments damaged, worn thin, some open/cracked seams

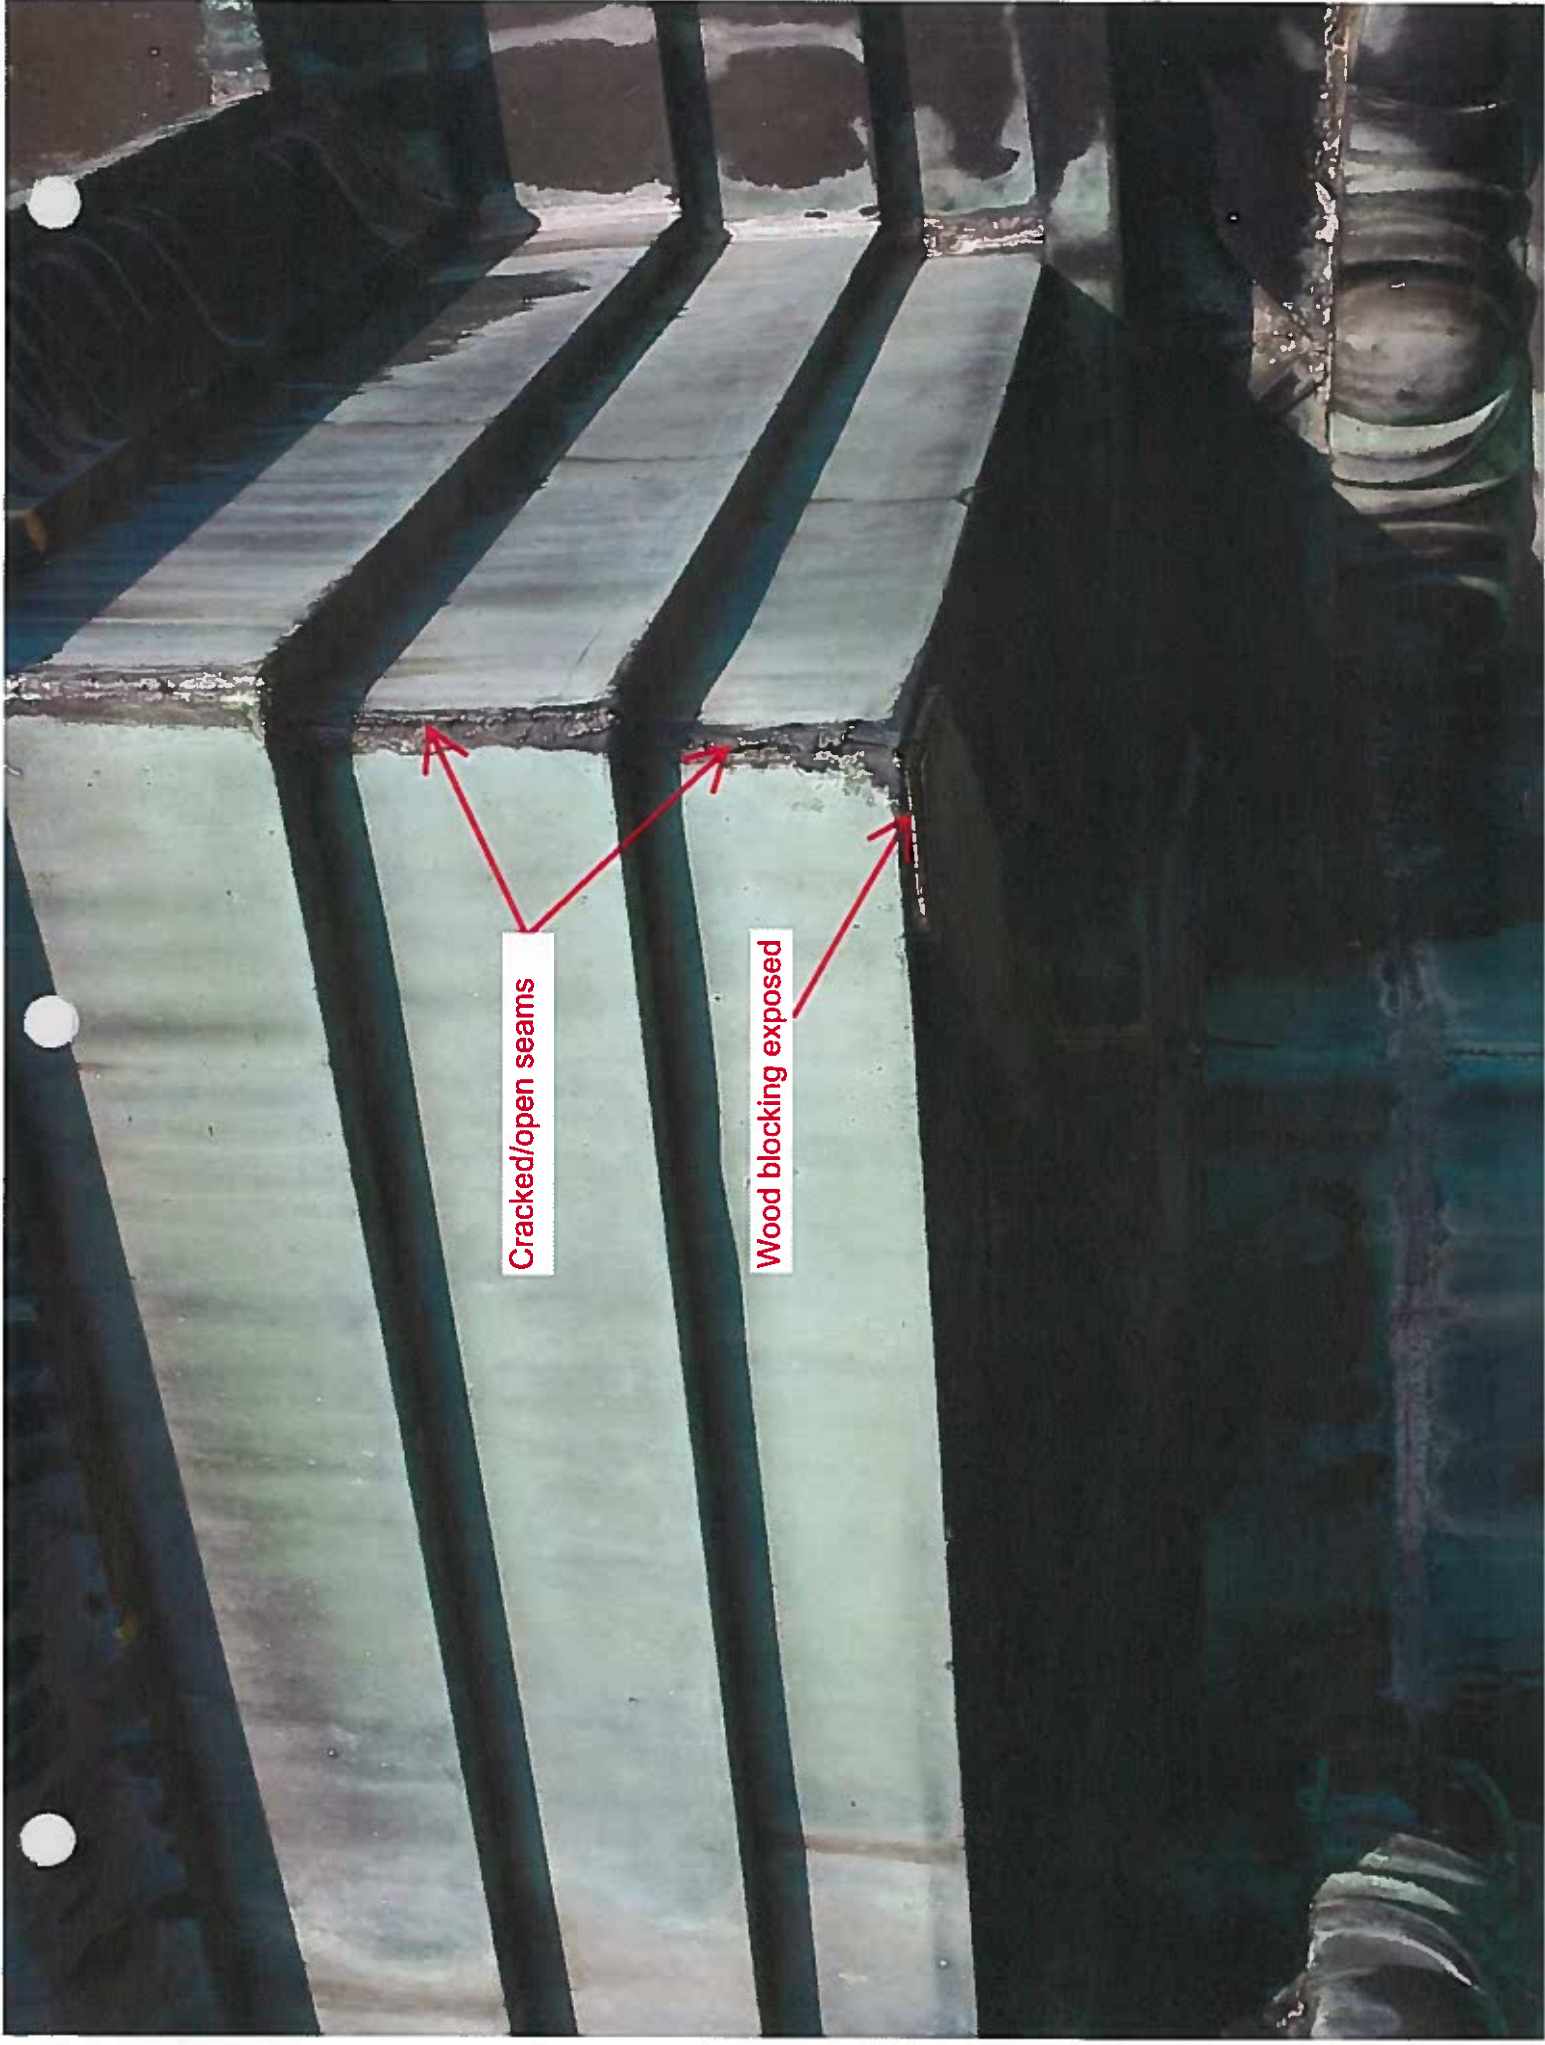
Cracked/open seams

Wood blocking exposed

Fasteners pulling through copper in multiple locations

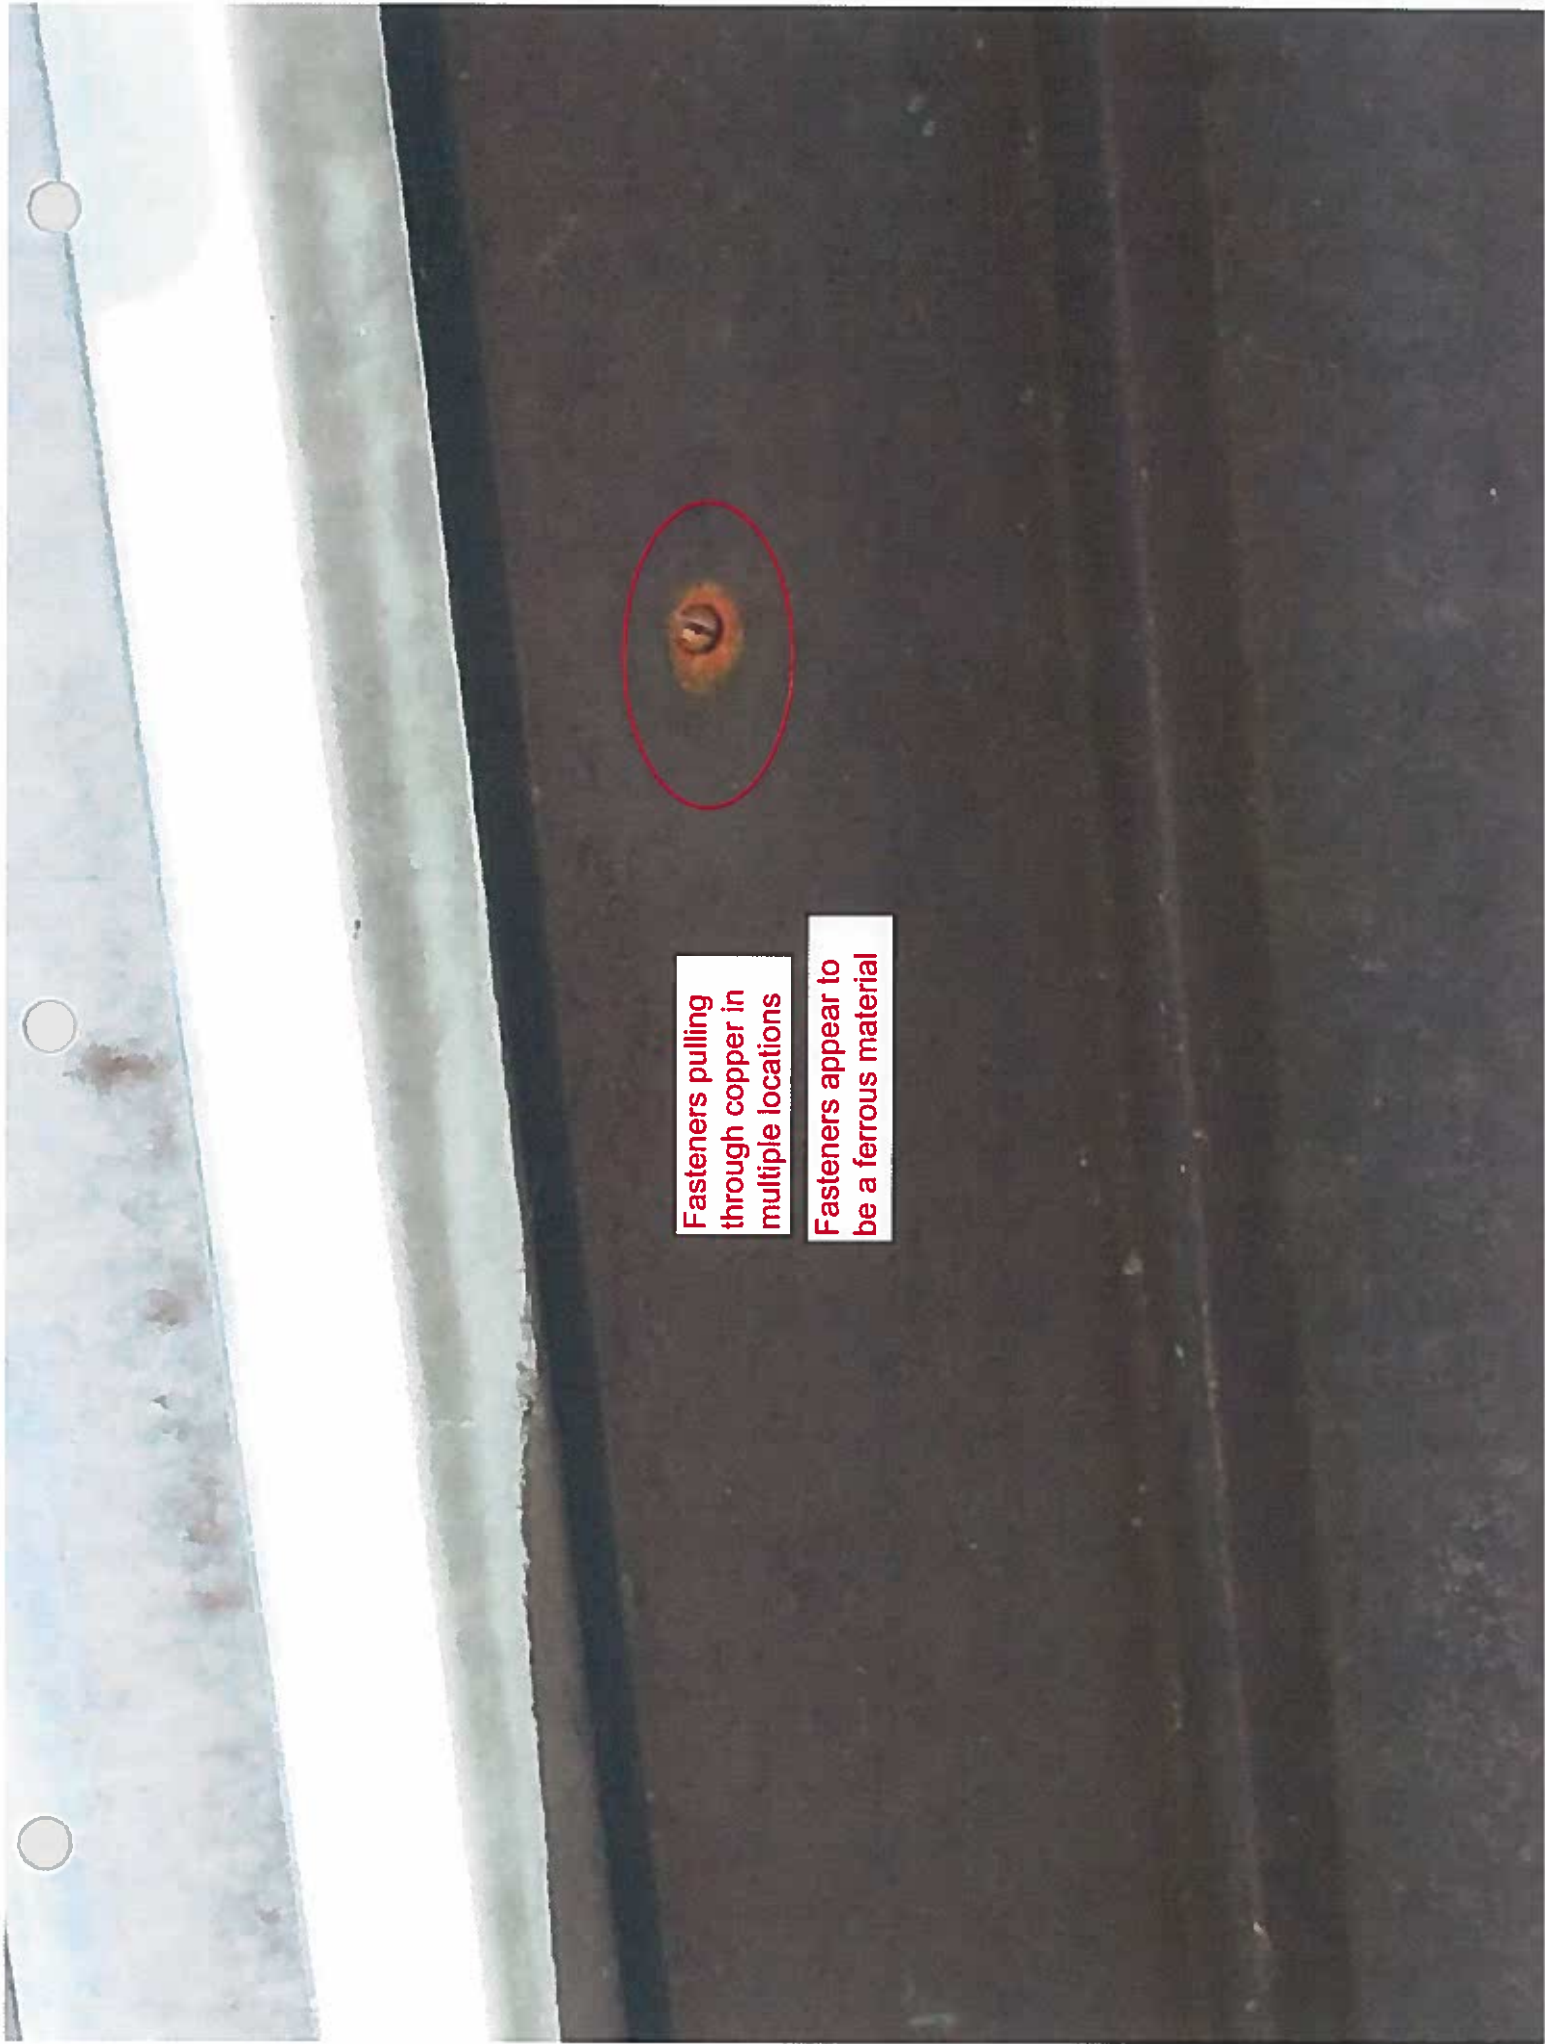
Fasteners pulling  
through copper in  
multiple locations

Fasteners appear to  
be a ferrous material

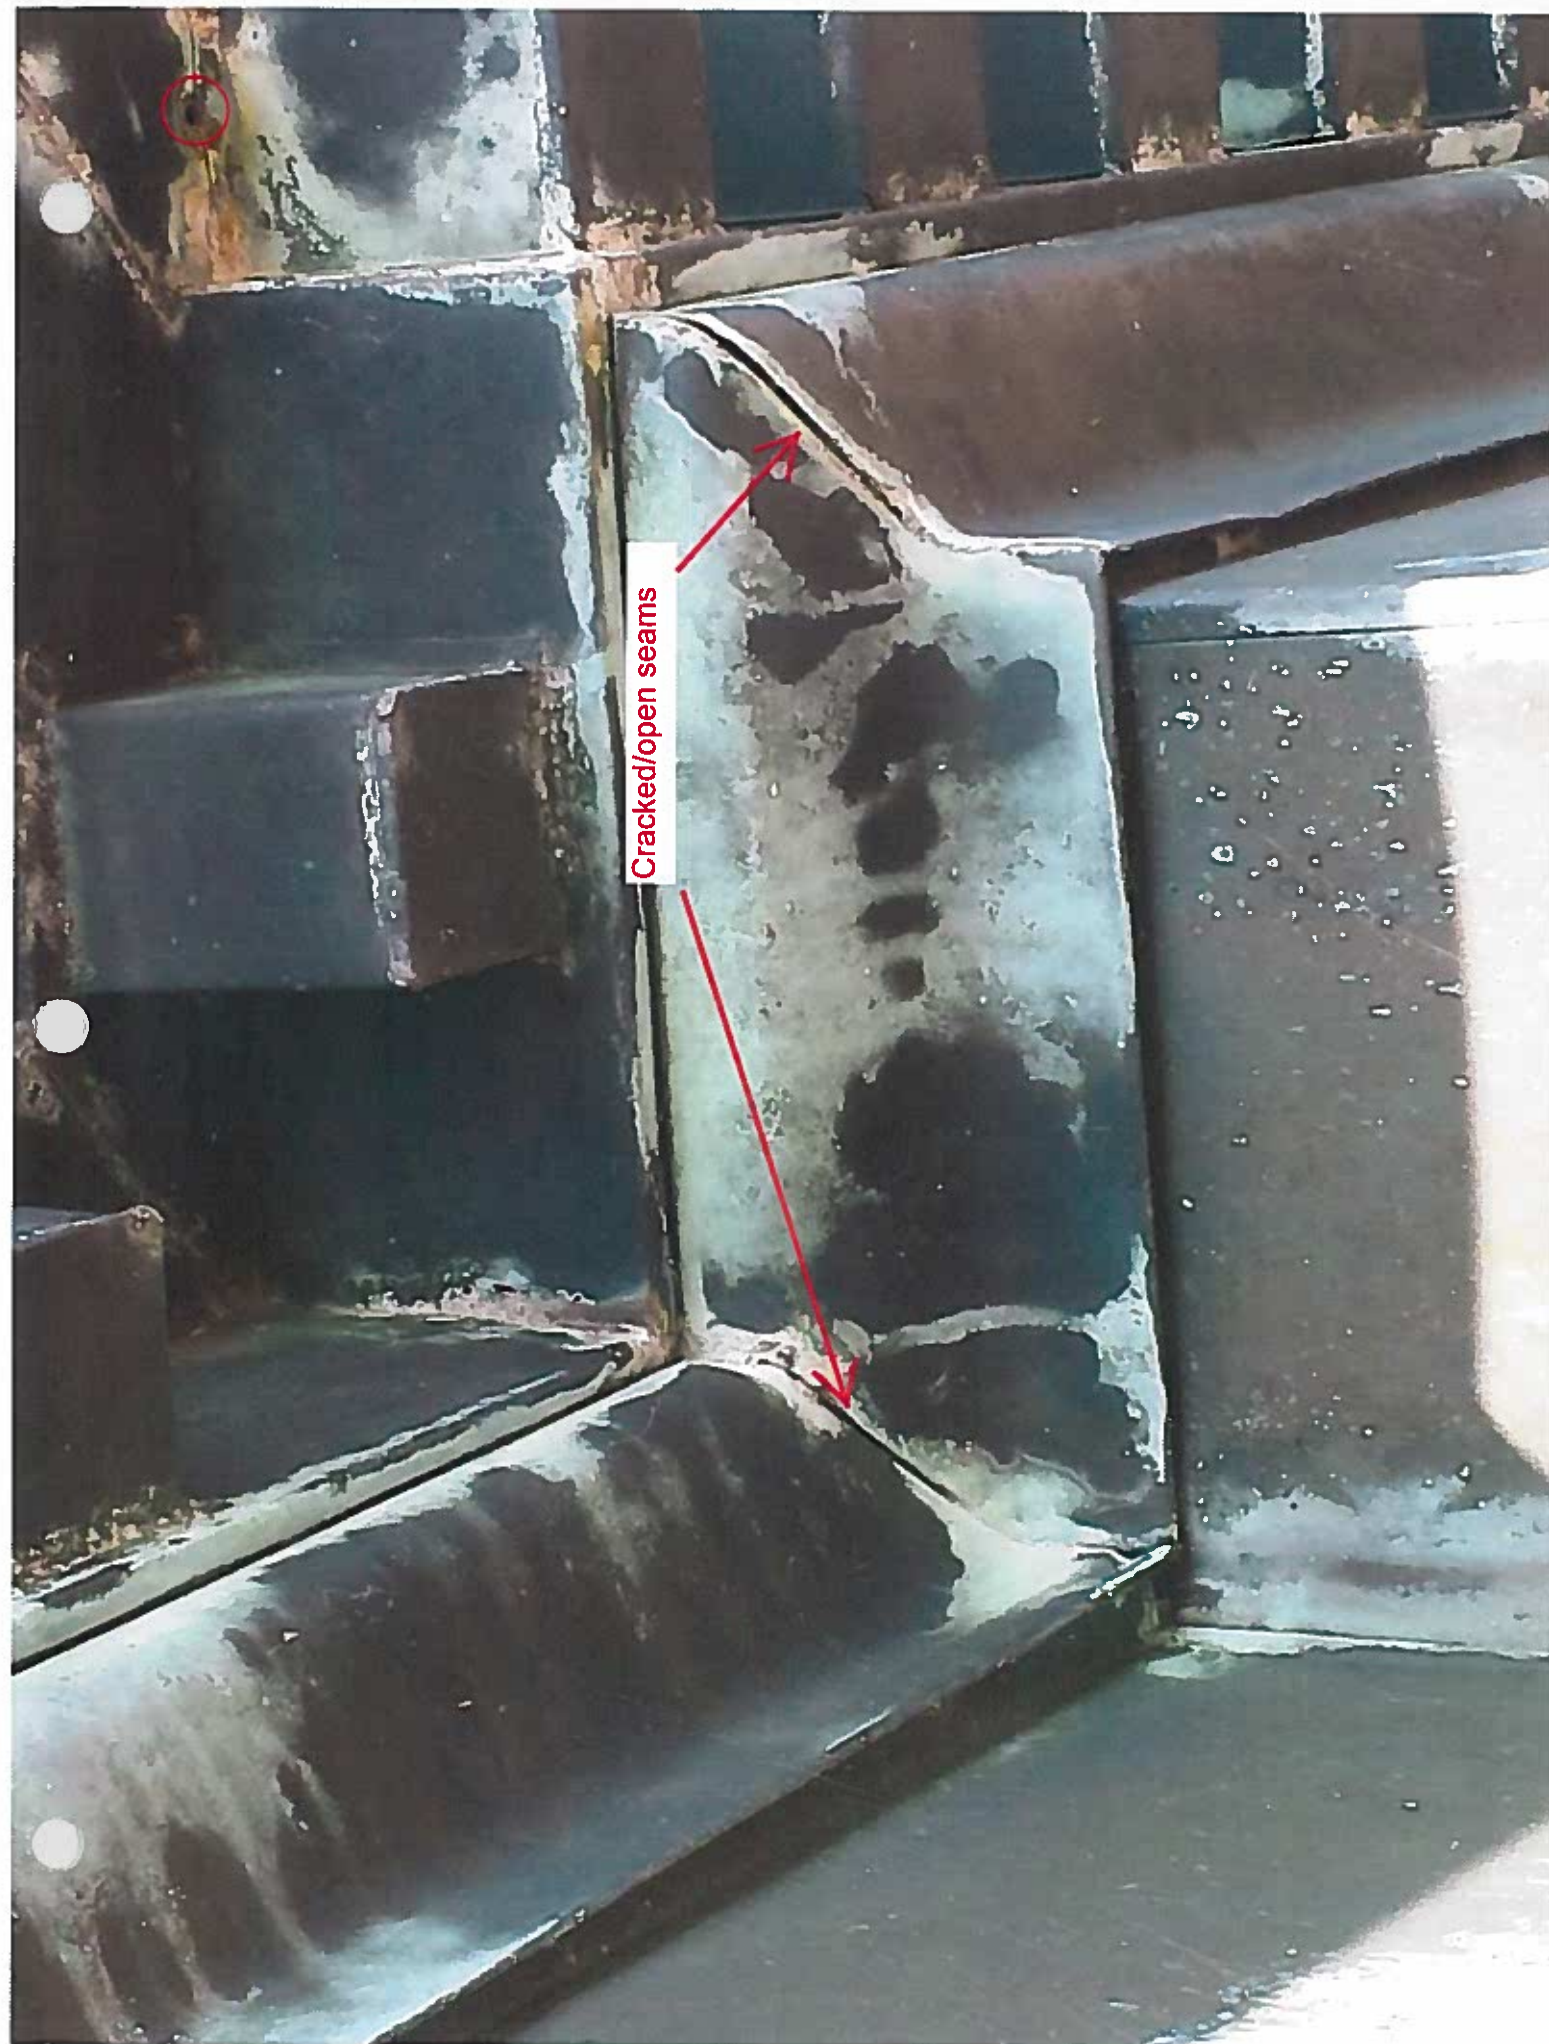
Cracked/open seams
