# Clerestory Photos

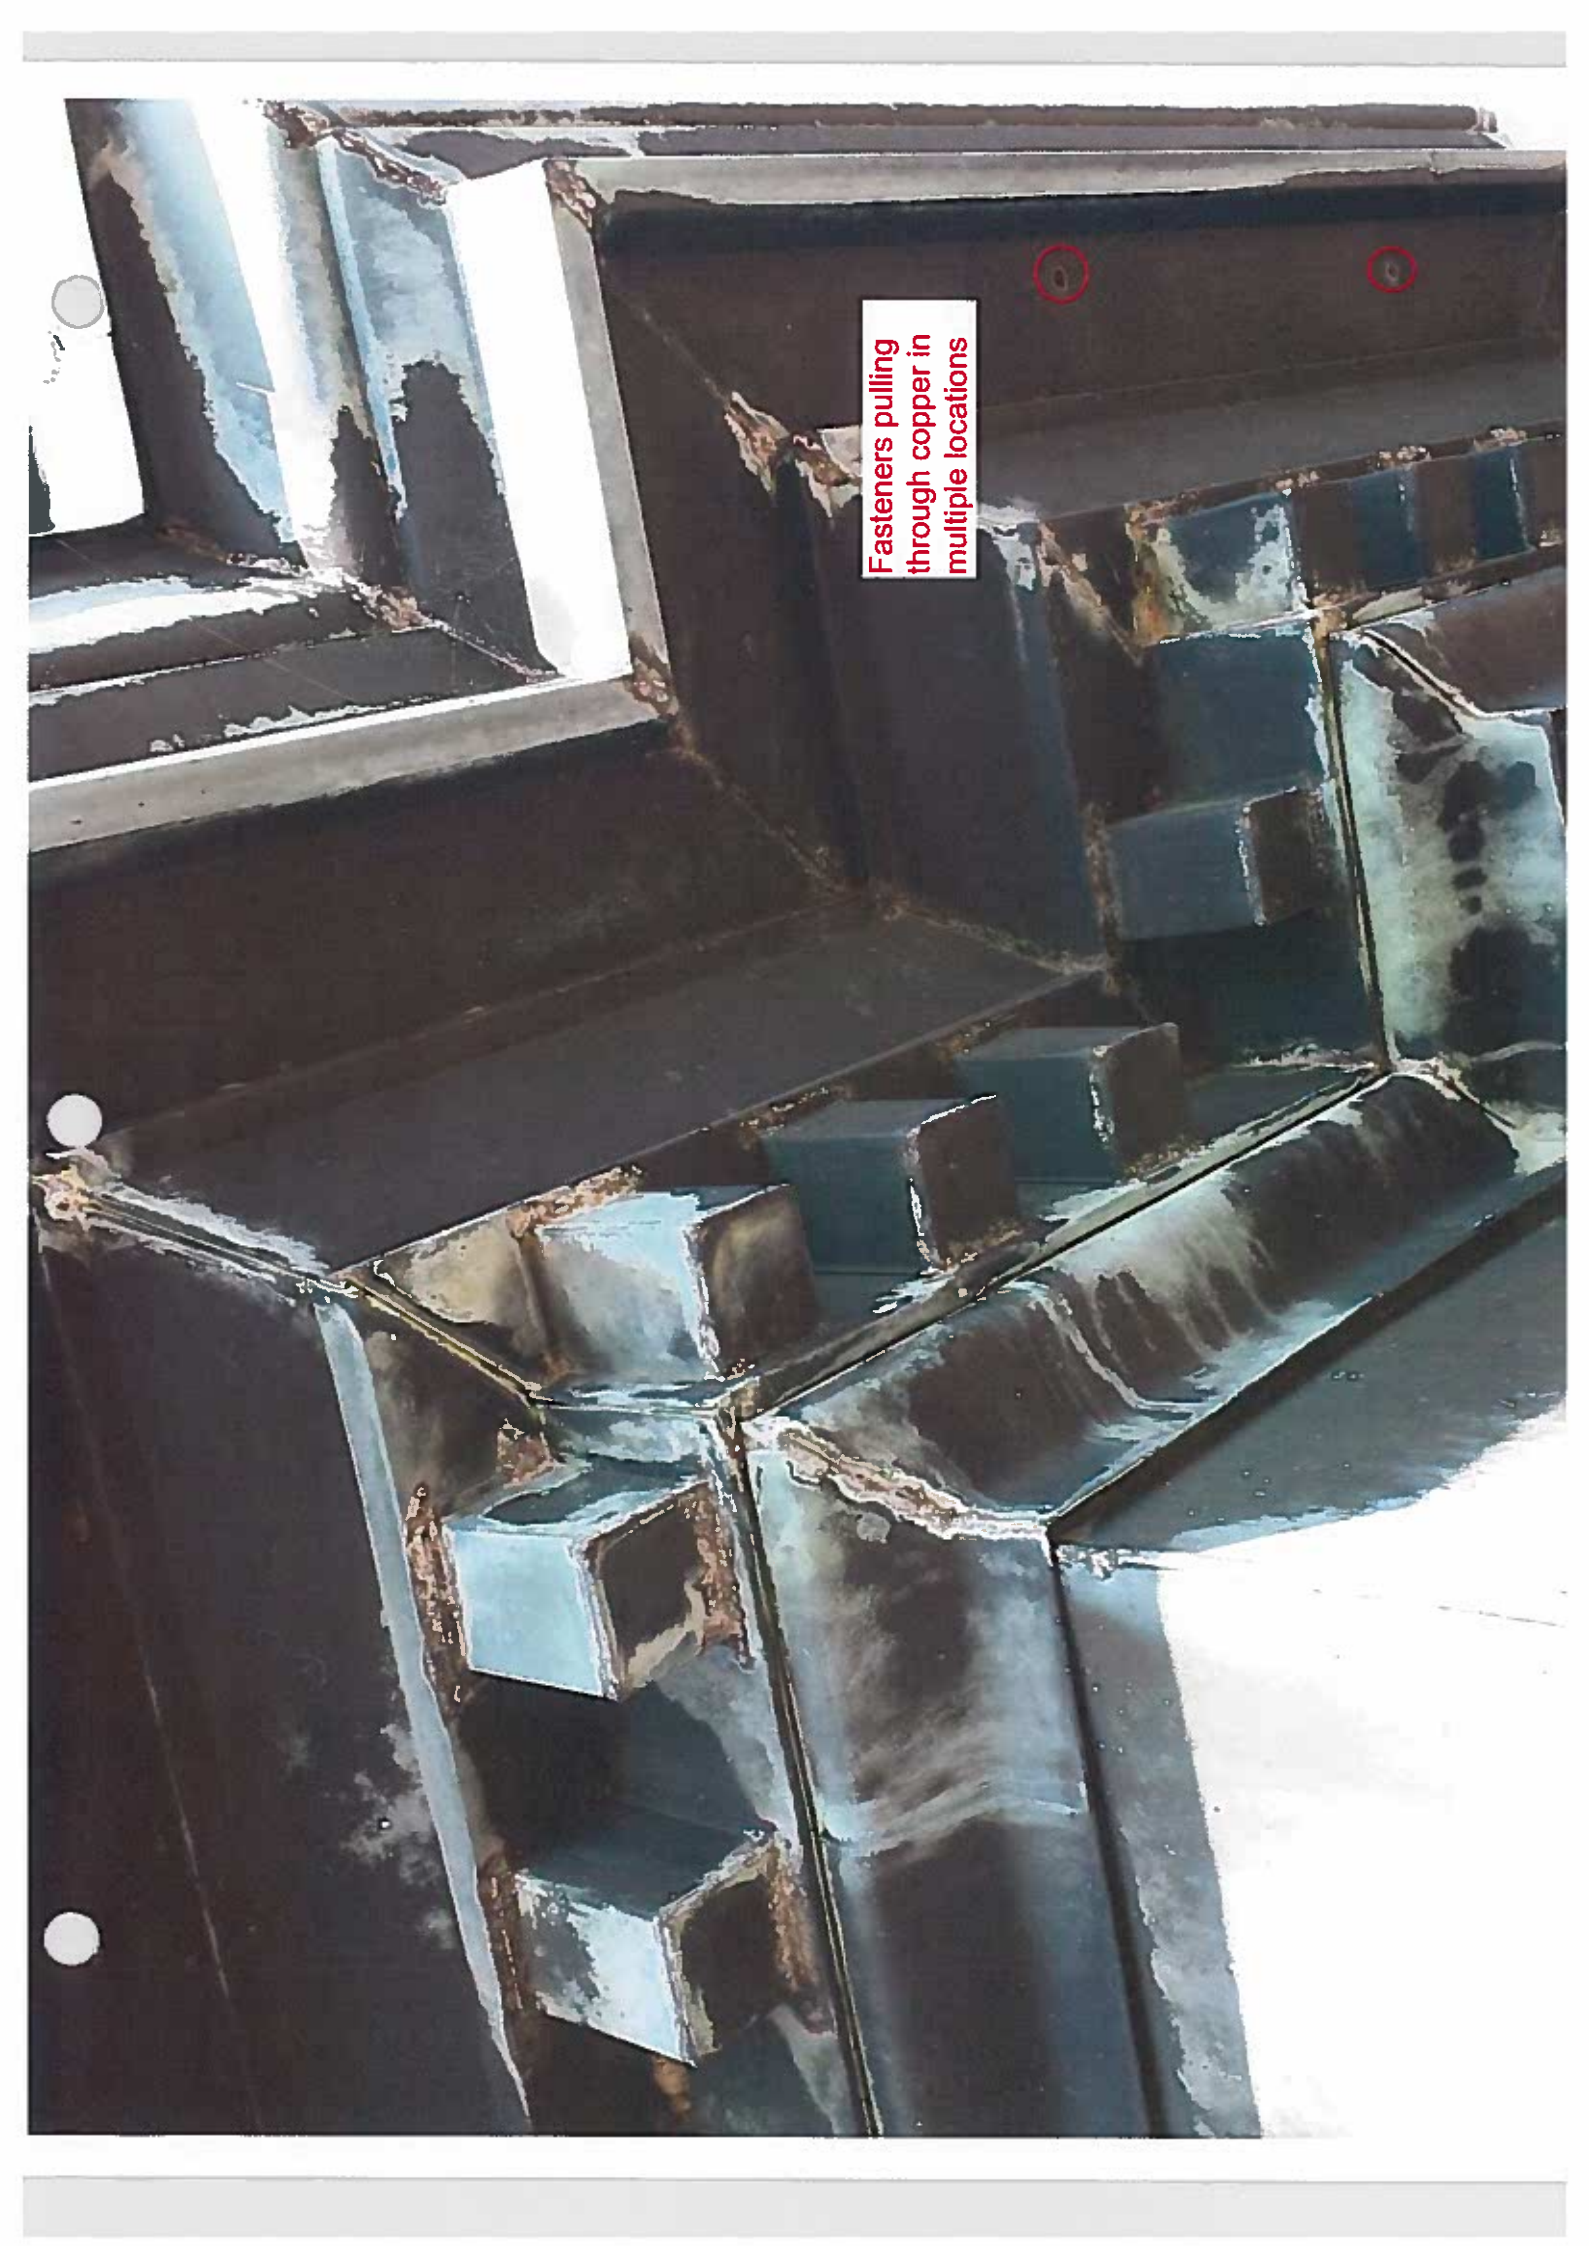
Fasteners pulling  
through copper in  
multiple locations

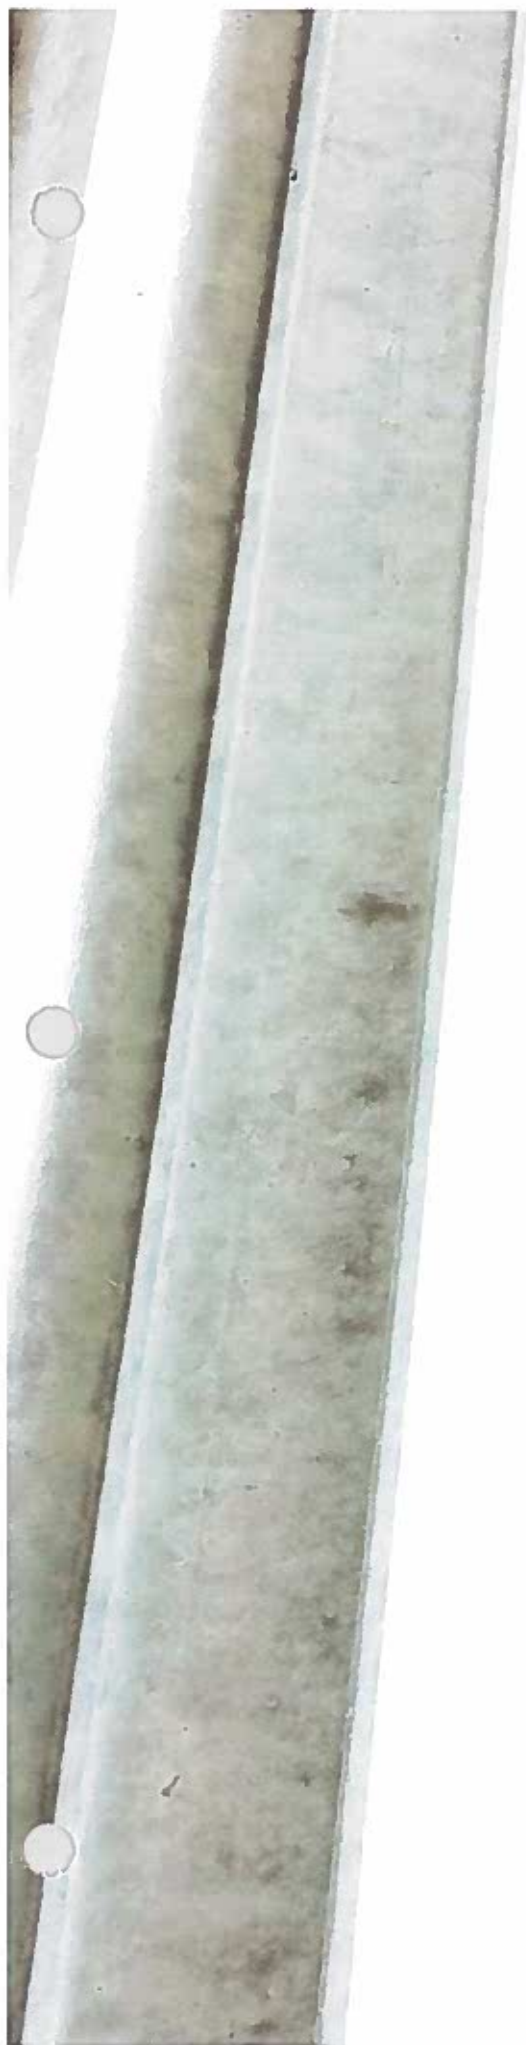
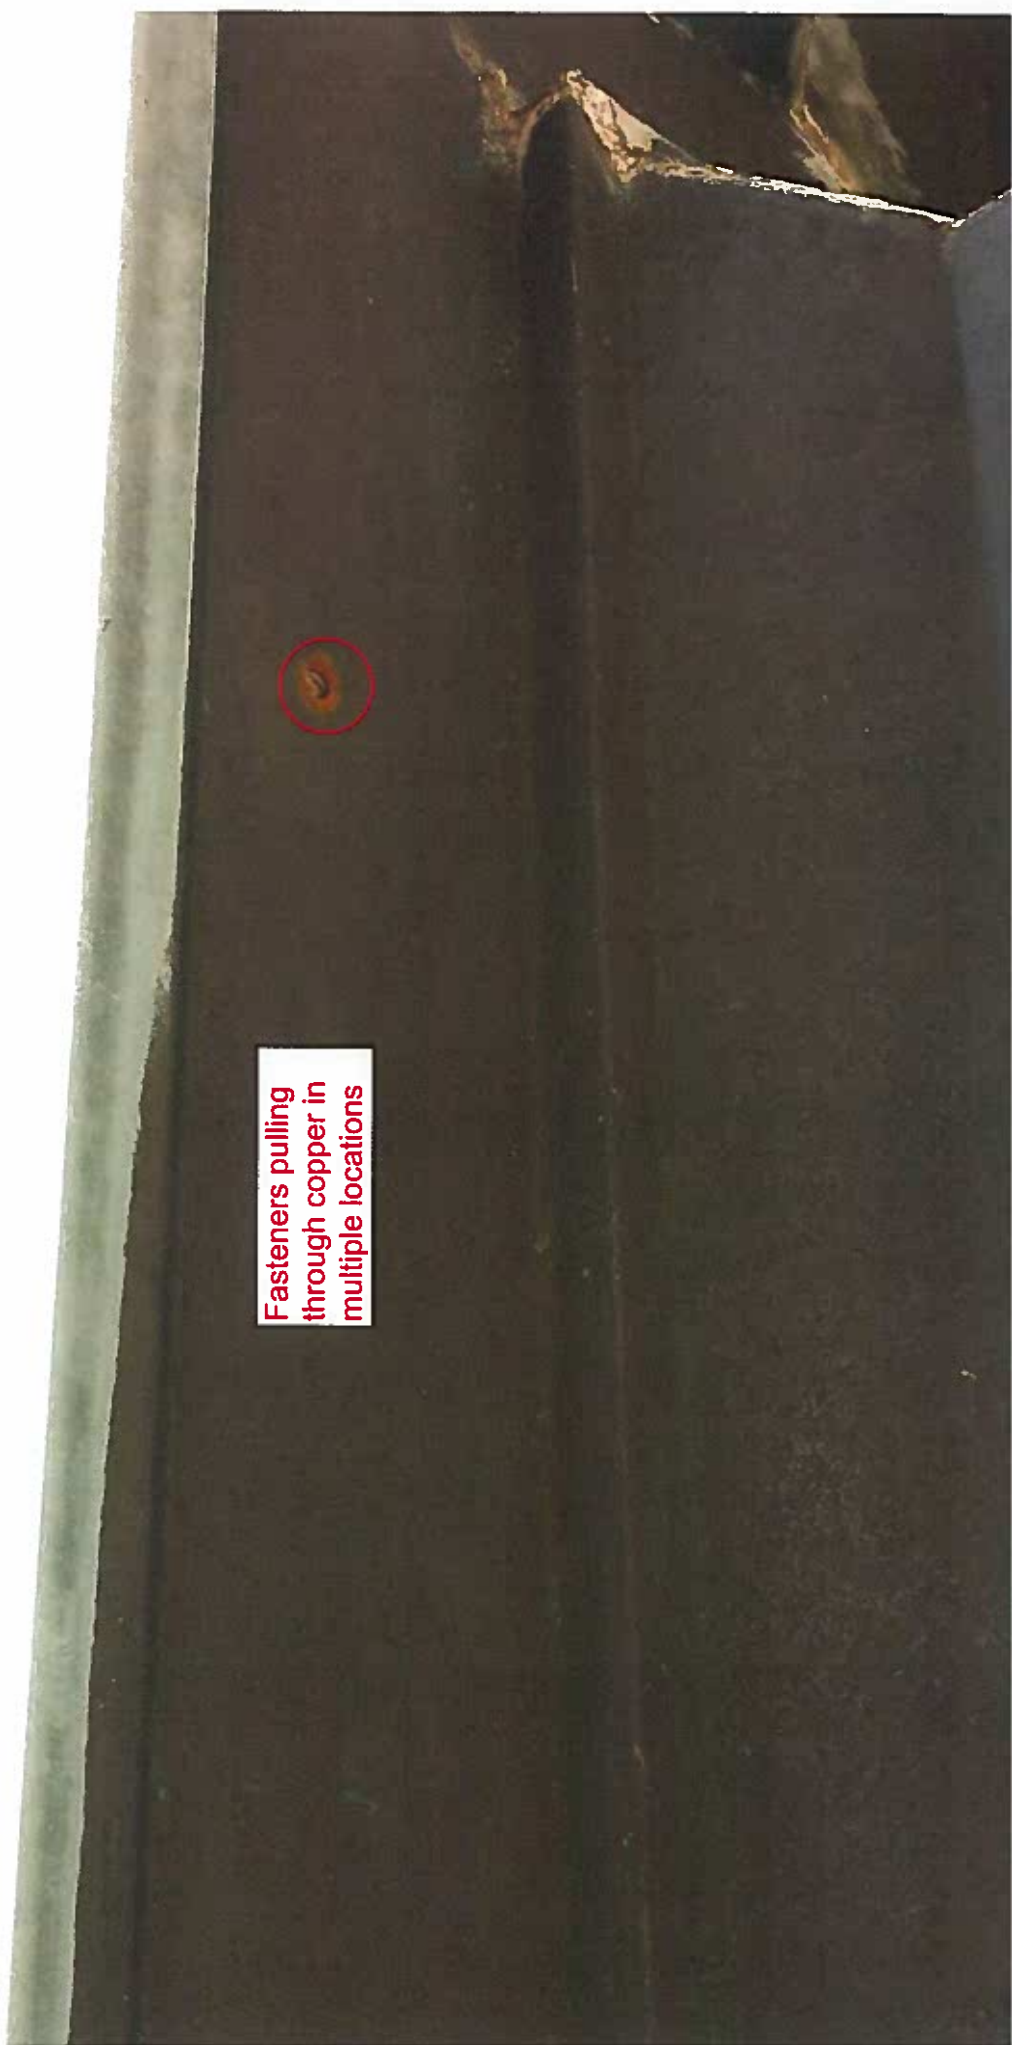
Fasteners pulling  
through copper in  
multiple locations

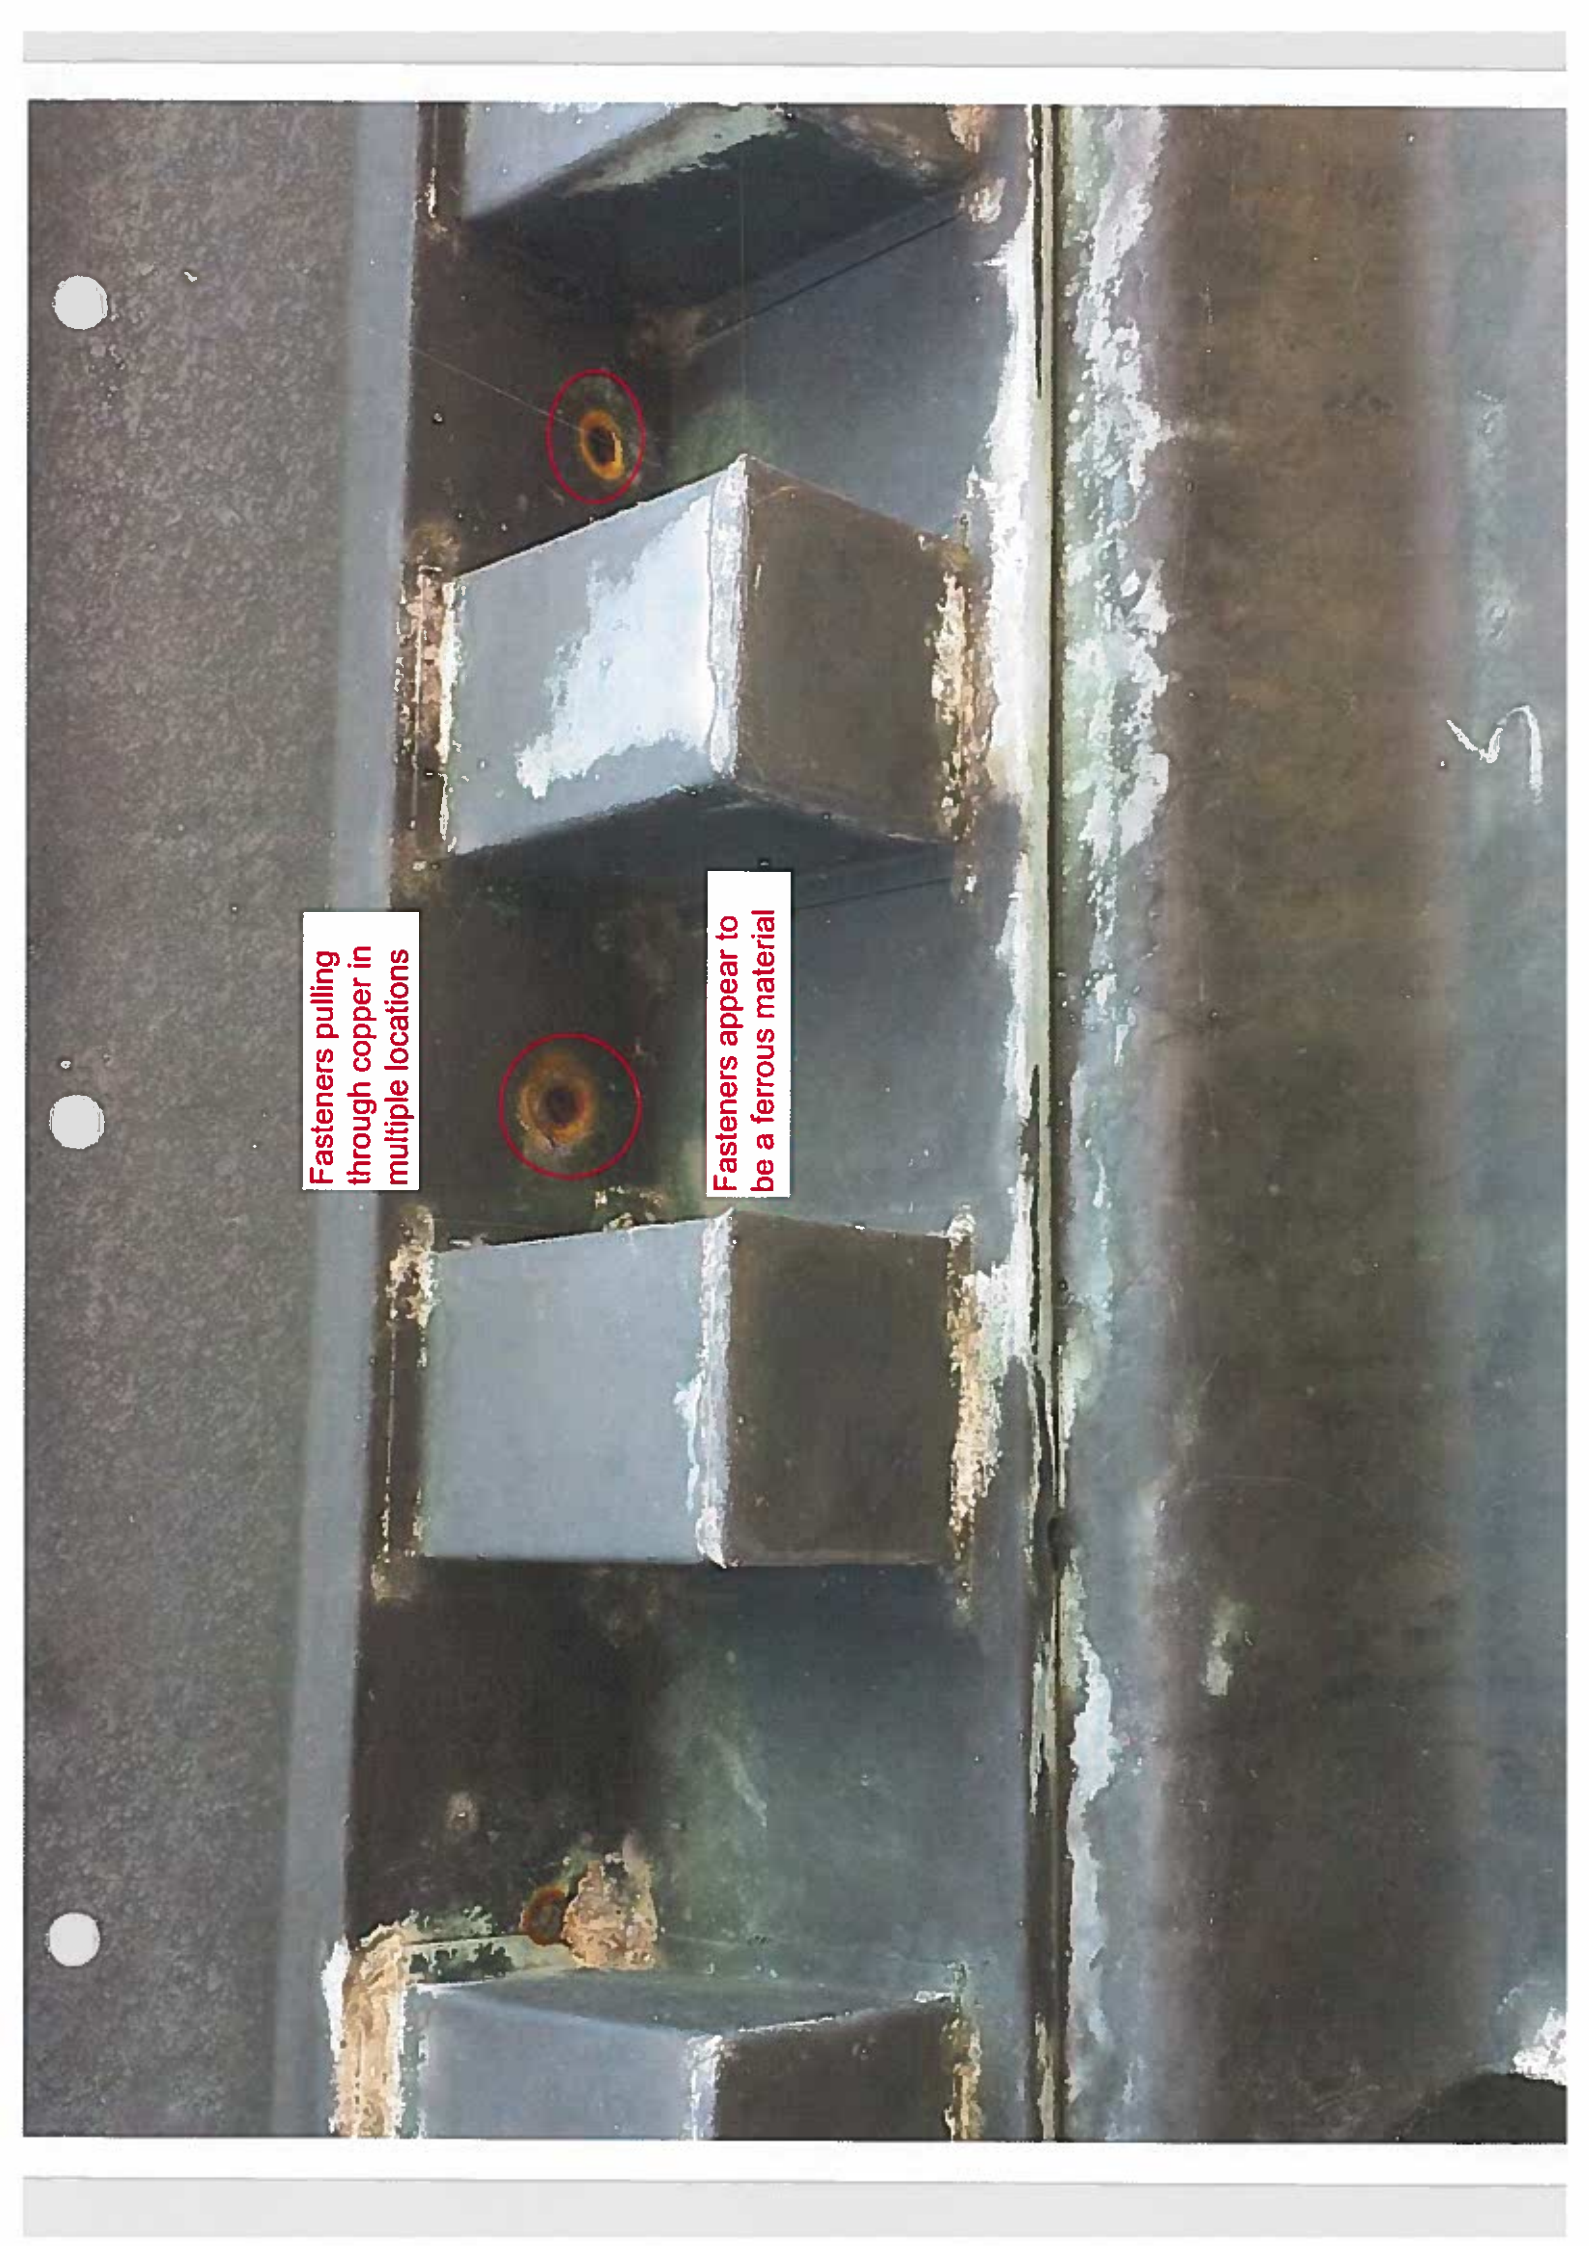
Fasteners pulling through copper in multiple locations

Fasteners appear to be a ferrous material

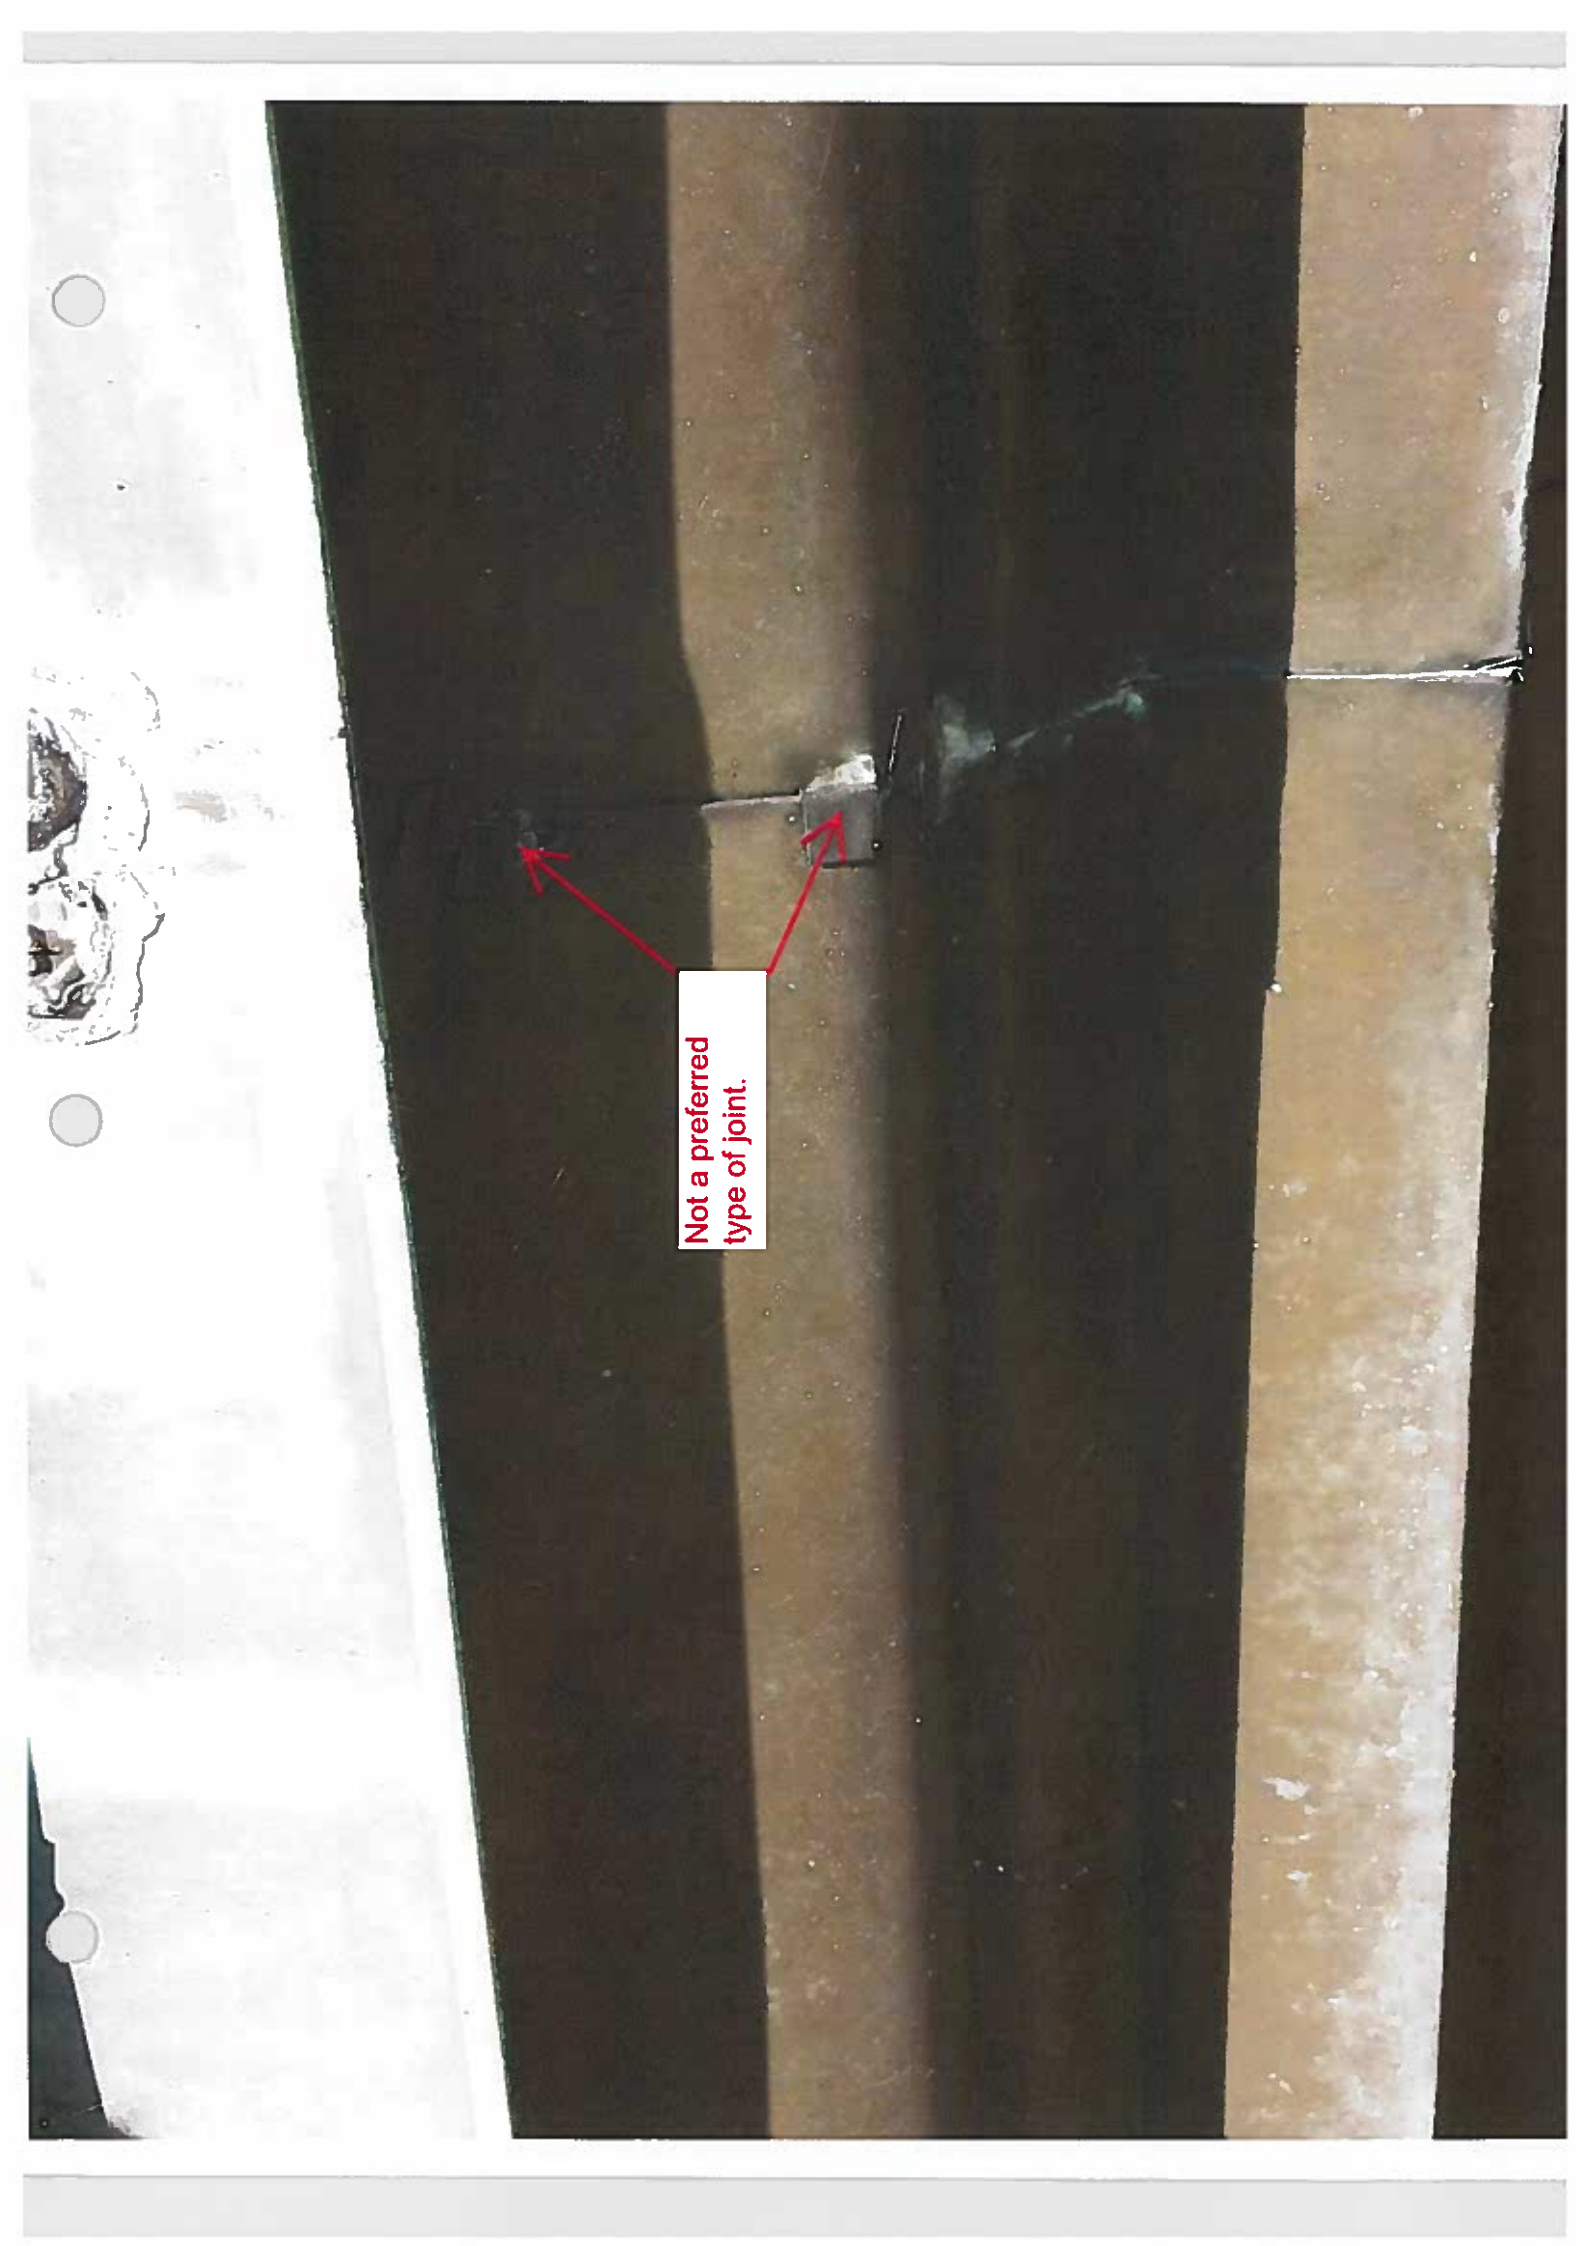
Not a preferred  
type of joint.

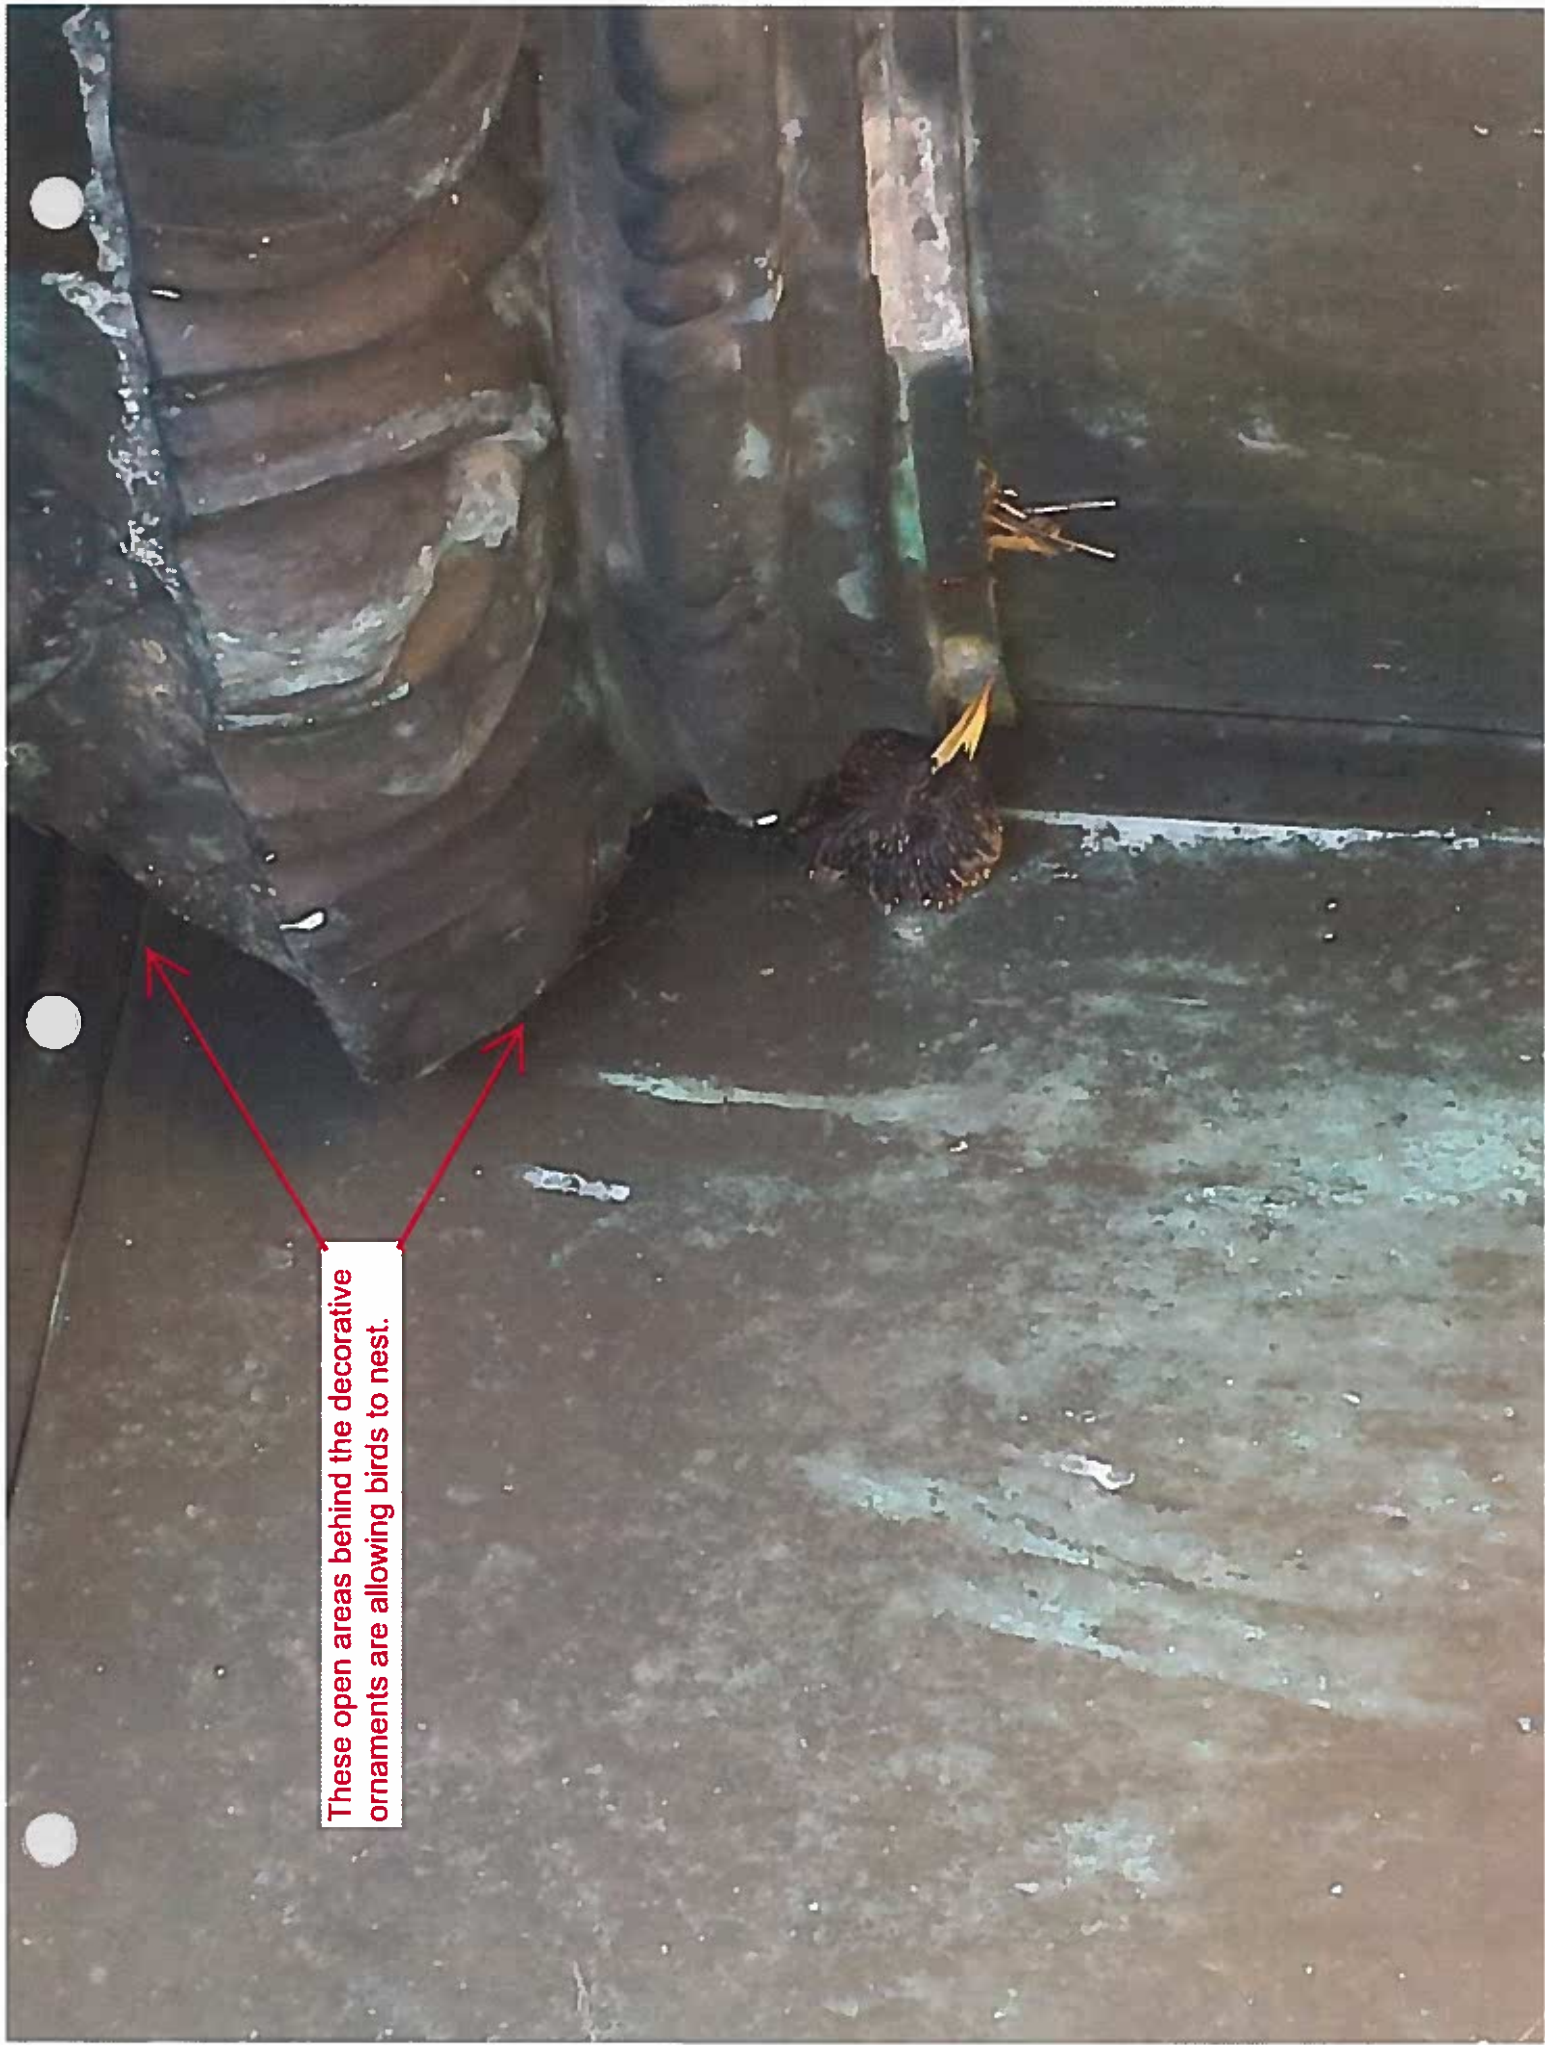
These open areas behind the decorative ornaments are allowing birds to nest.

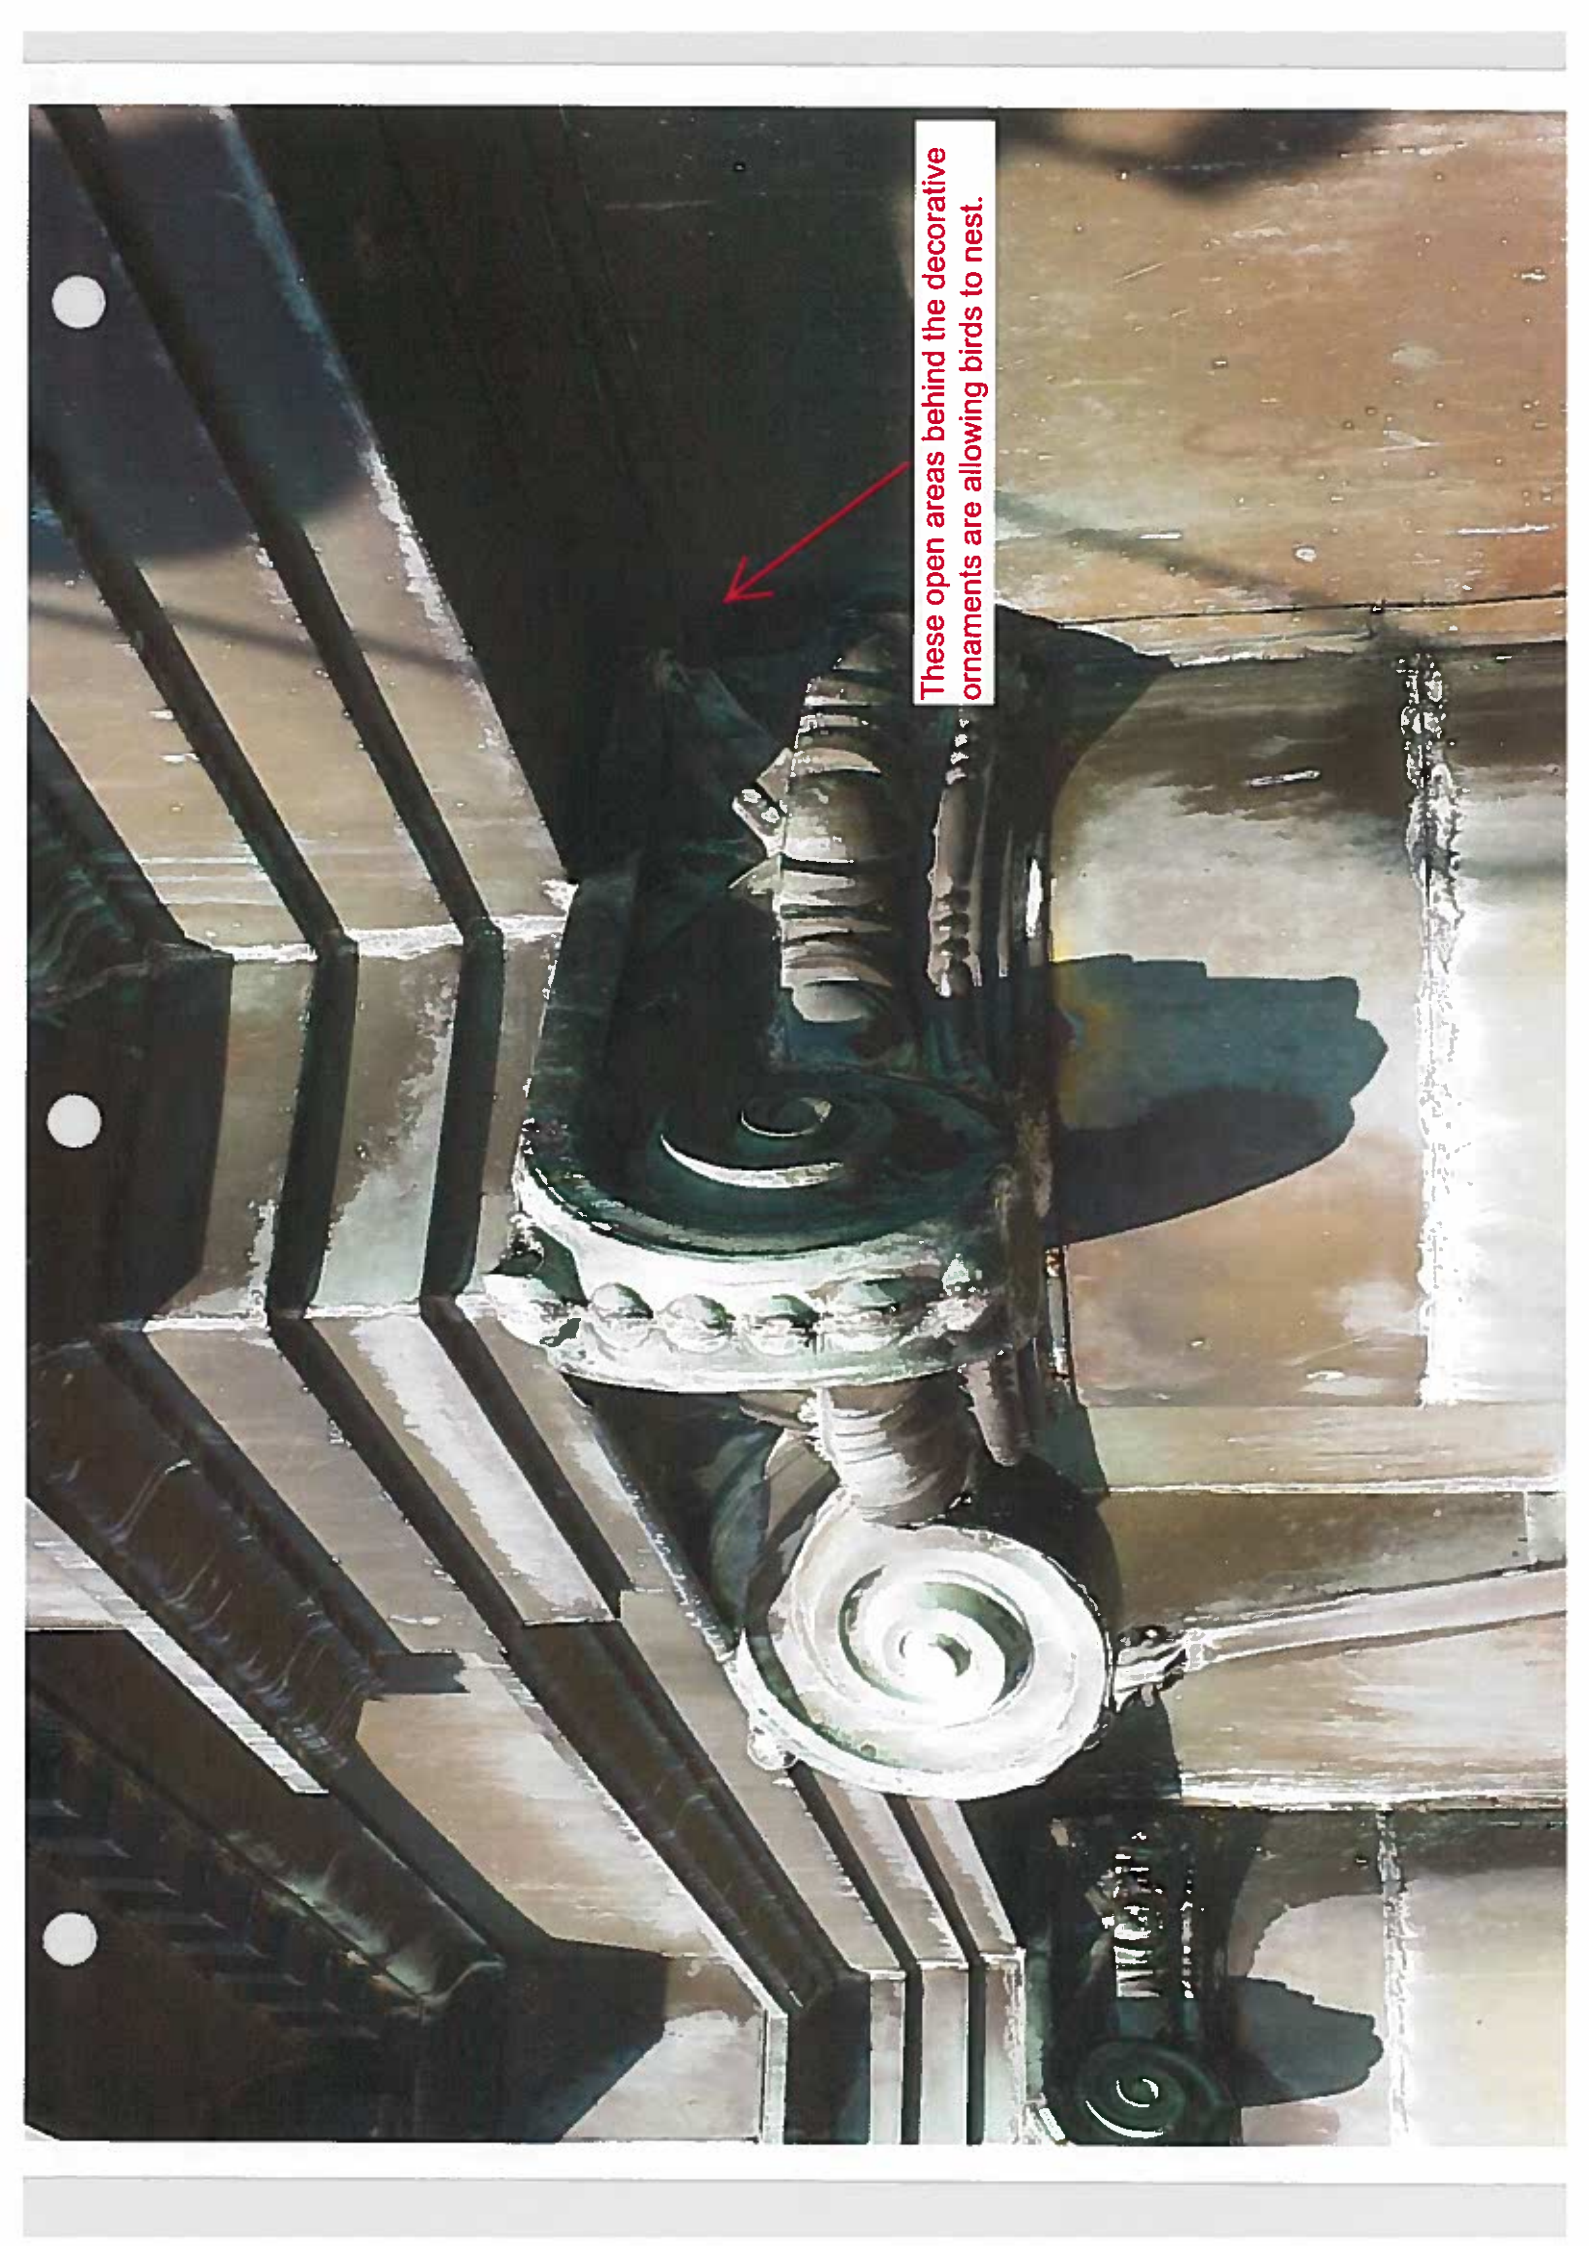
These open areas behind the decorative ornaments are allowing birds to nest.
