# Clerestory Photos

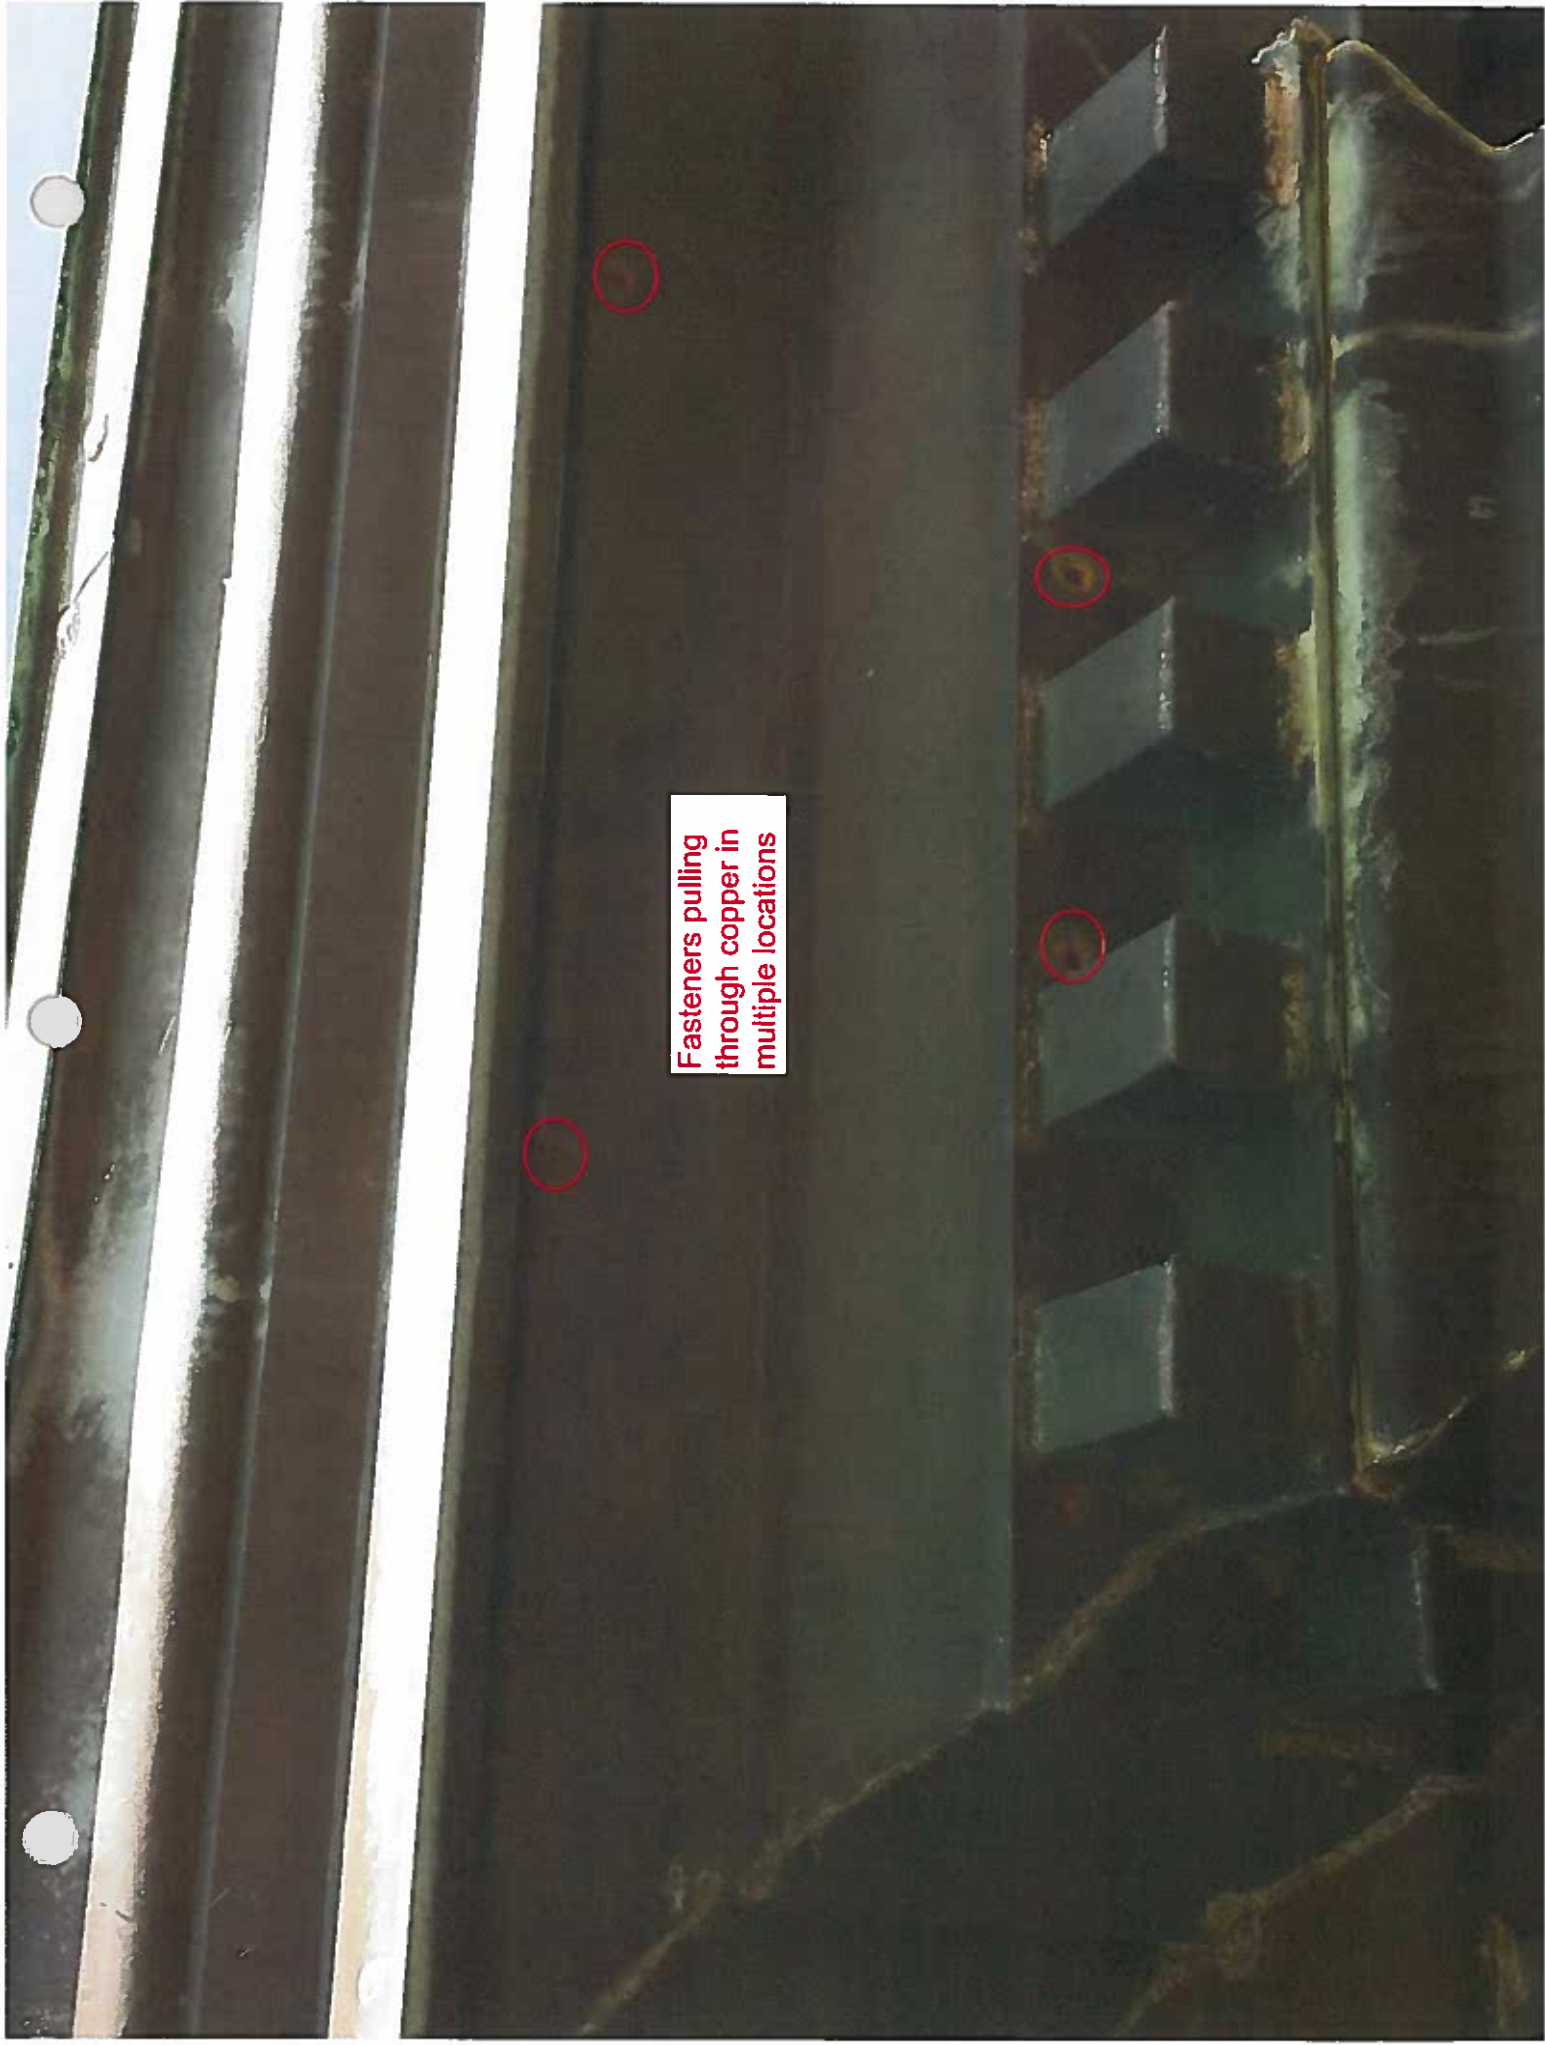
Fasteners pulling  
through copper in  
multiple locations

Simple Overlapping joints are not typically recommended. If they are used they should utilize rivets and solder to achieve a solid joint.

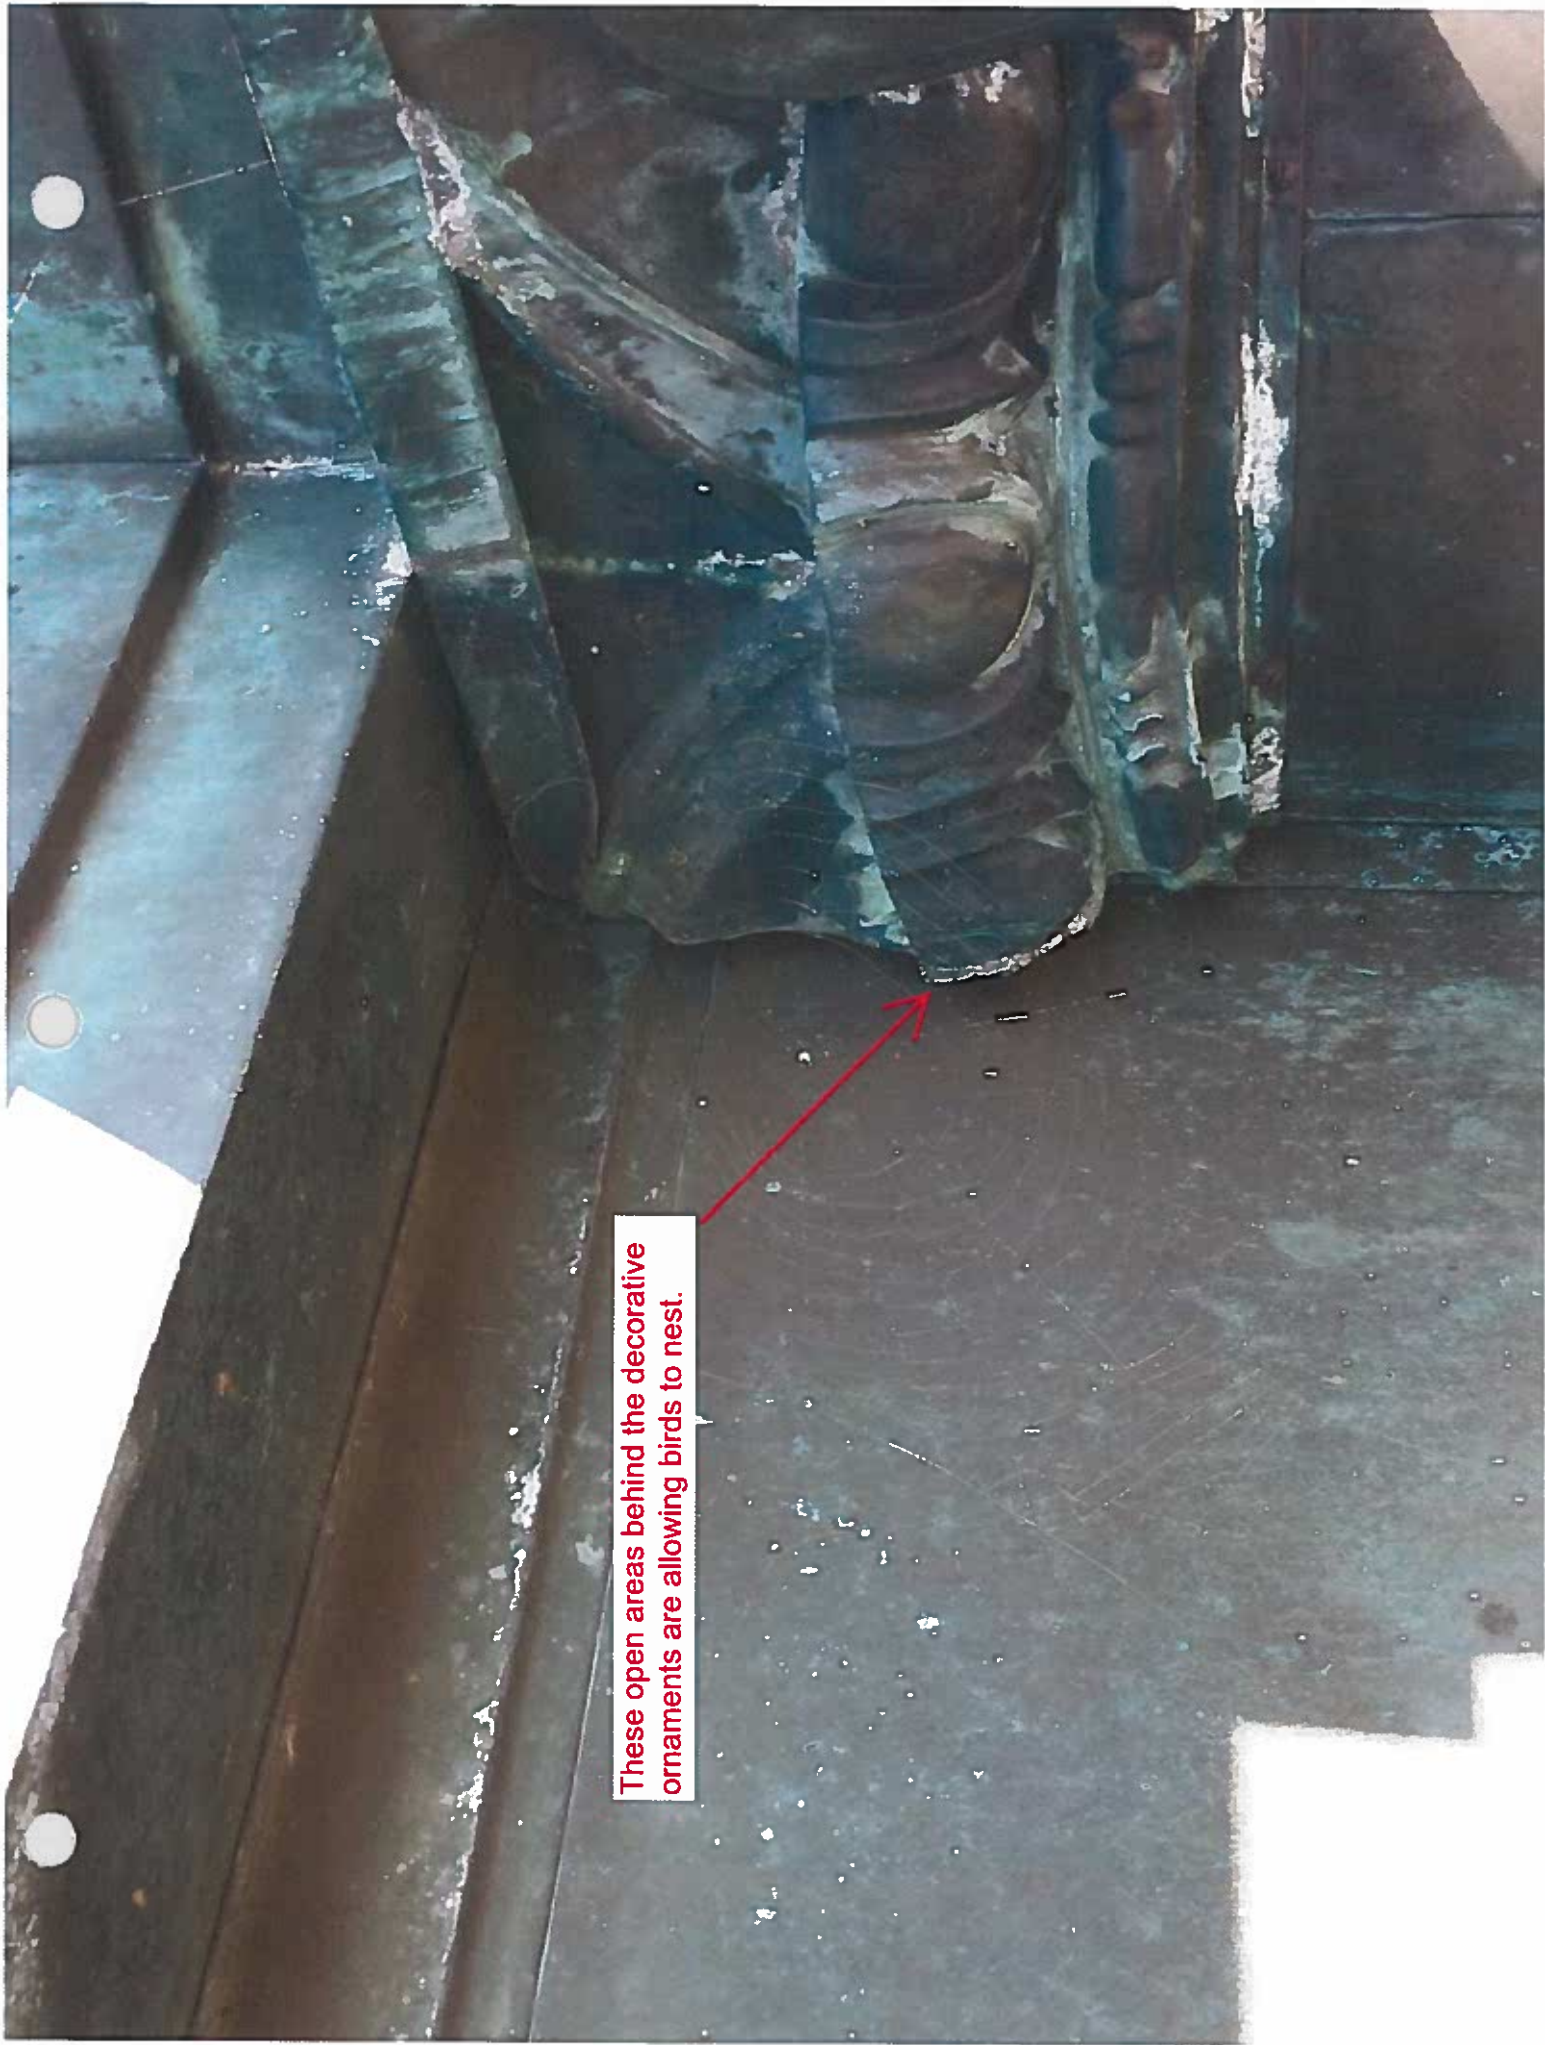
These open areas behind the decorative ornaments are allowing birds to nest.

Some ornaments damaged, worn  
thin, some open/cracked seams

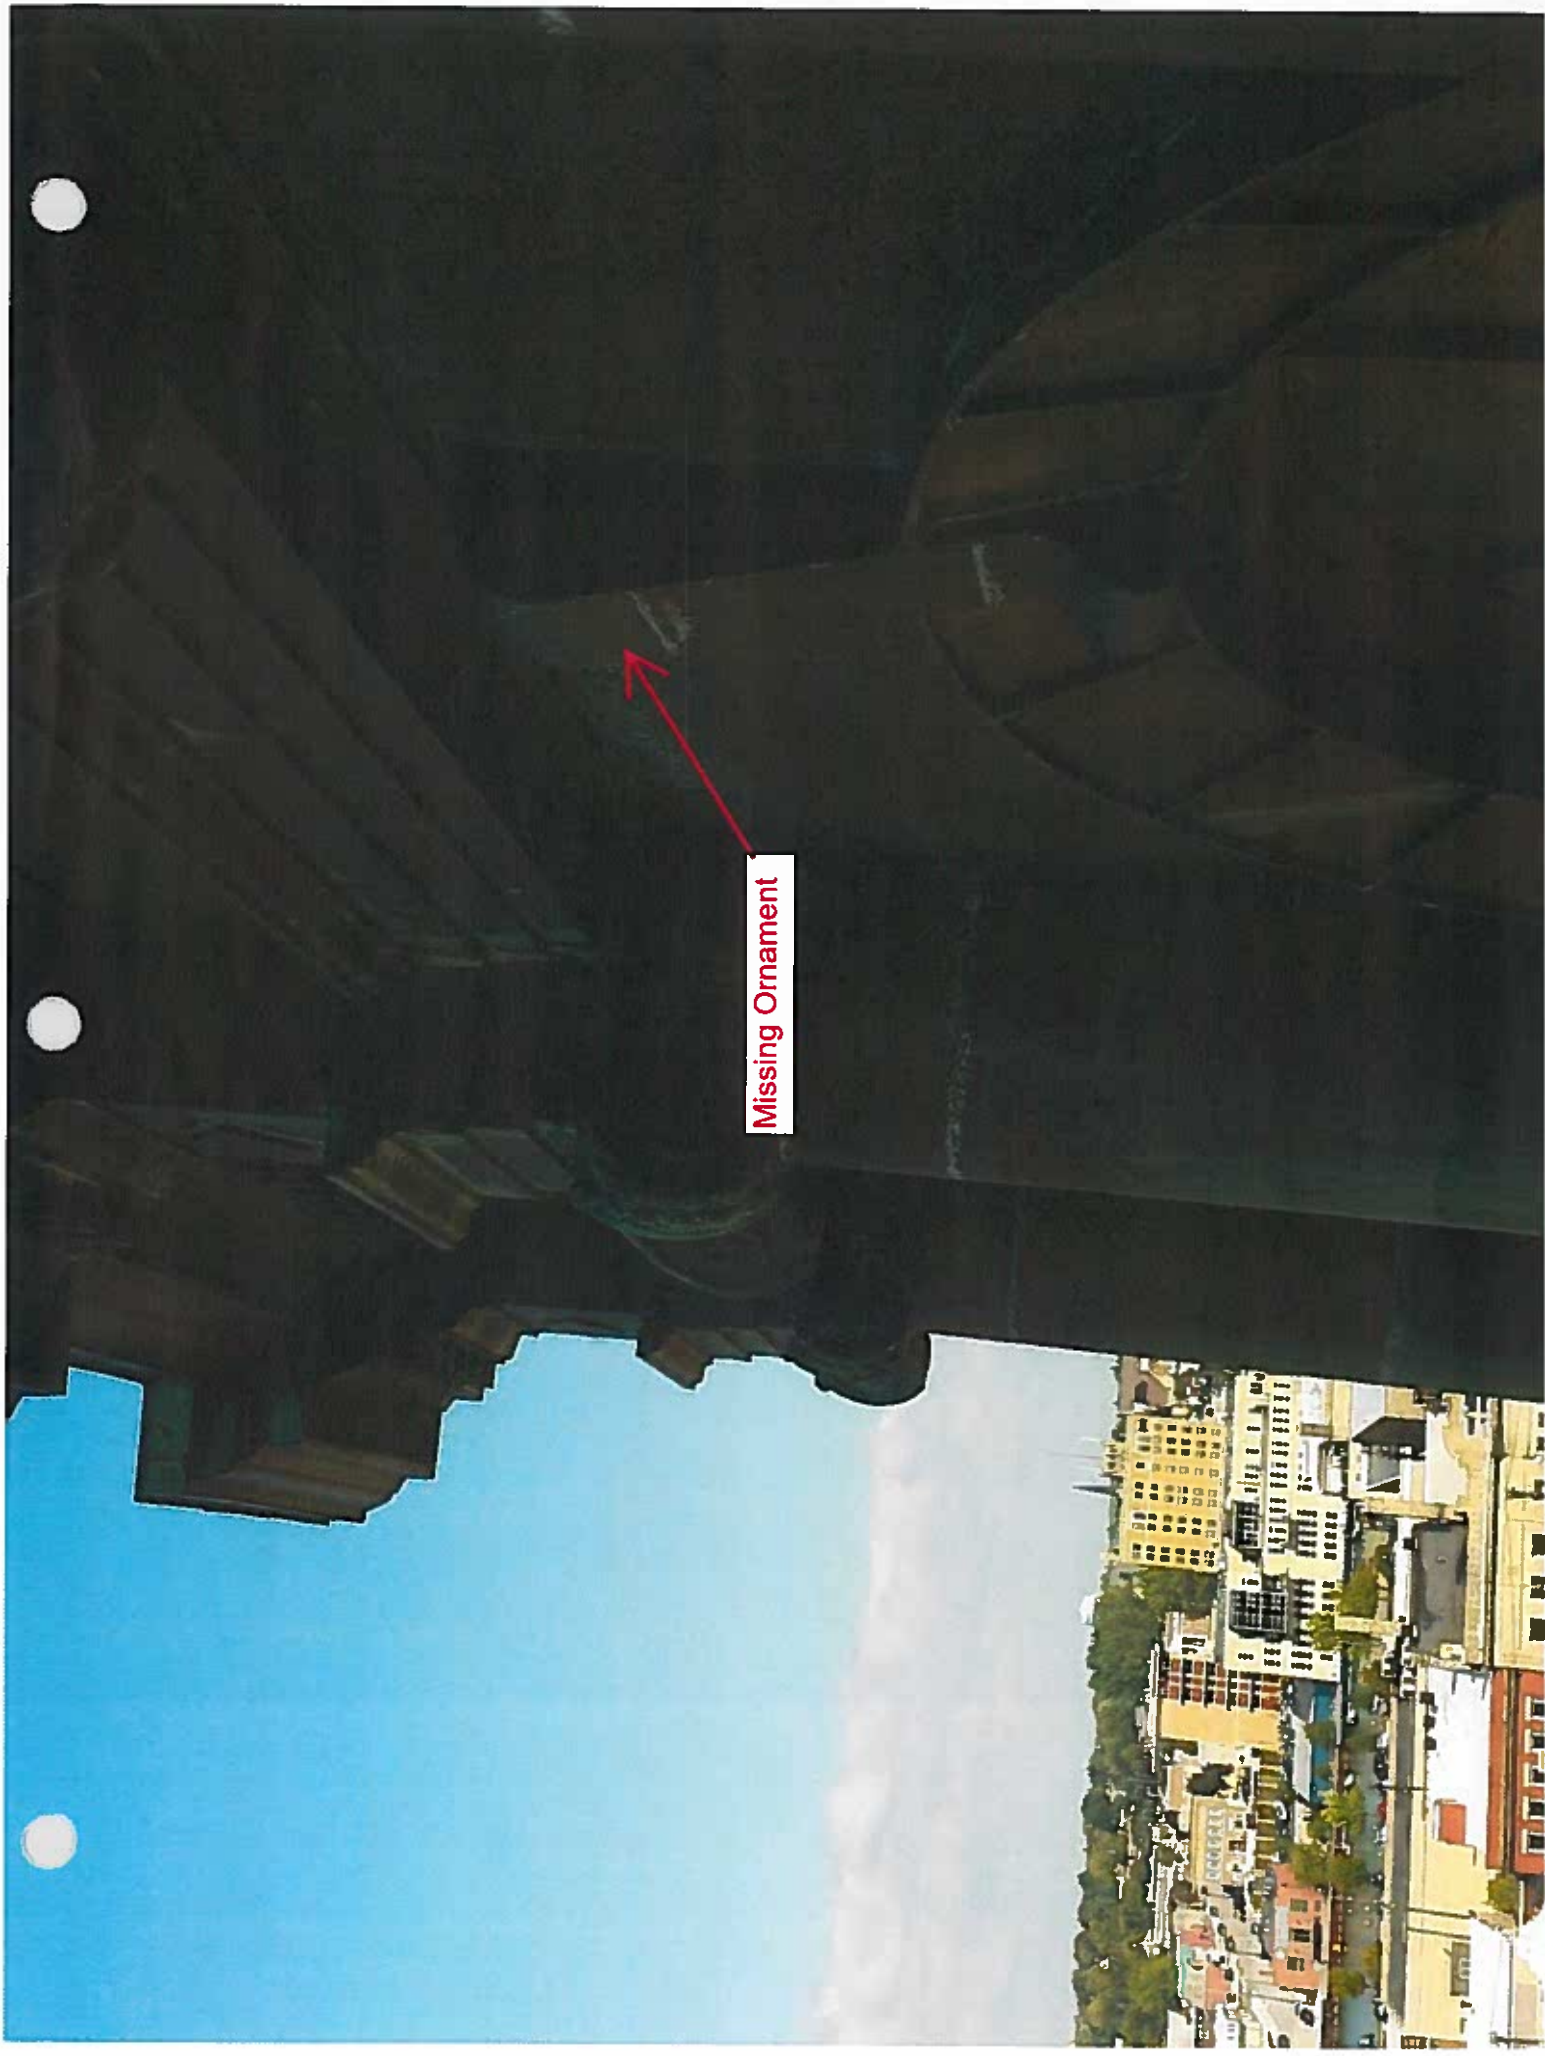
Missing Ornament

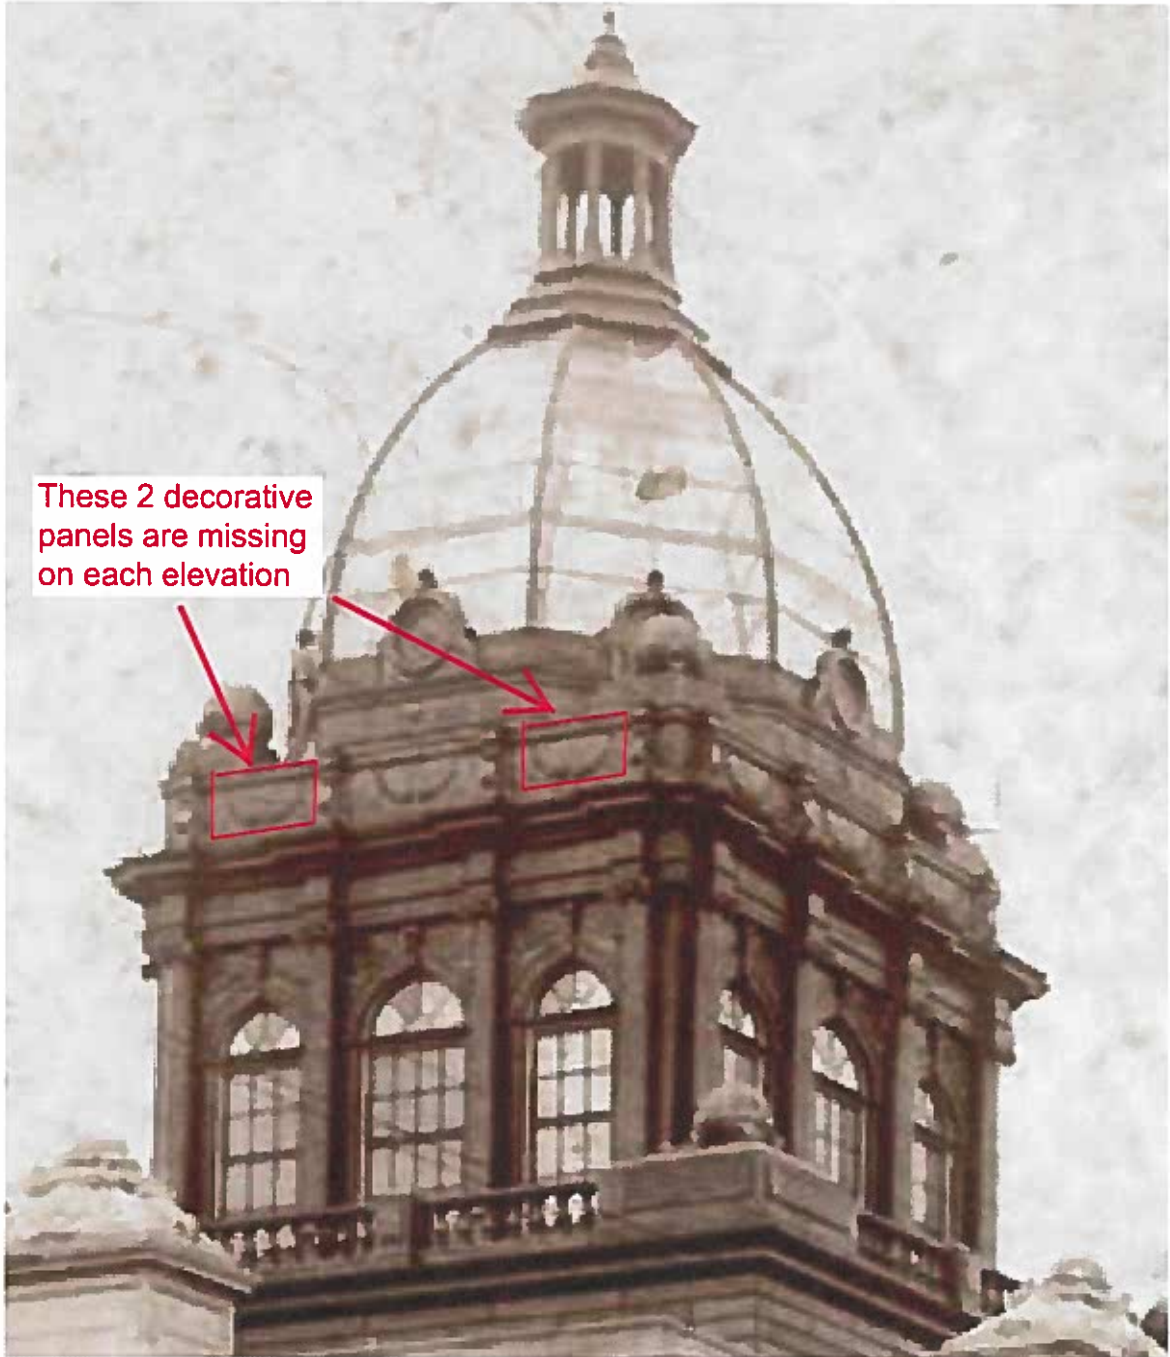
These 2 decorative panels are missing on each elevation

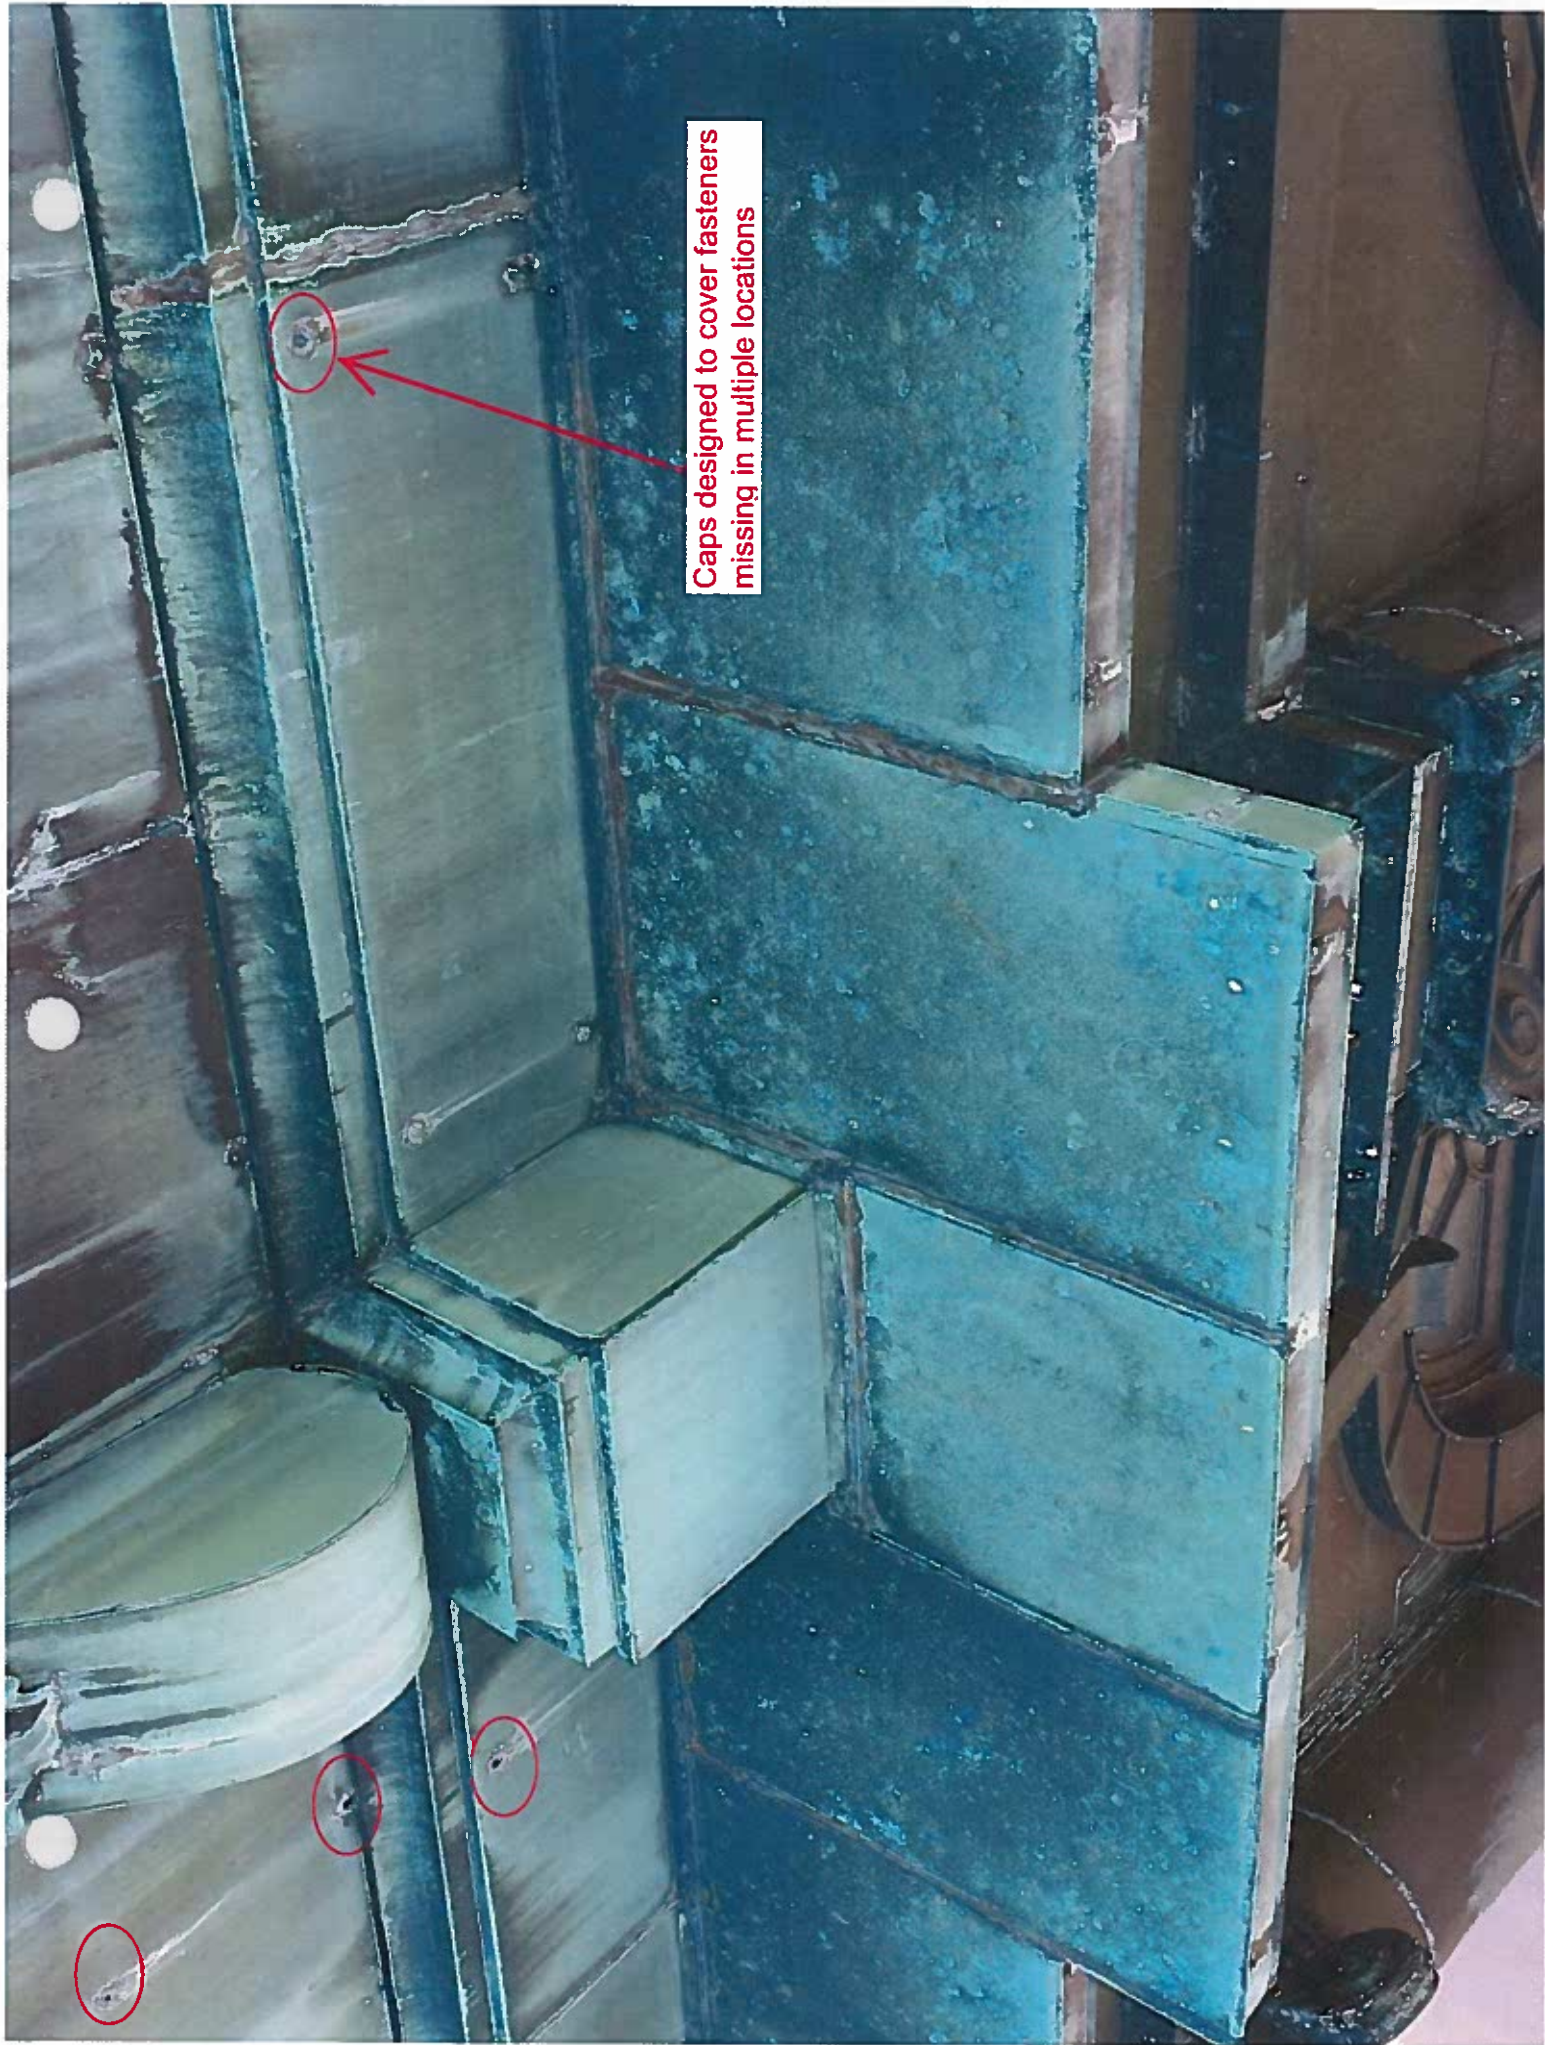
Caps designed to cover fasteners  
missing in multiple locations

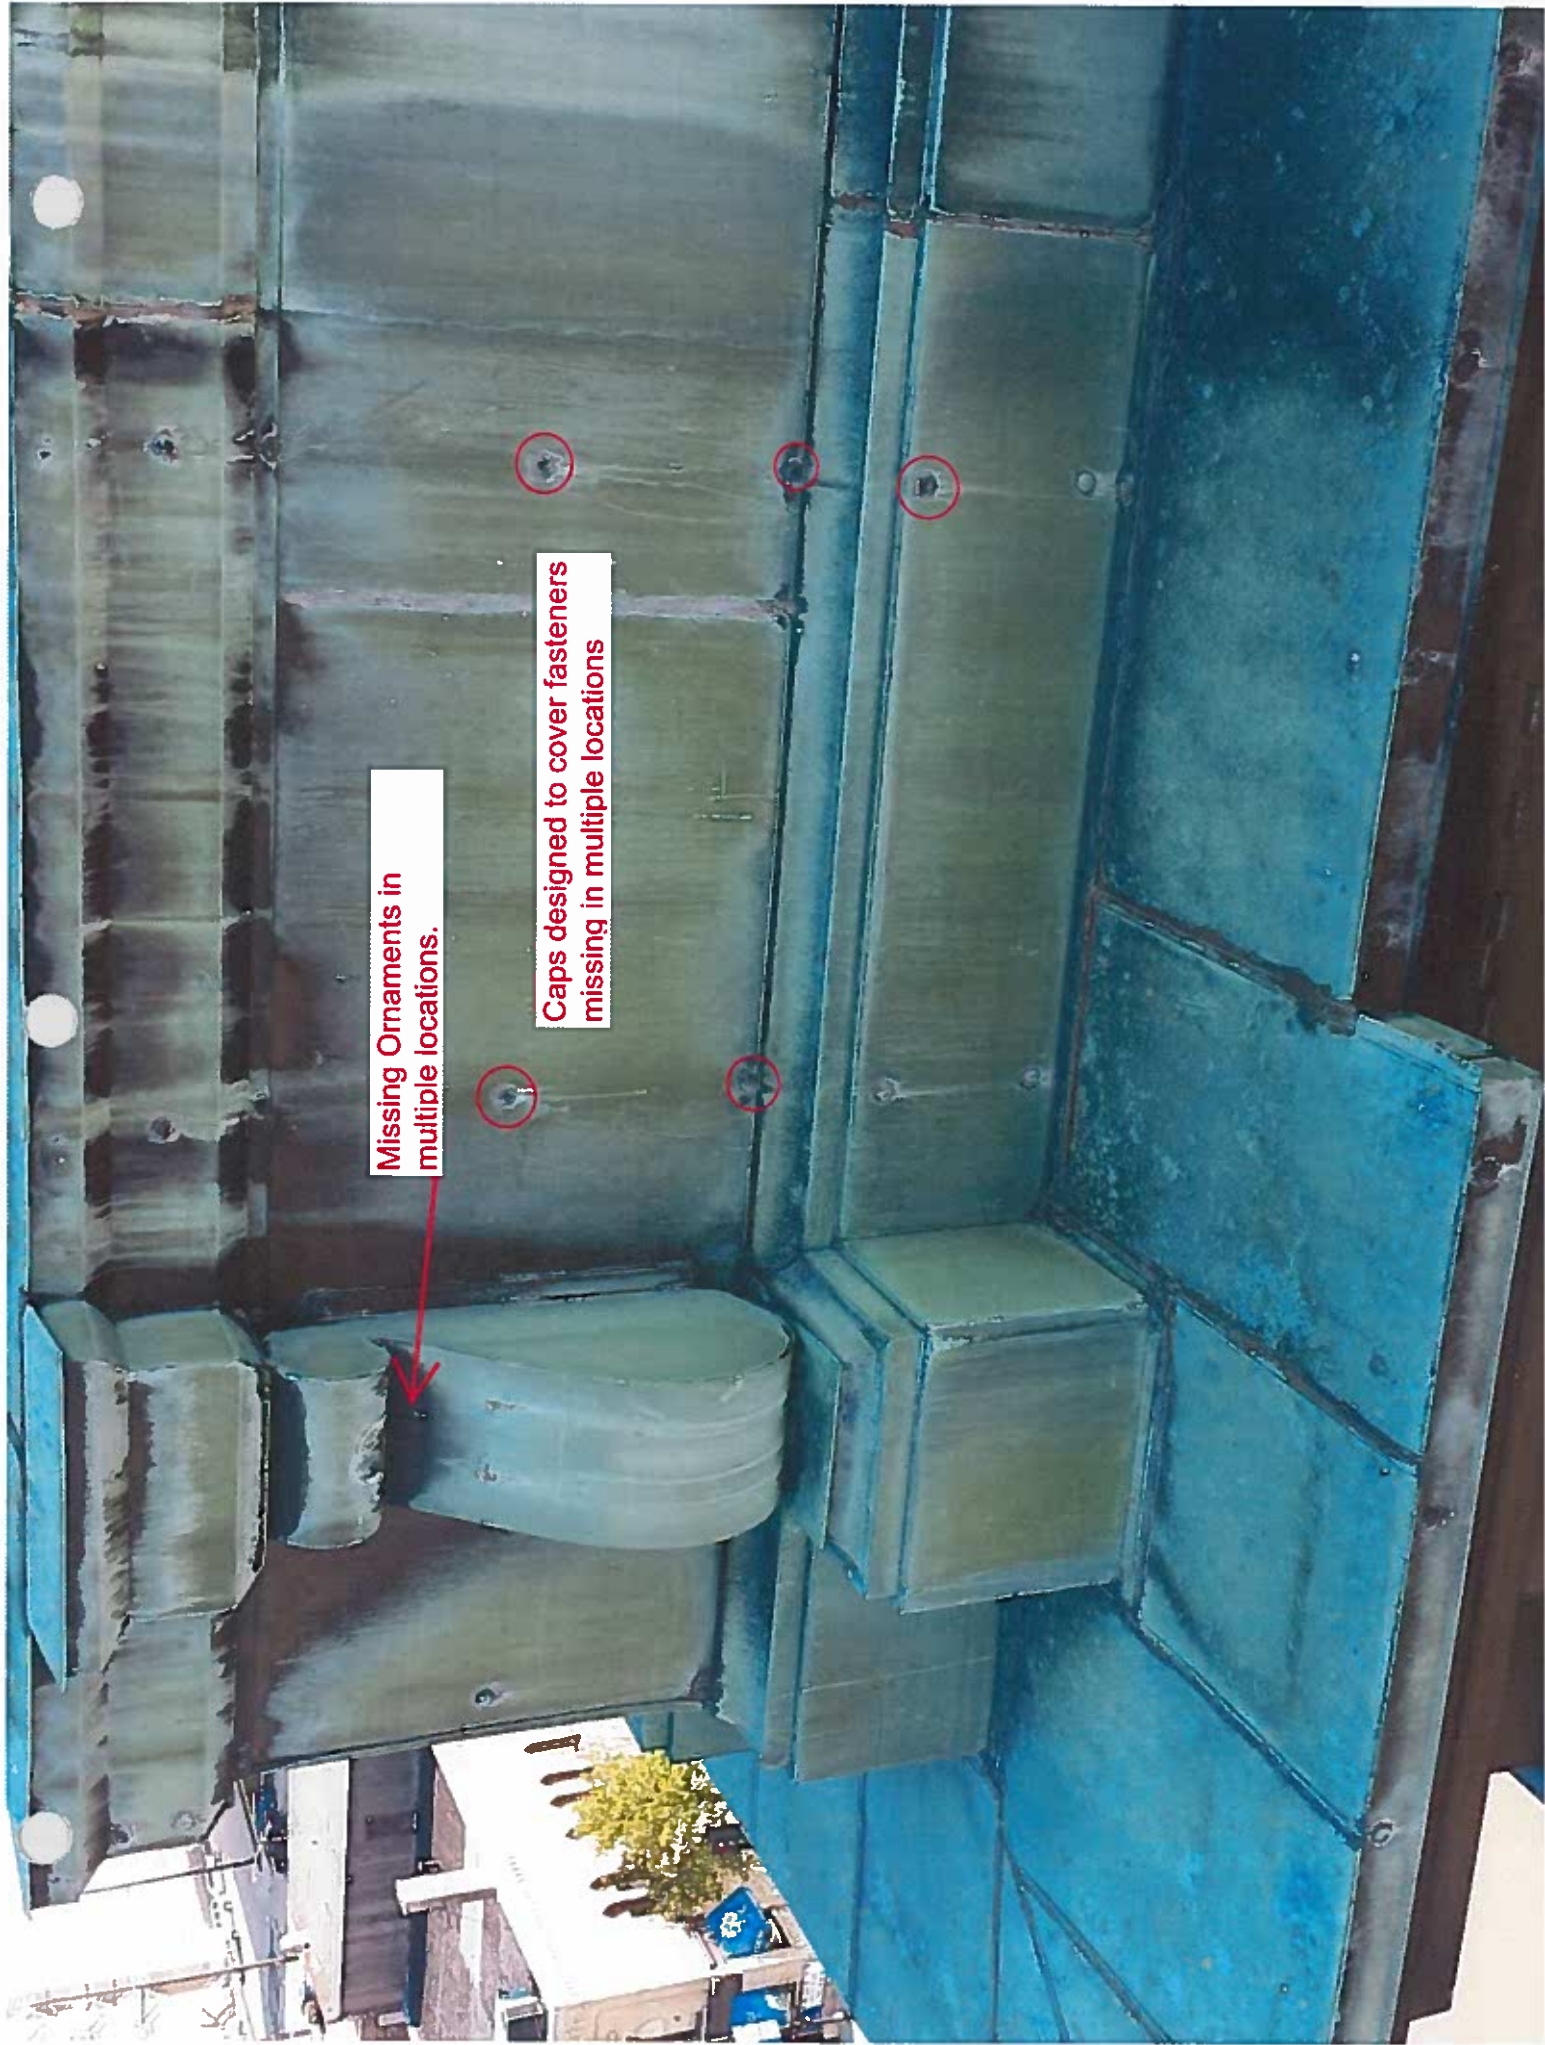
Missing Ornaments in multiple locations.

Caps designed to cover fasteners missing in multiple locations

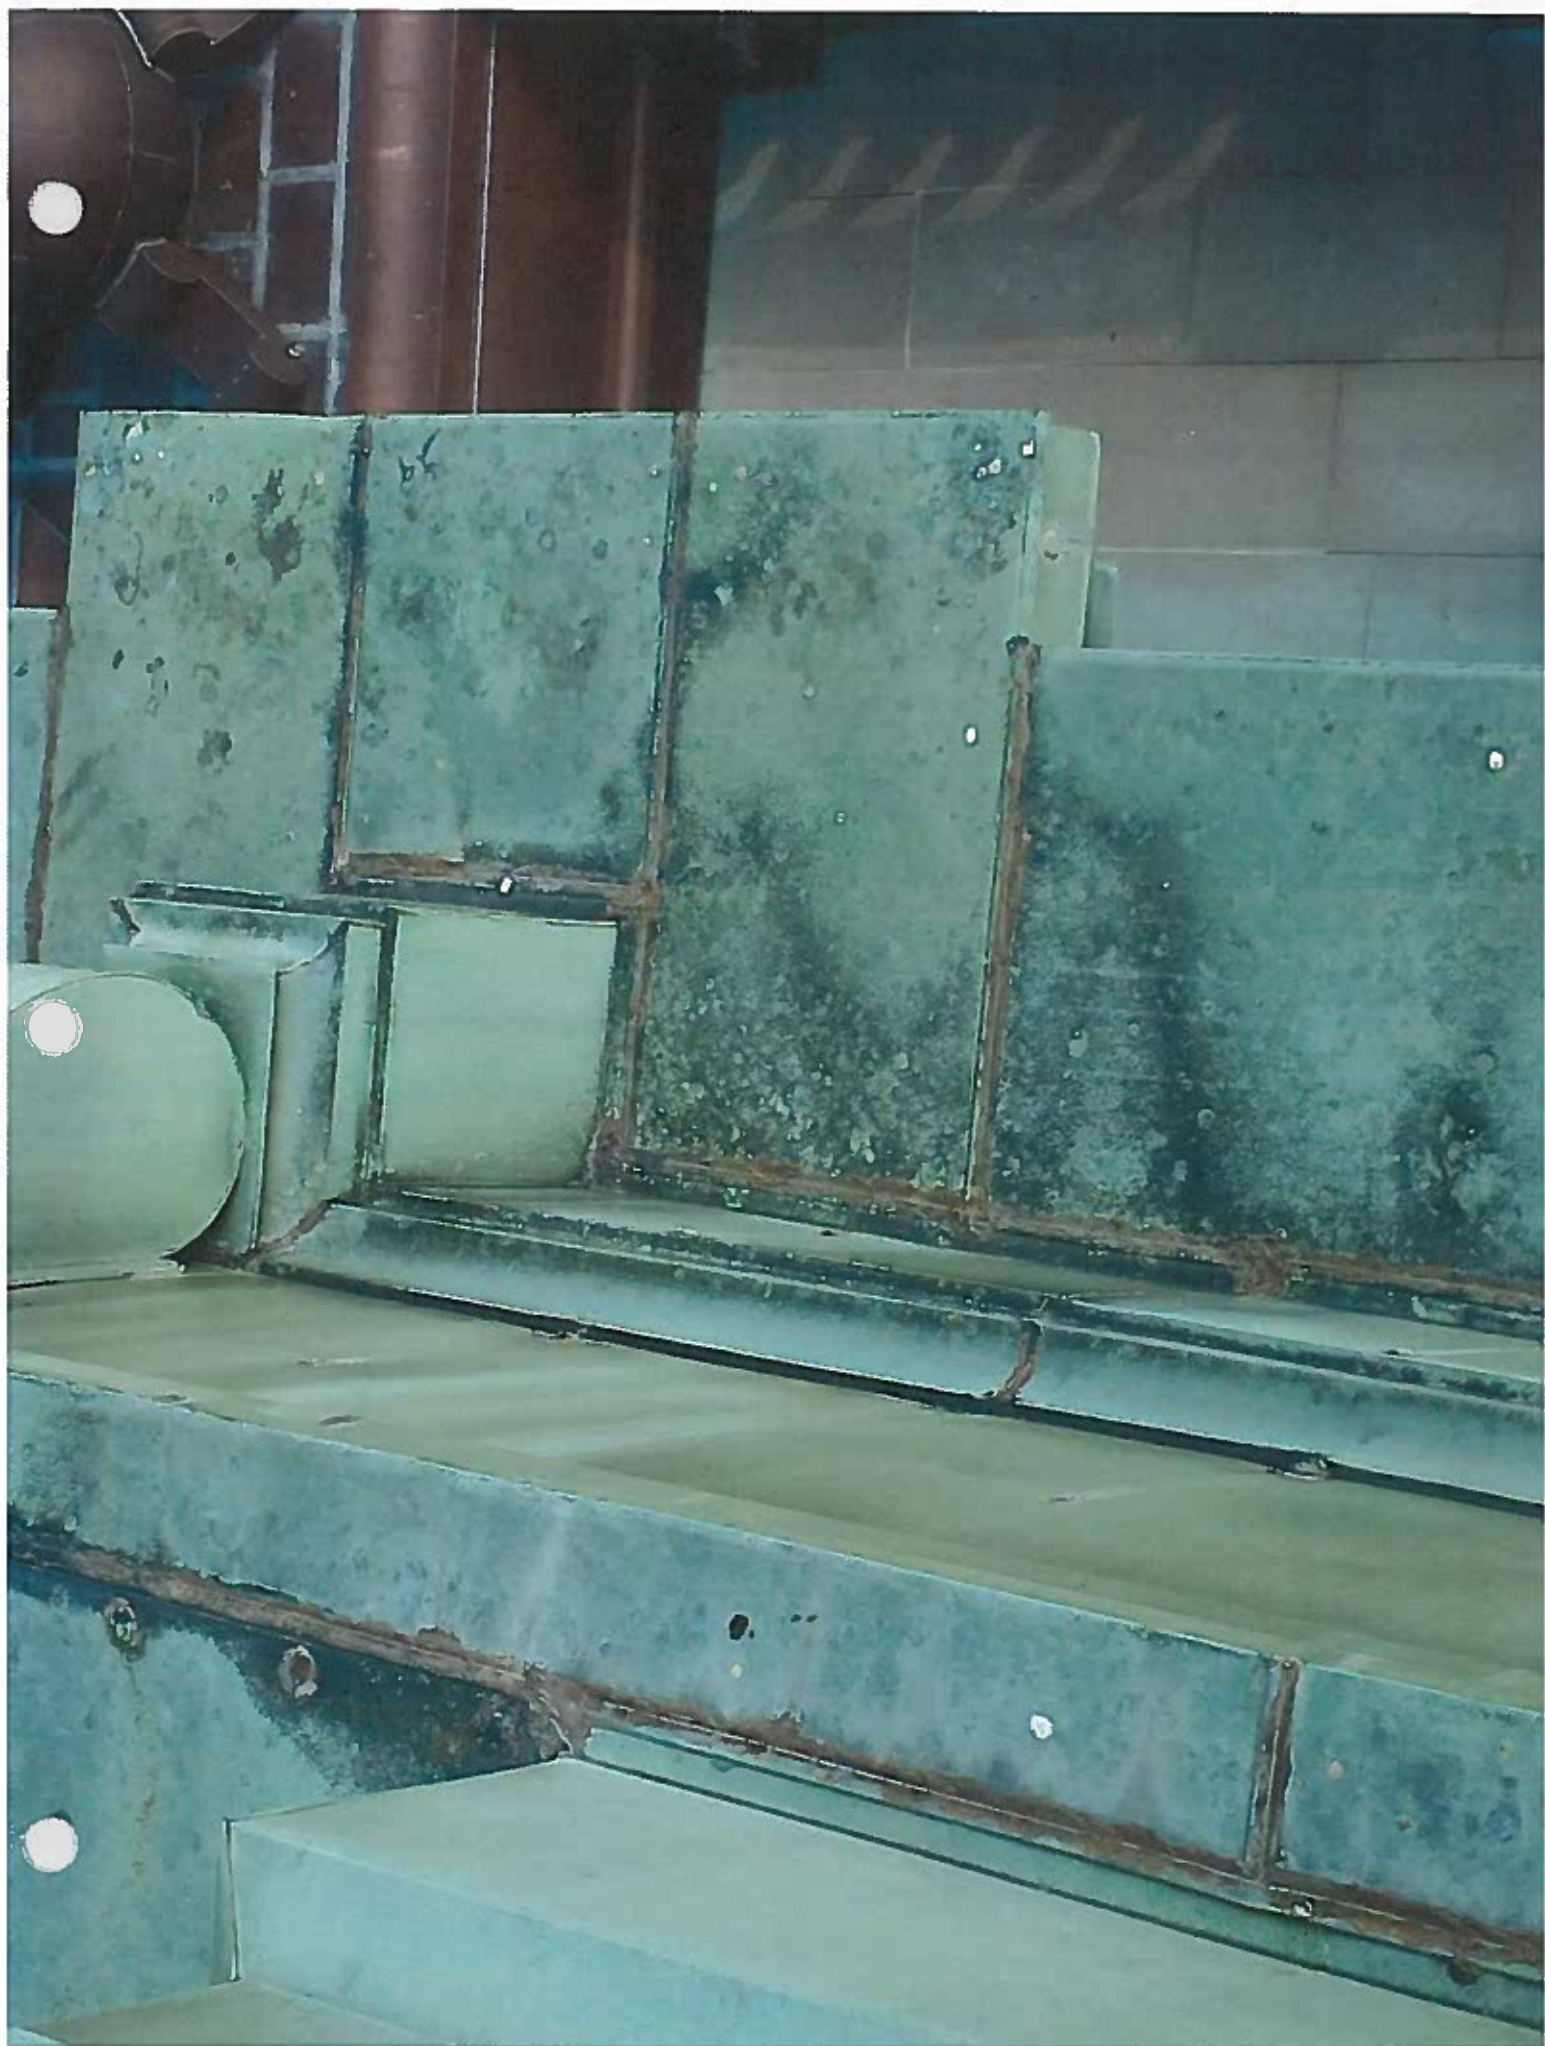
Stains indicate  
standing/ponding  
water
