# Clerestory Photos

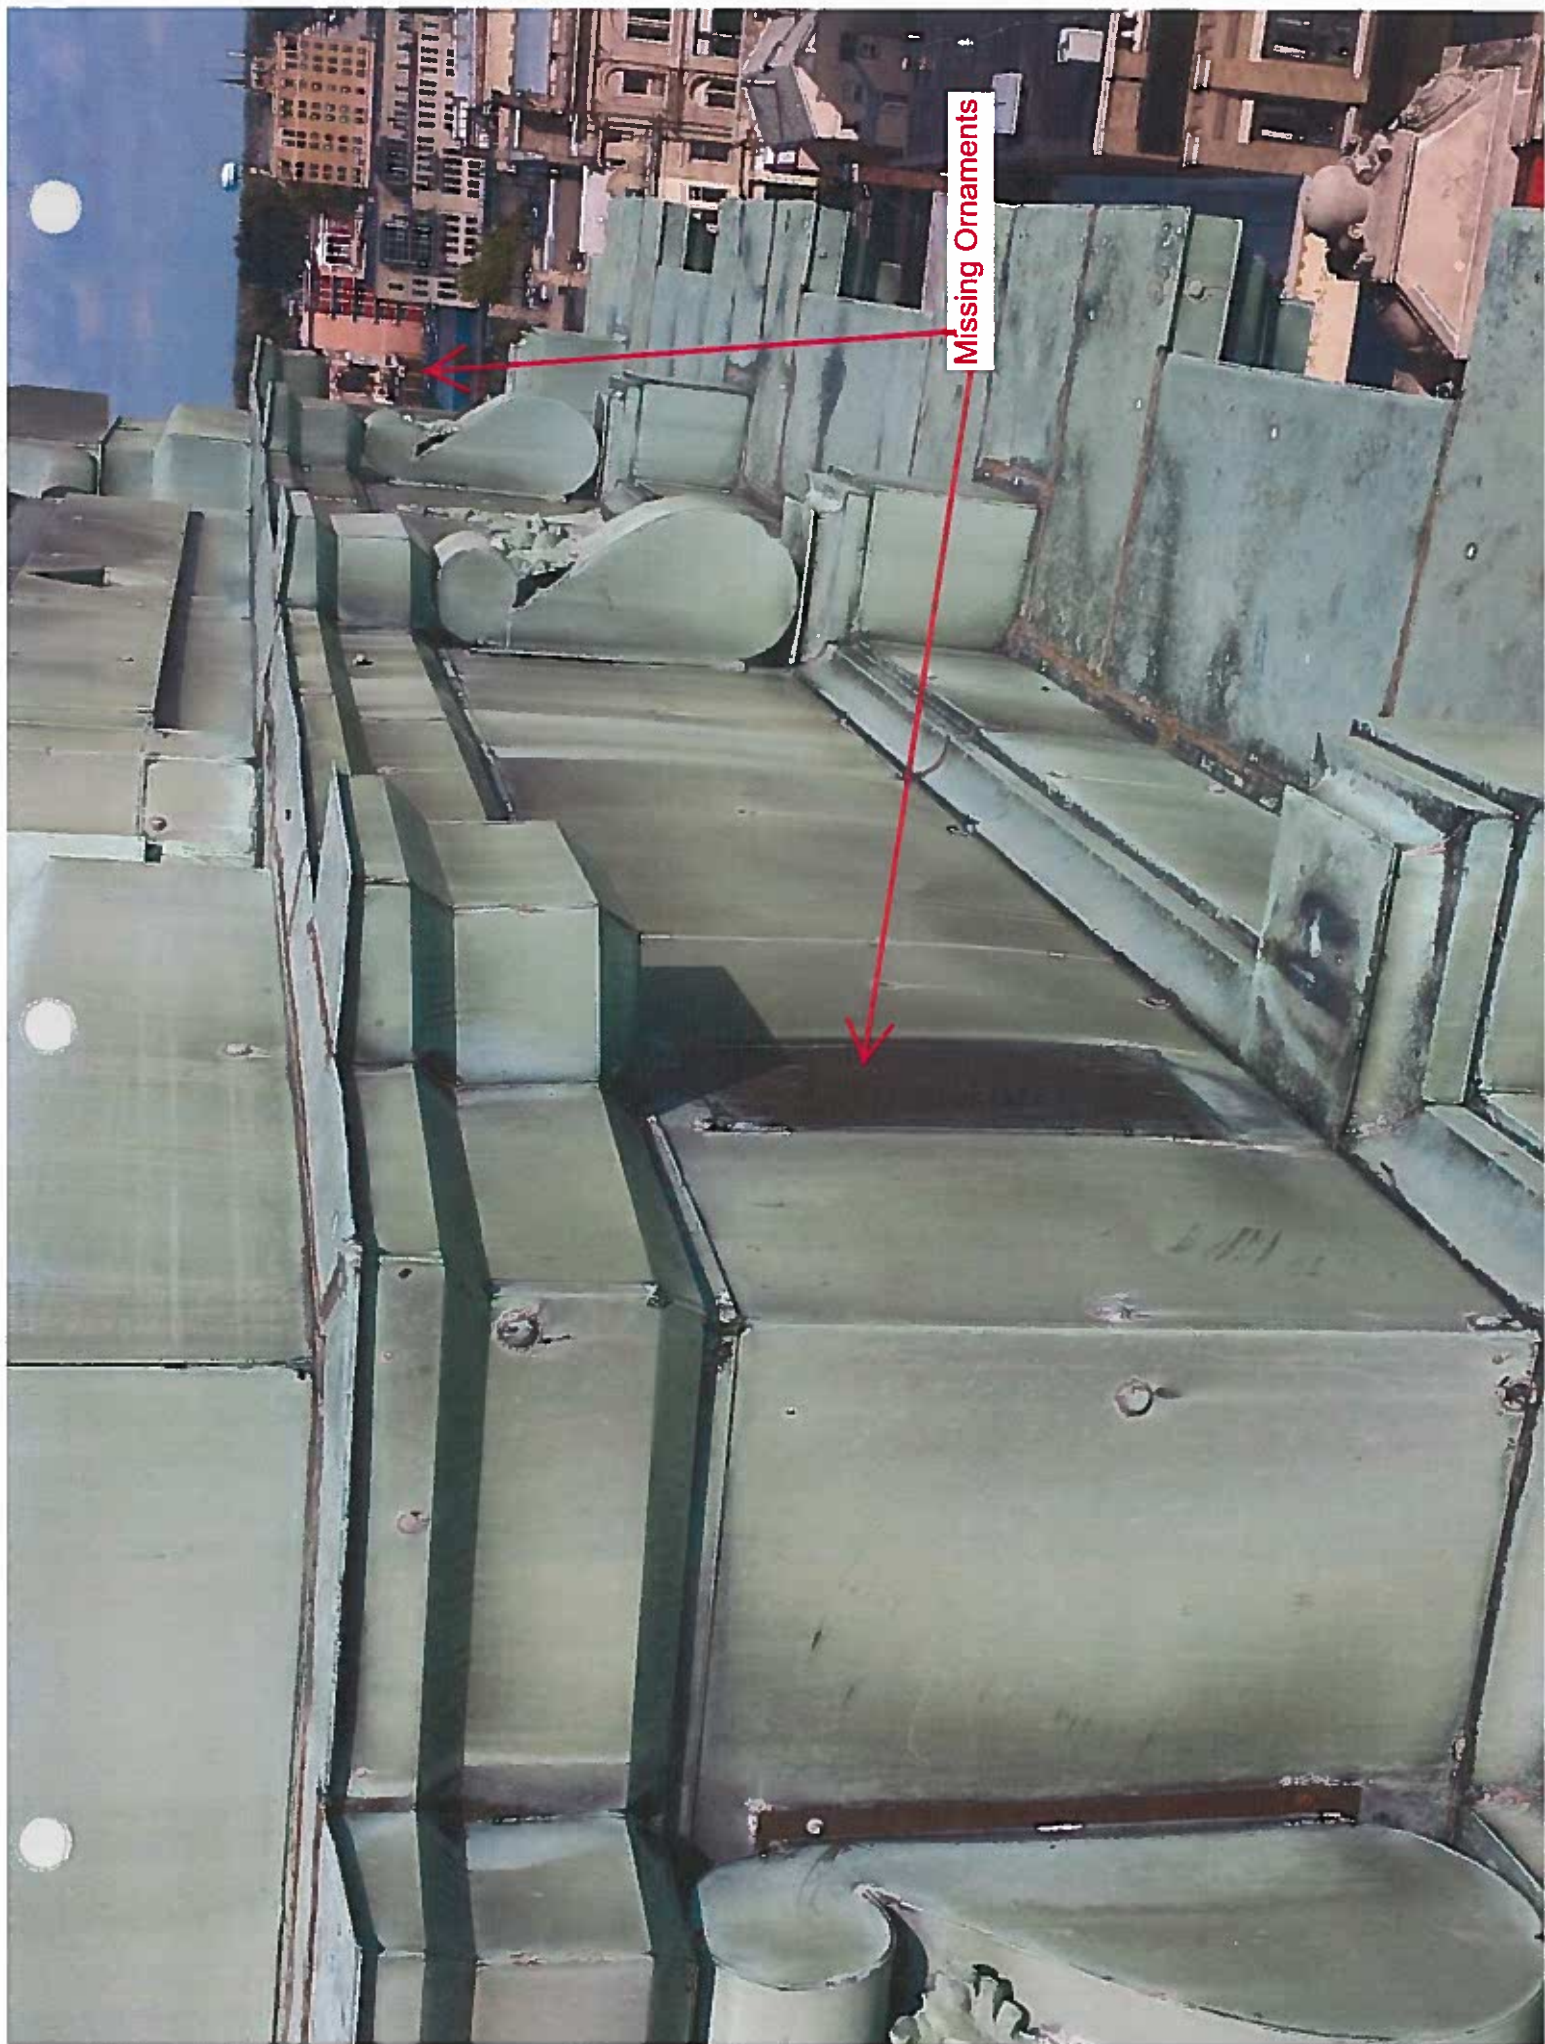
Missing Ornaments

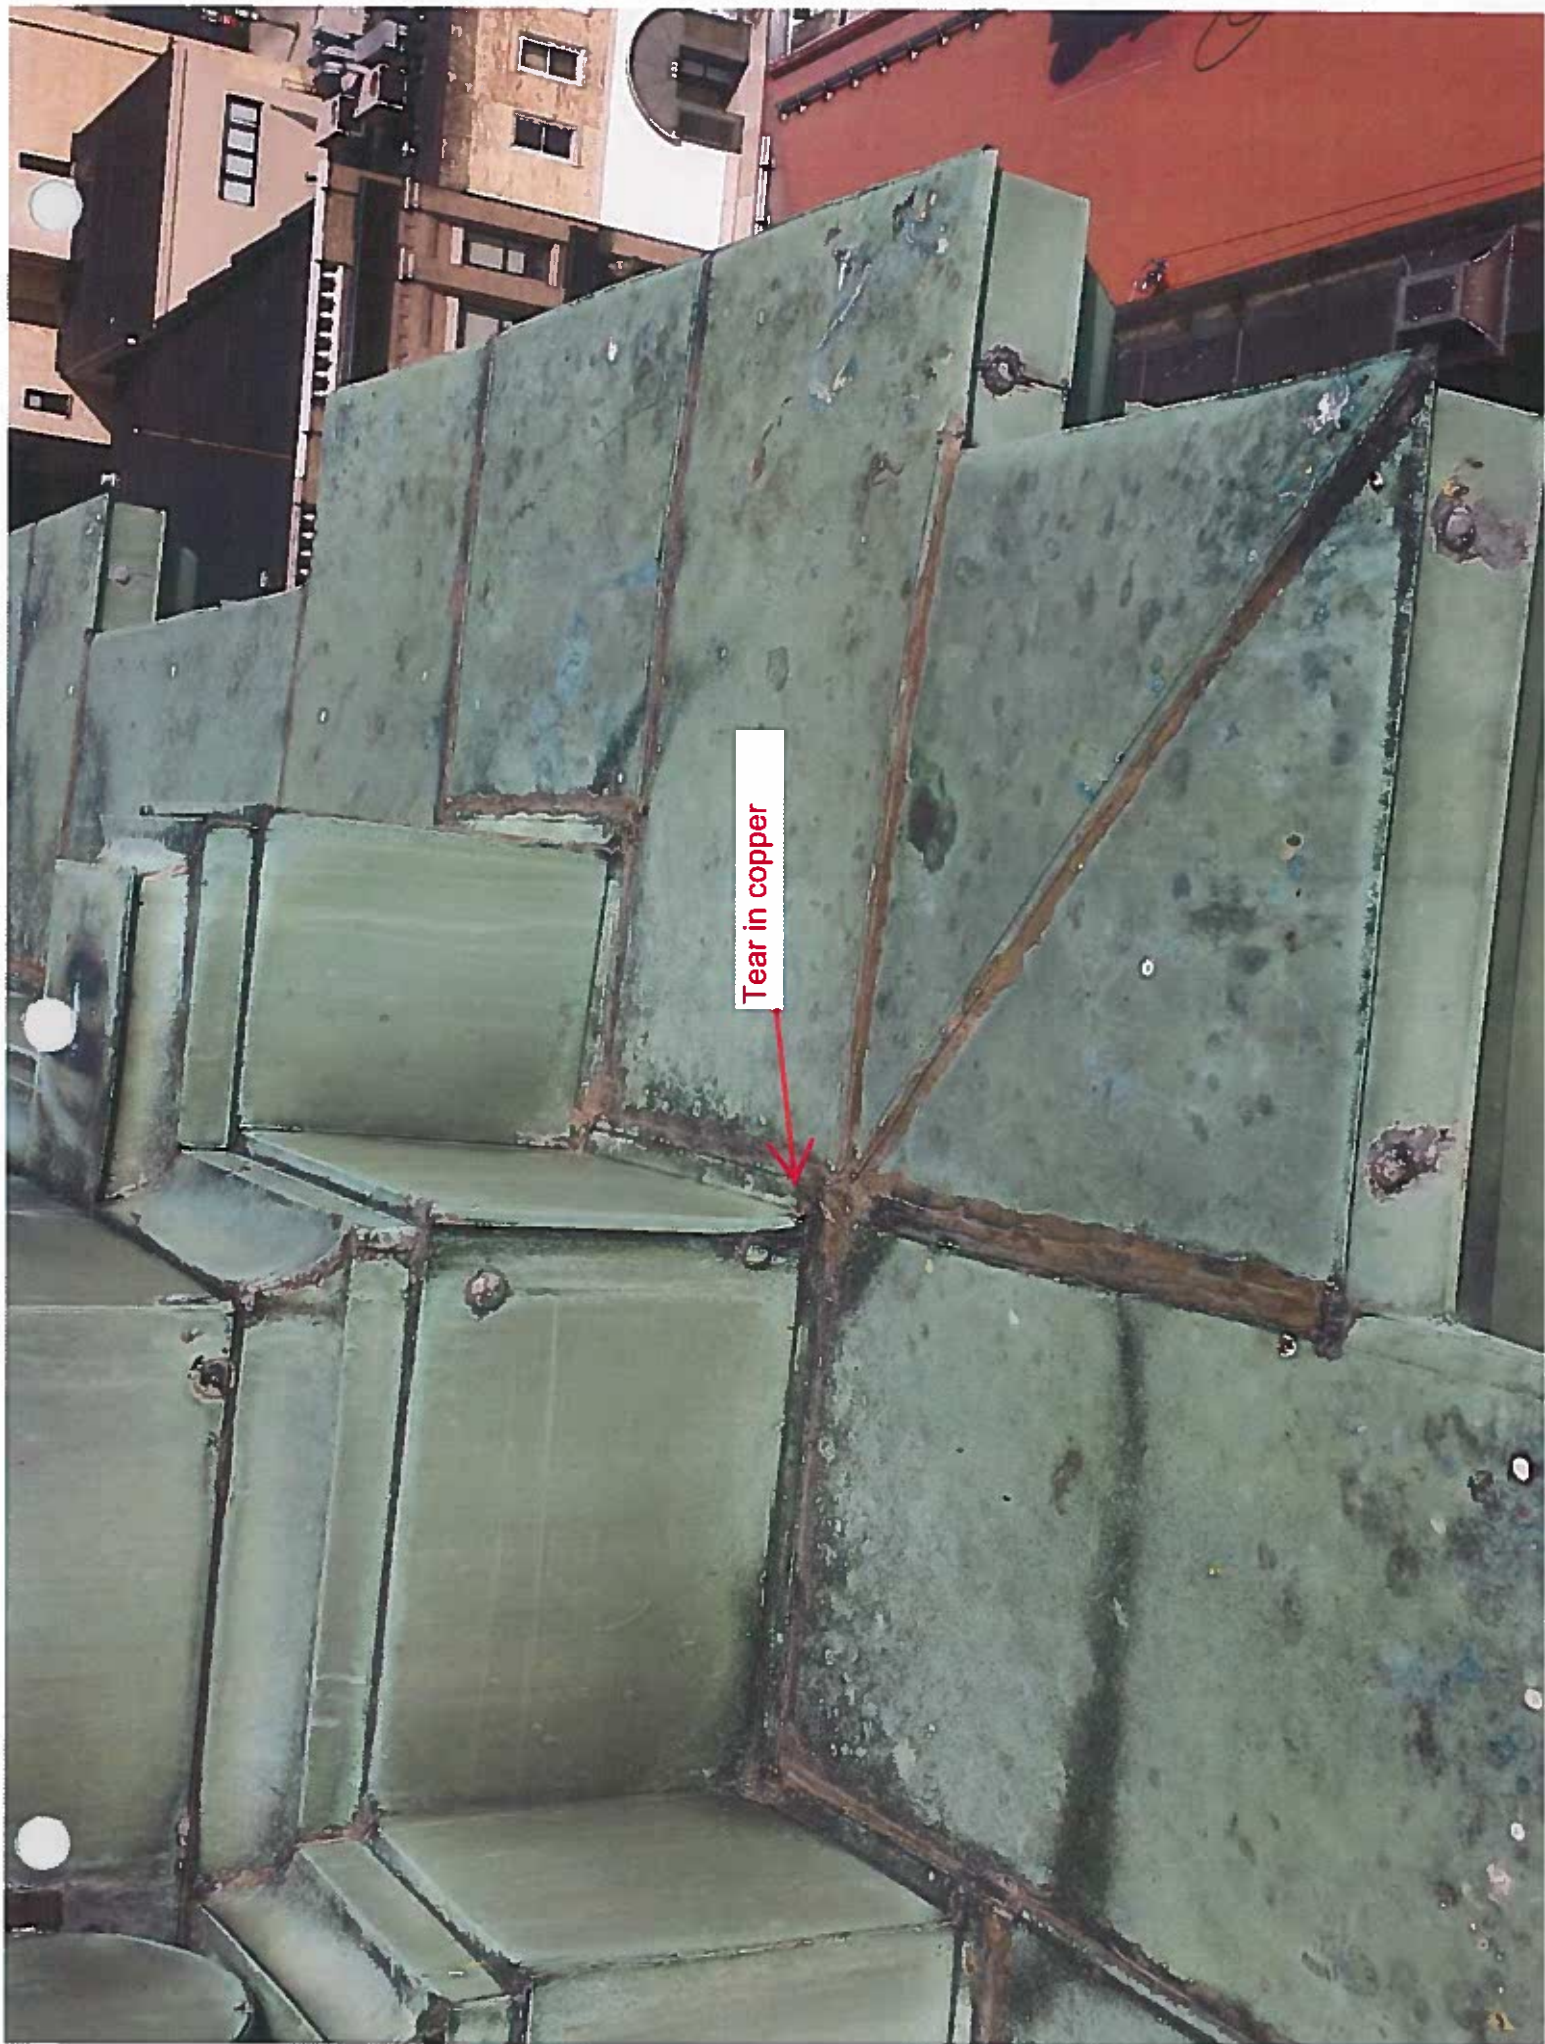
Tear in copper

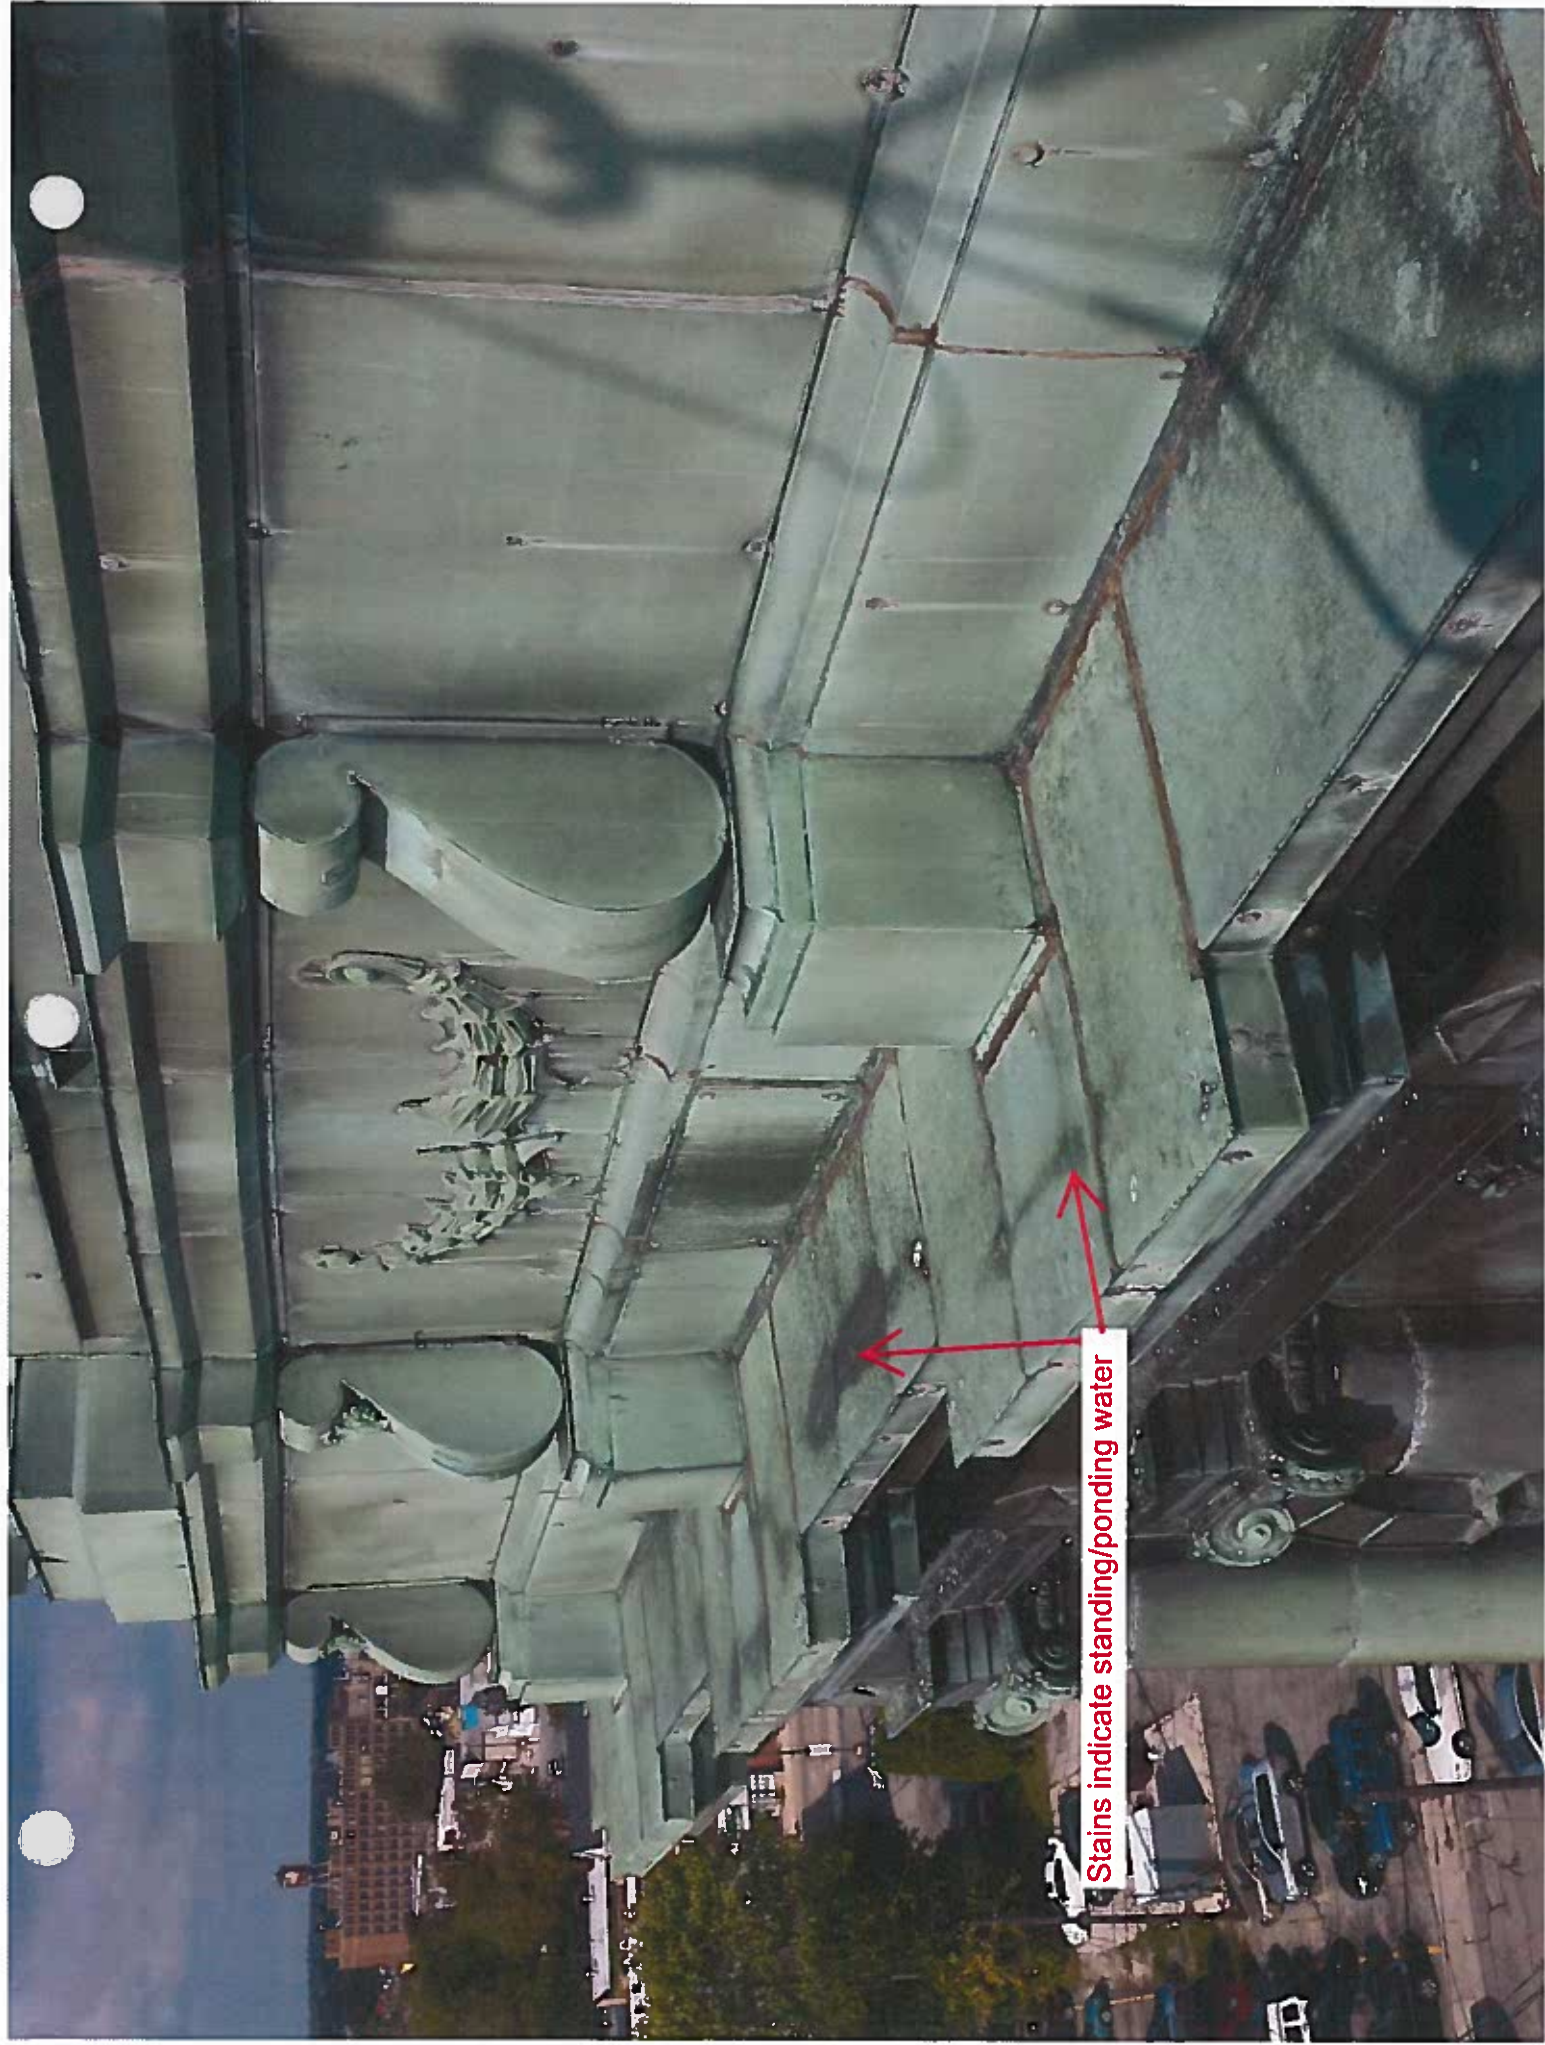
Stains indicate standing/ponding water

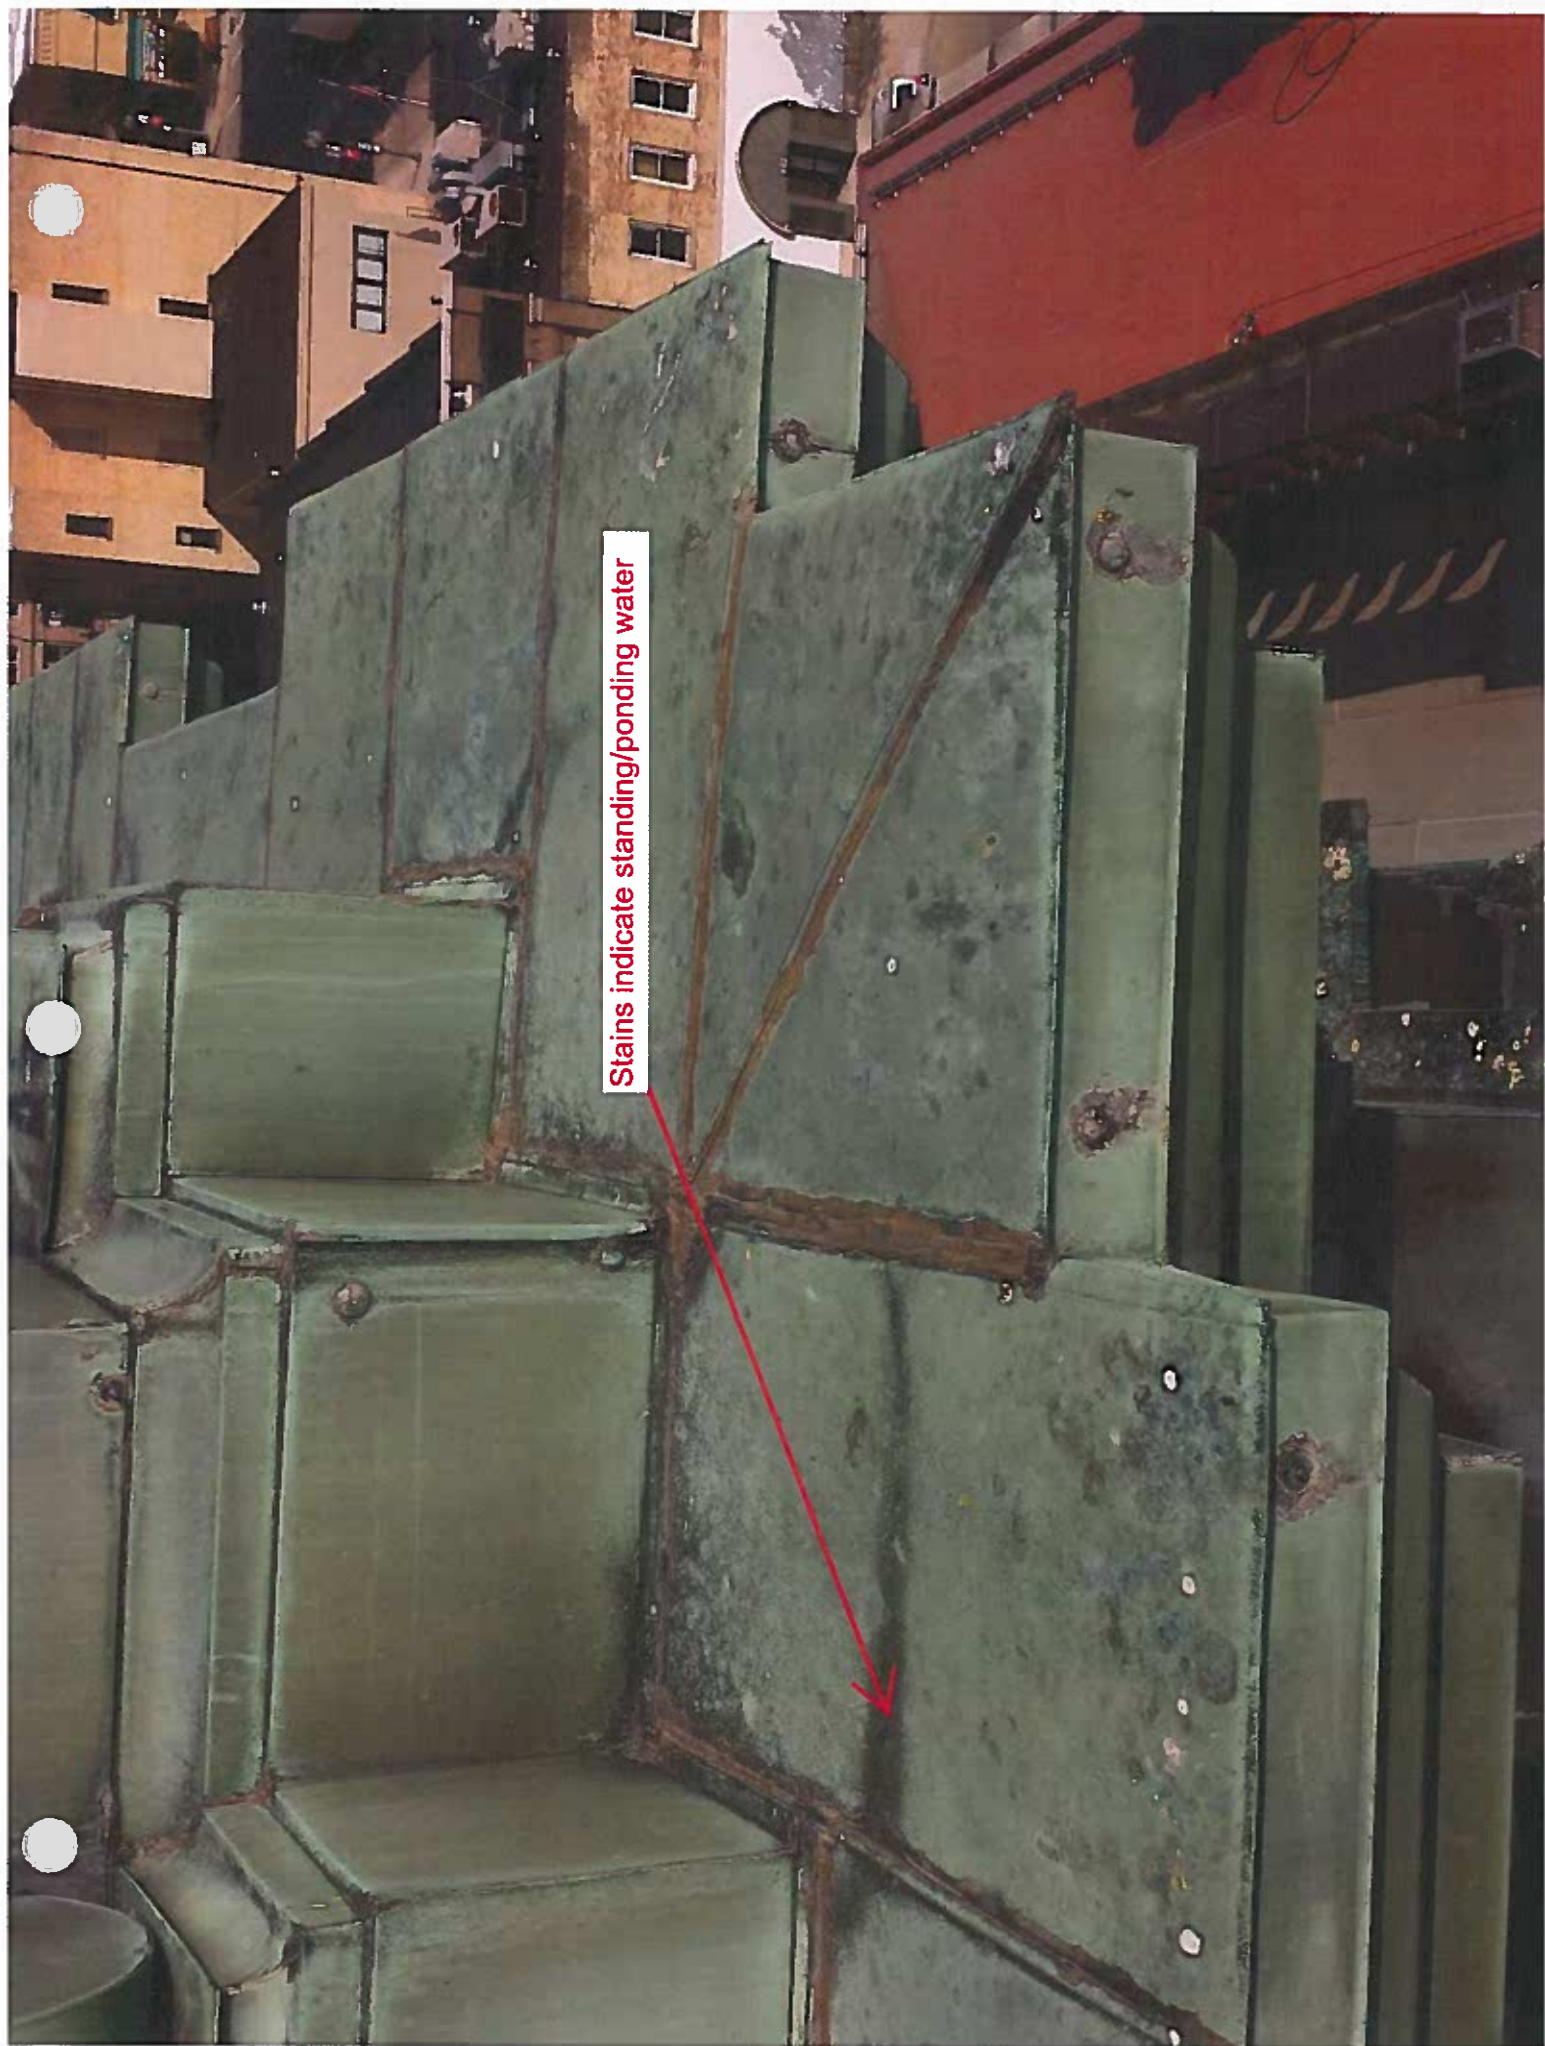
Stains indicate standing/ponding water

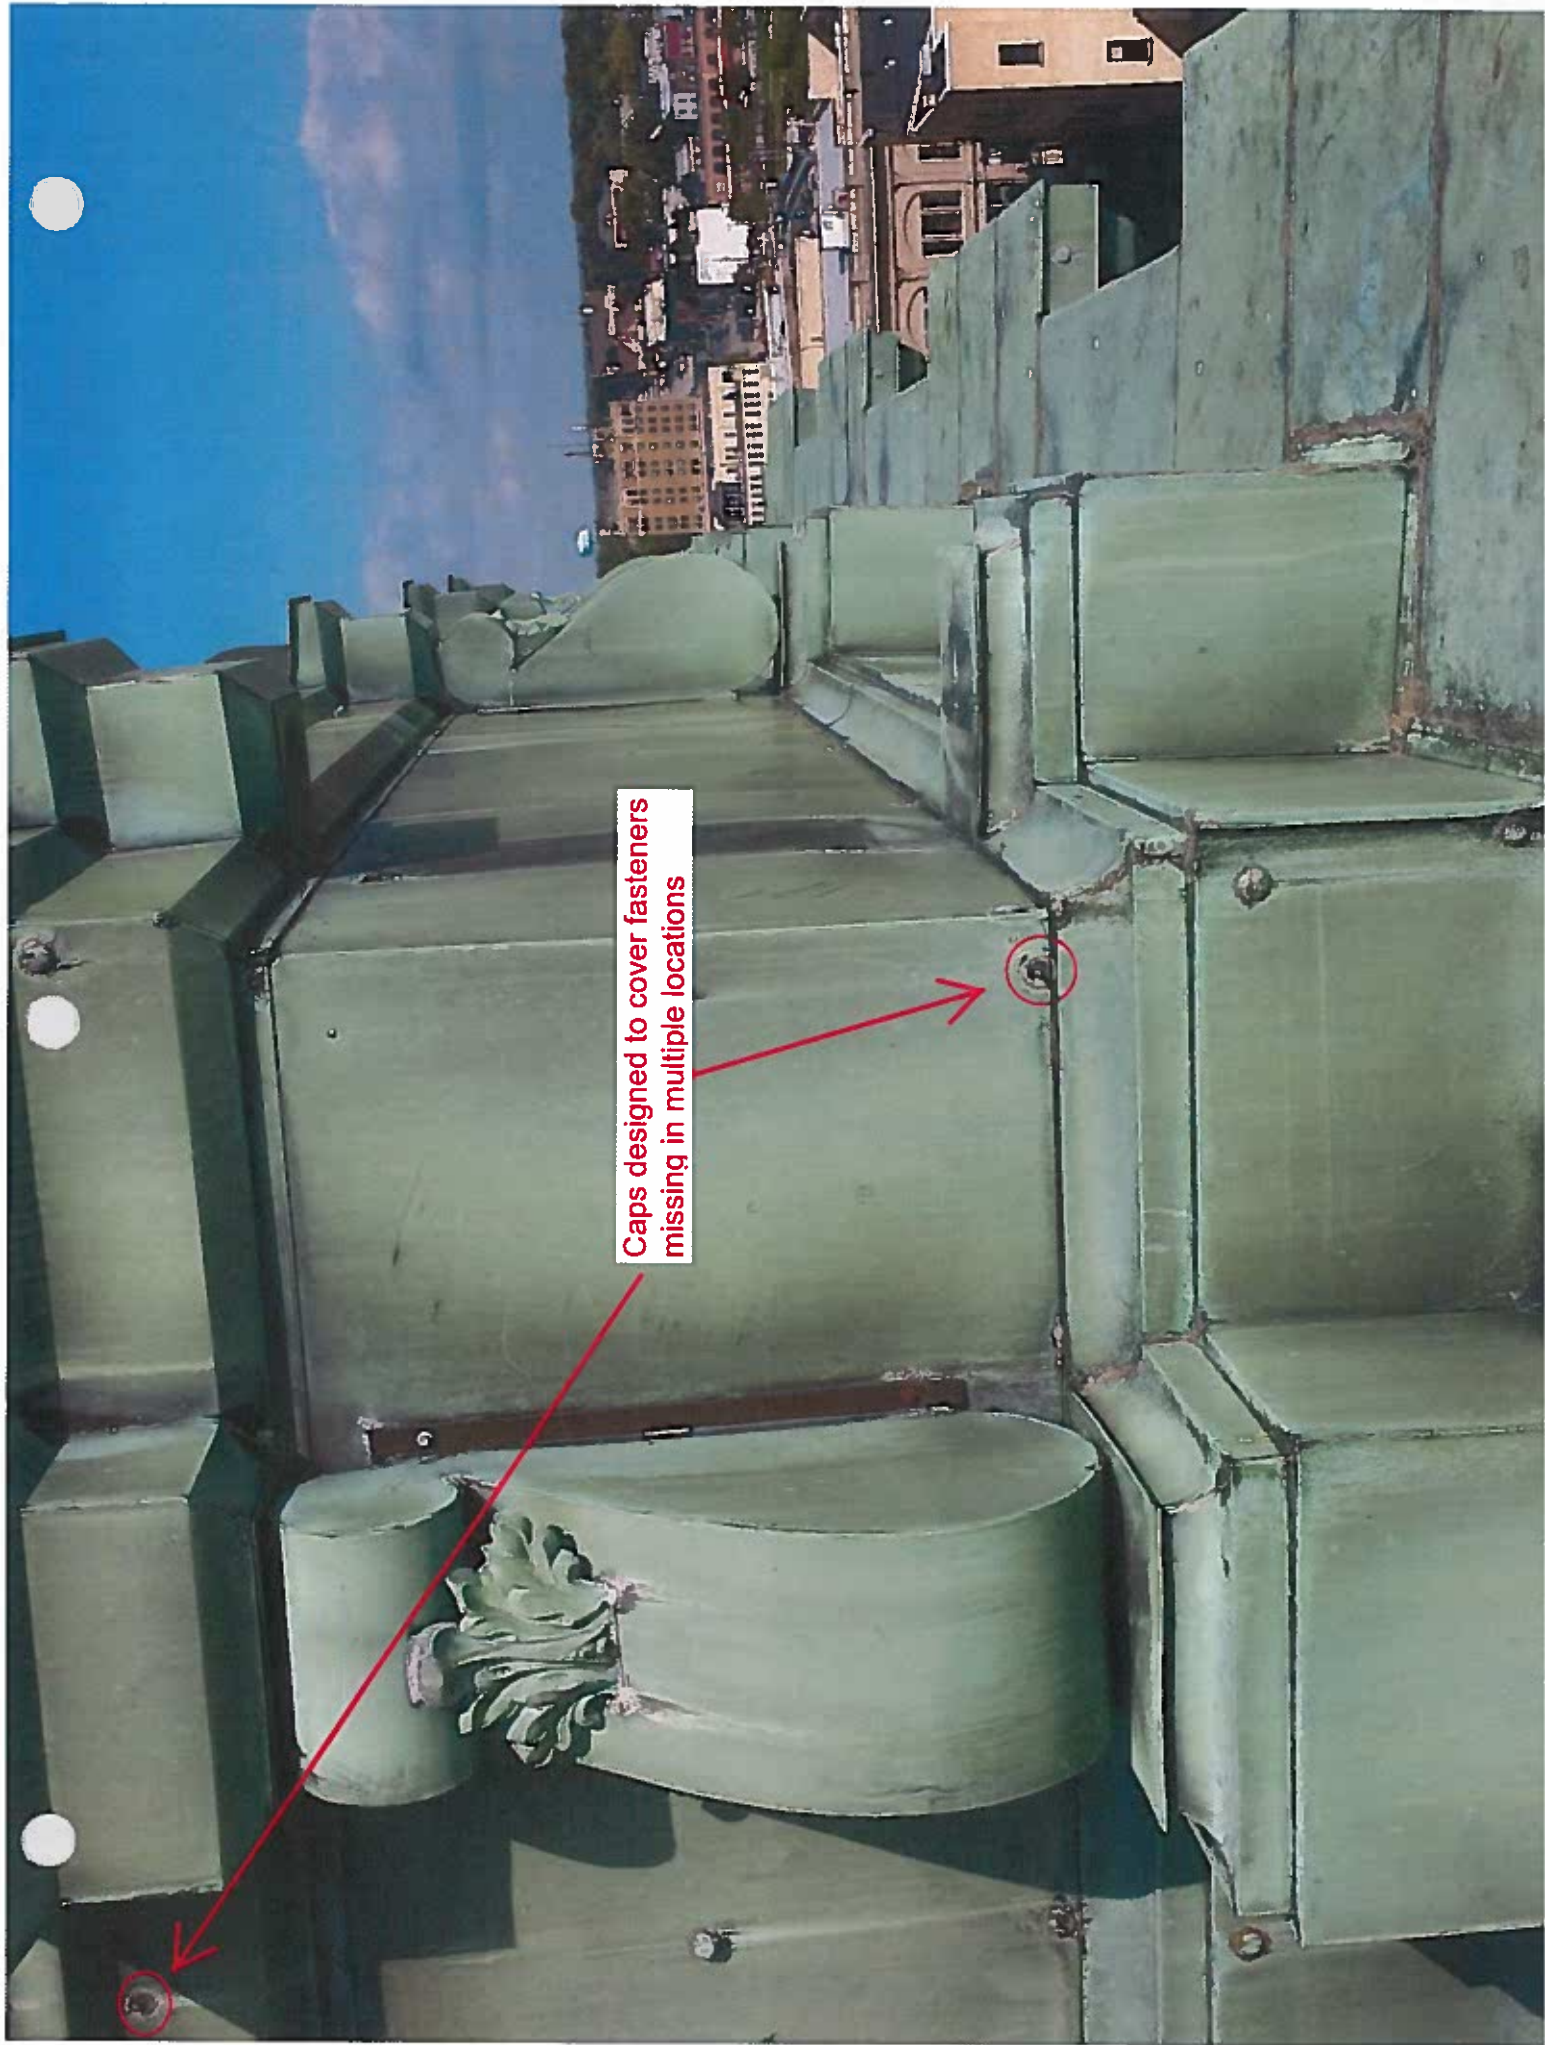
Caps designed to cover fasteners  
missing in multiple locations

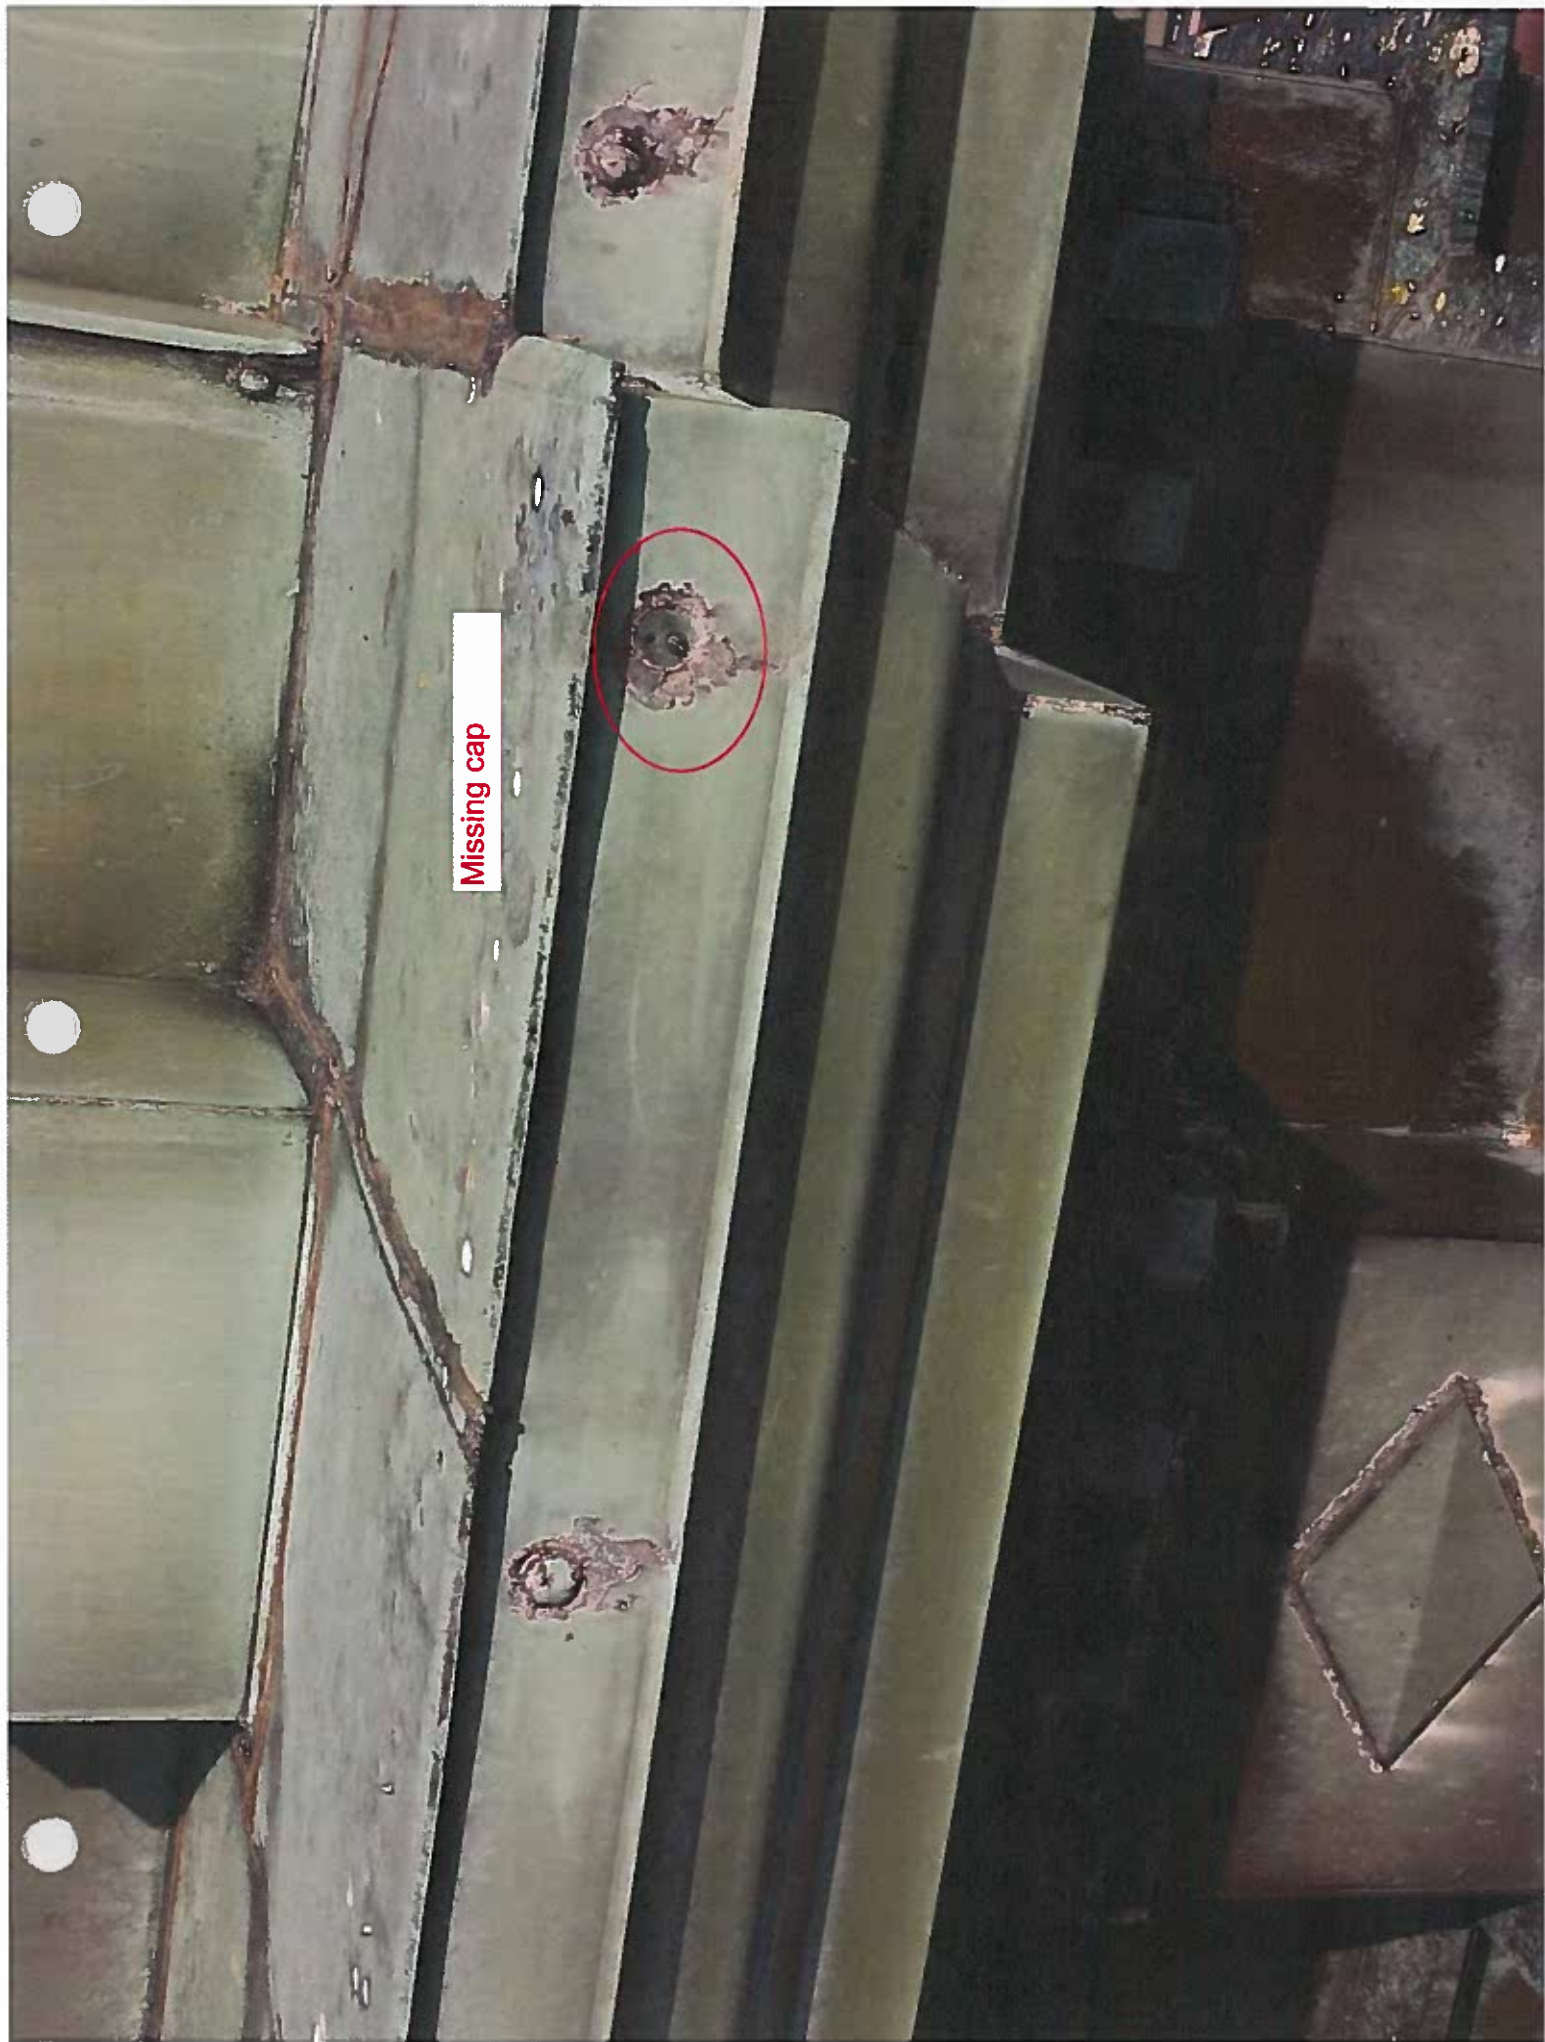
Missing cap

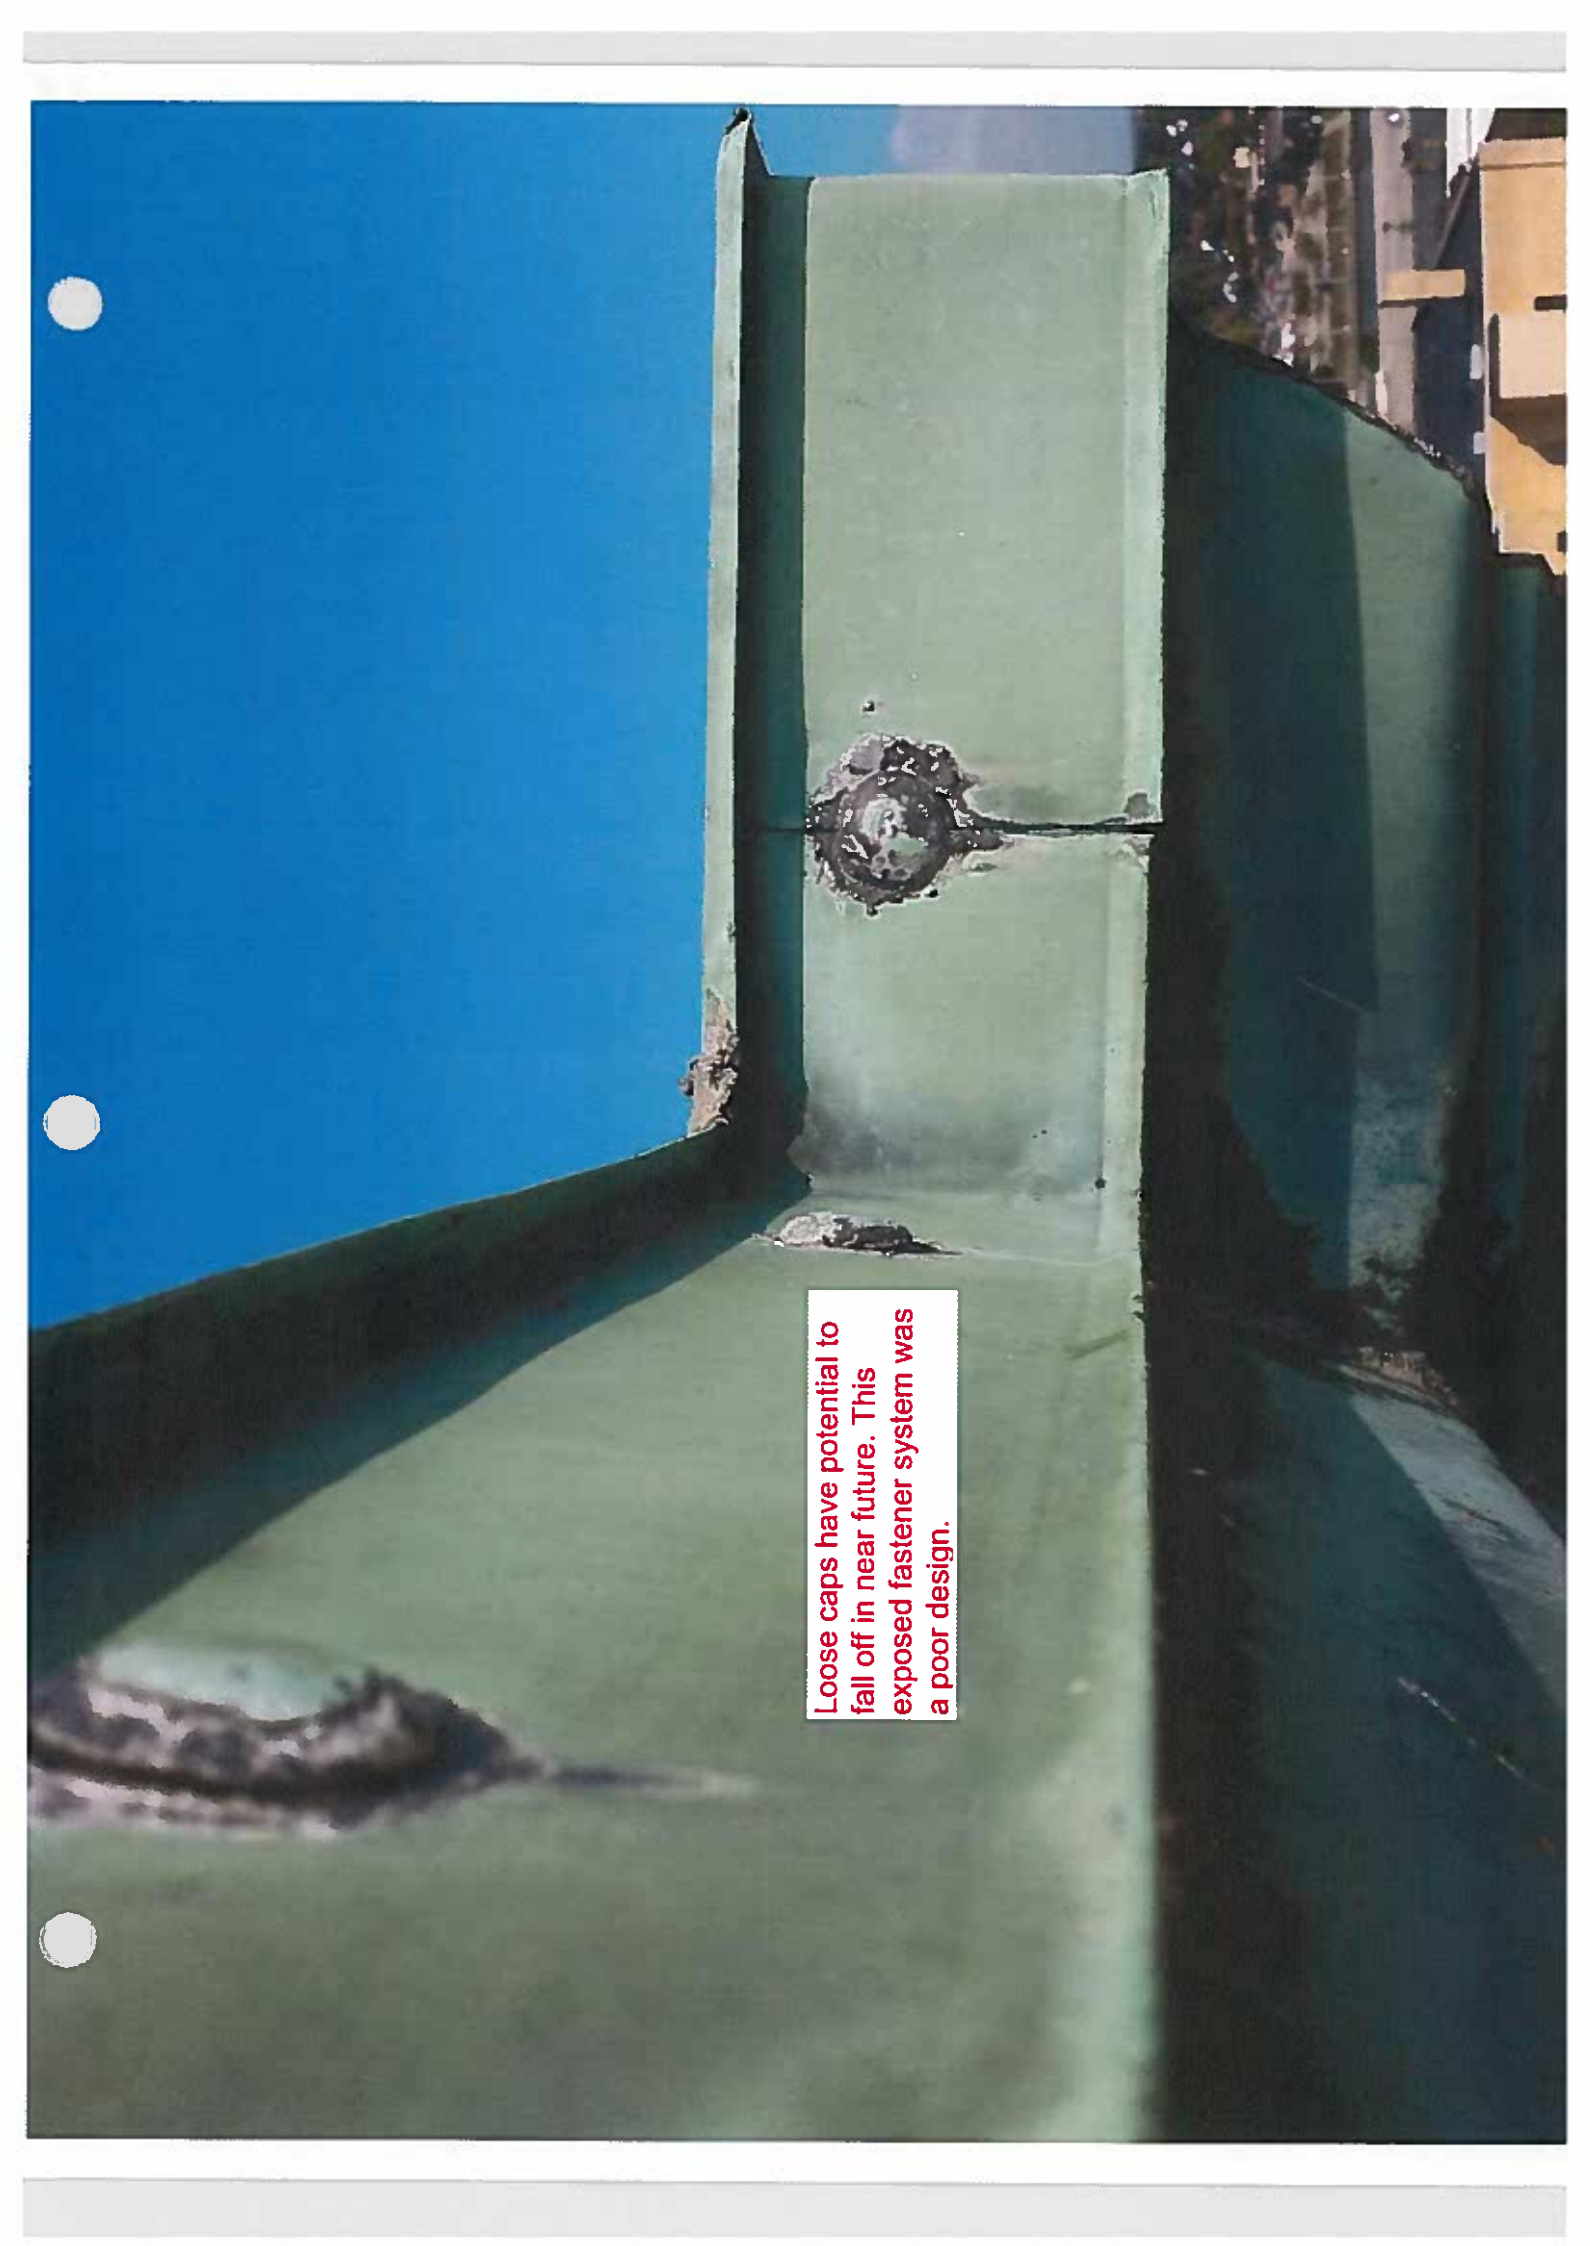
Loose caps have potential to fall off in near future. This exposed fastener system was a poor design.
