# Clerestory Photos

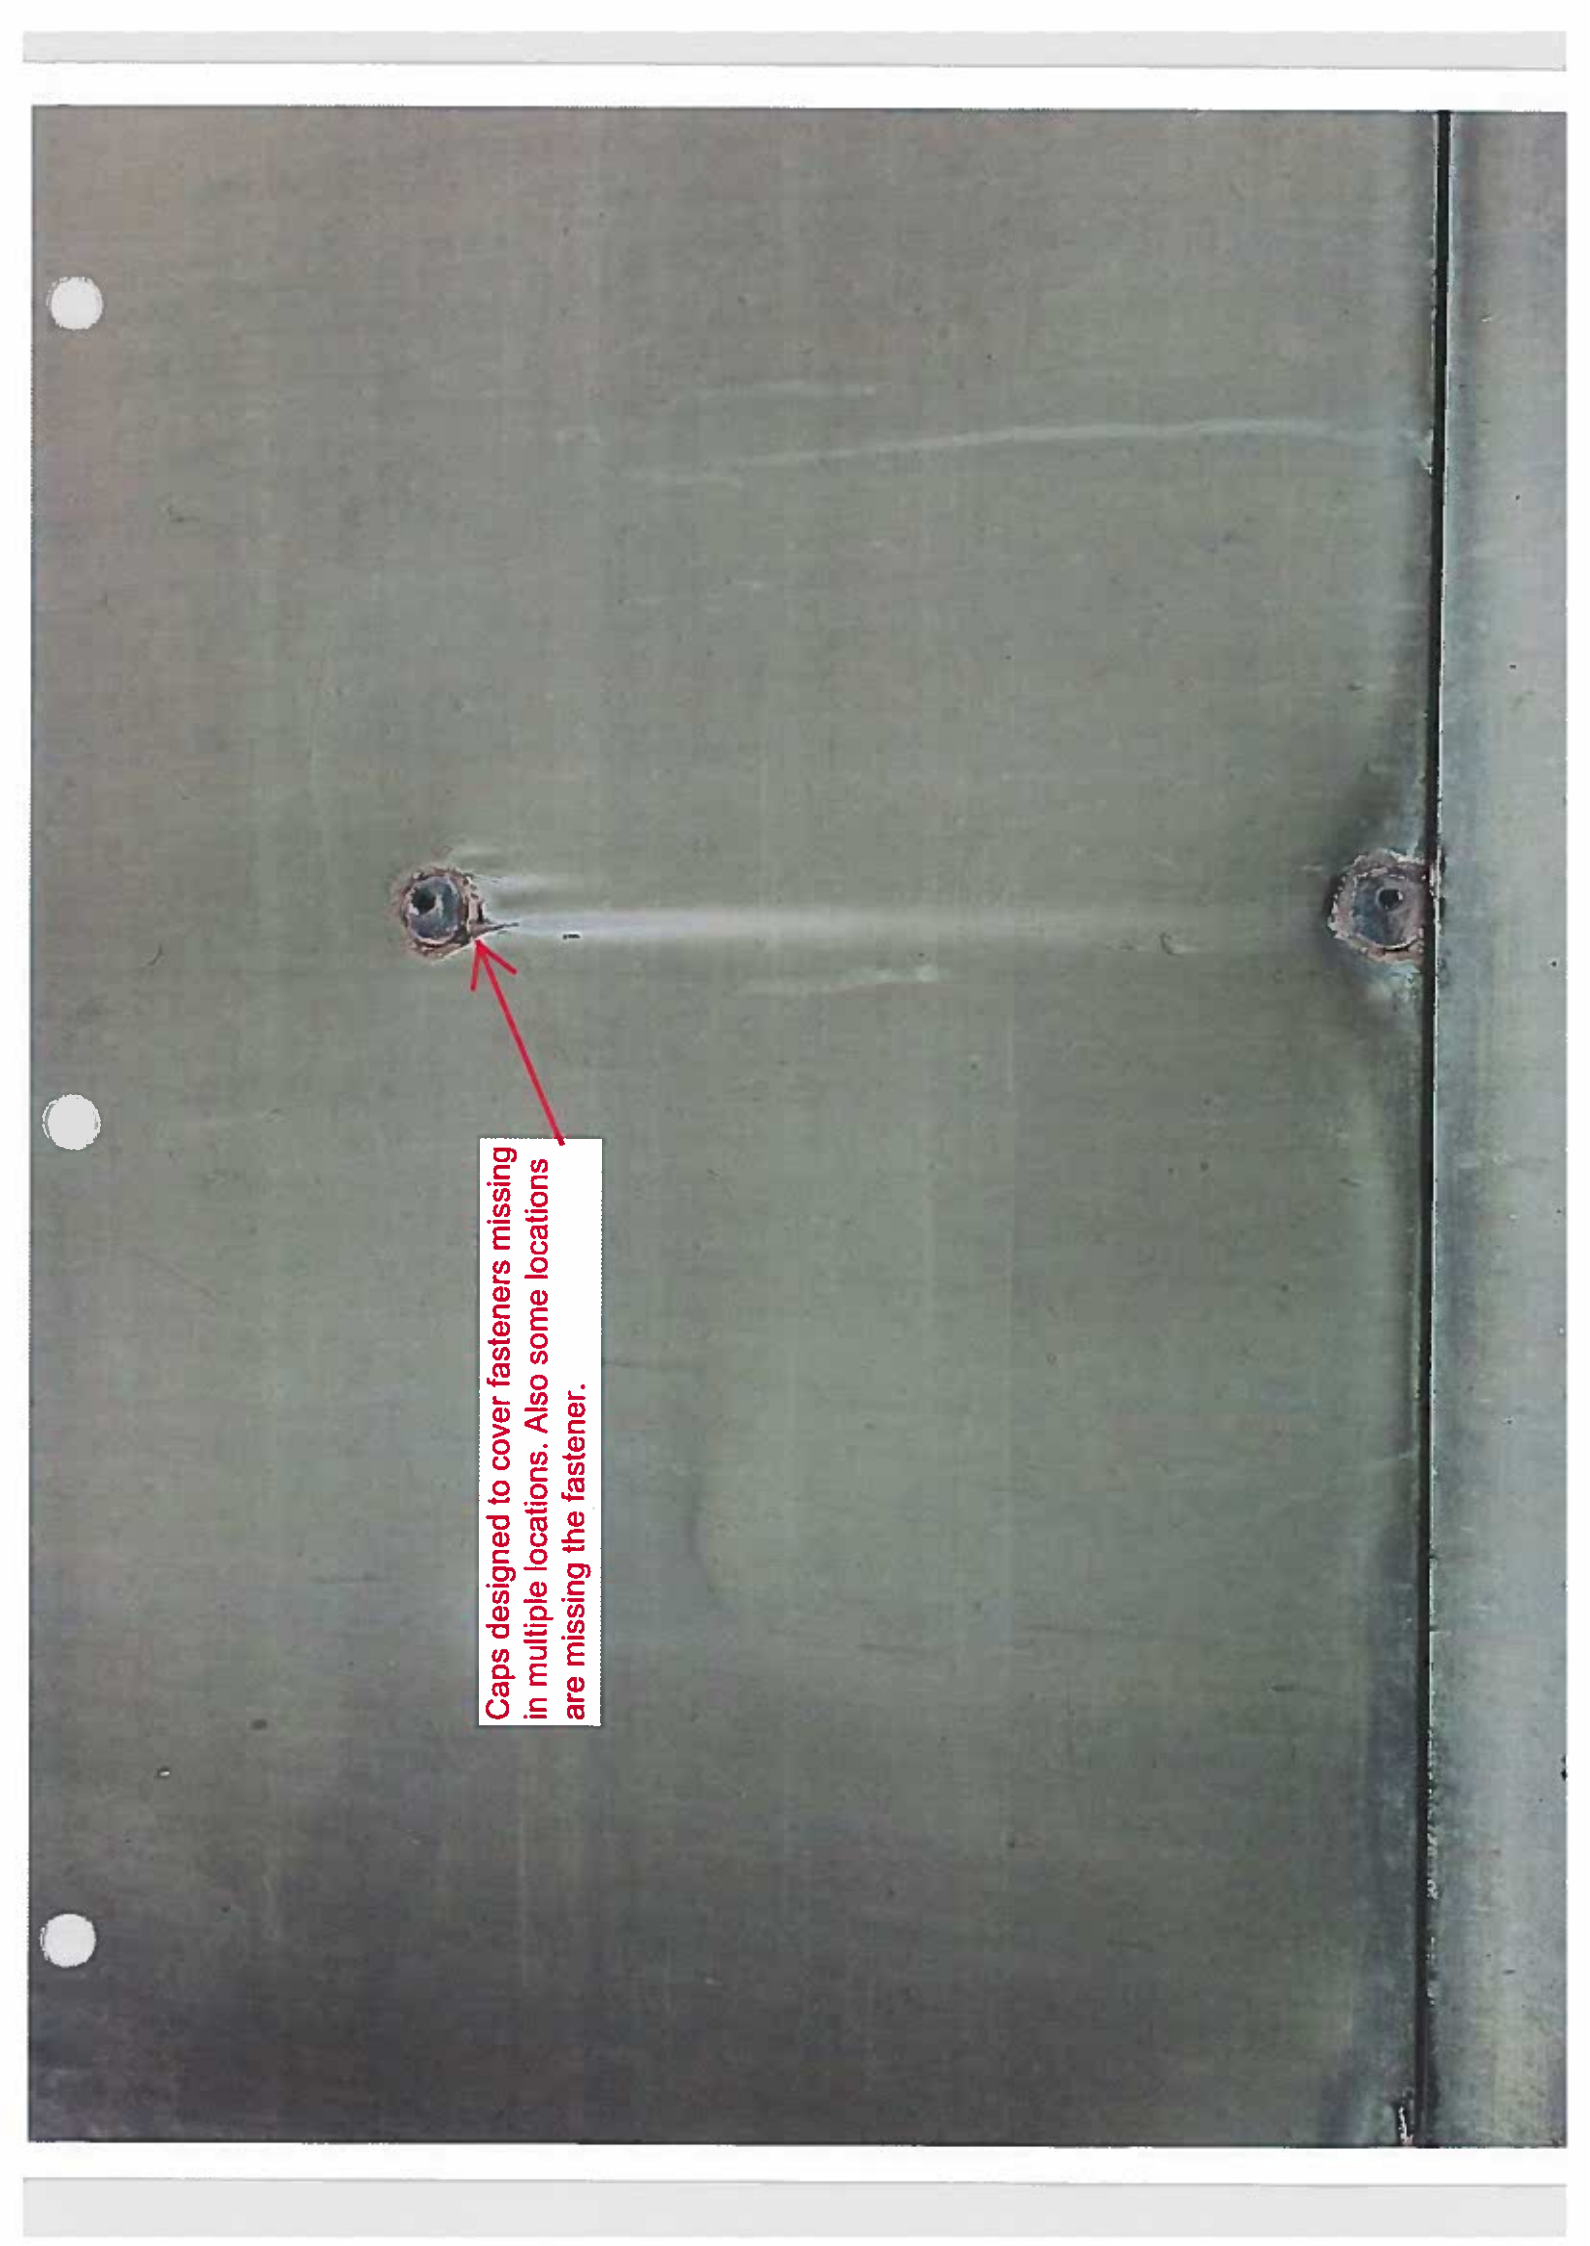
Caps designed to cover fasteners missing in multiple locations. Also some locations are missing the fastener.

Ornament has become detached from original location and slipping out of place. Looks to be held in place by one steel screw.

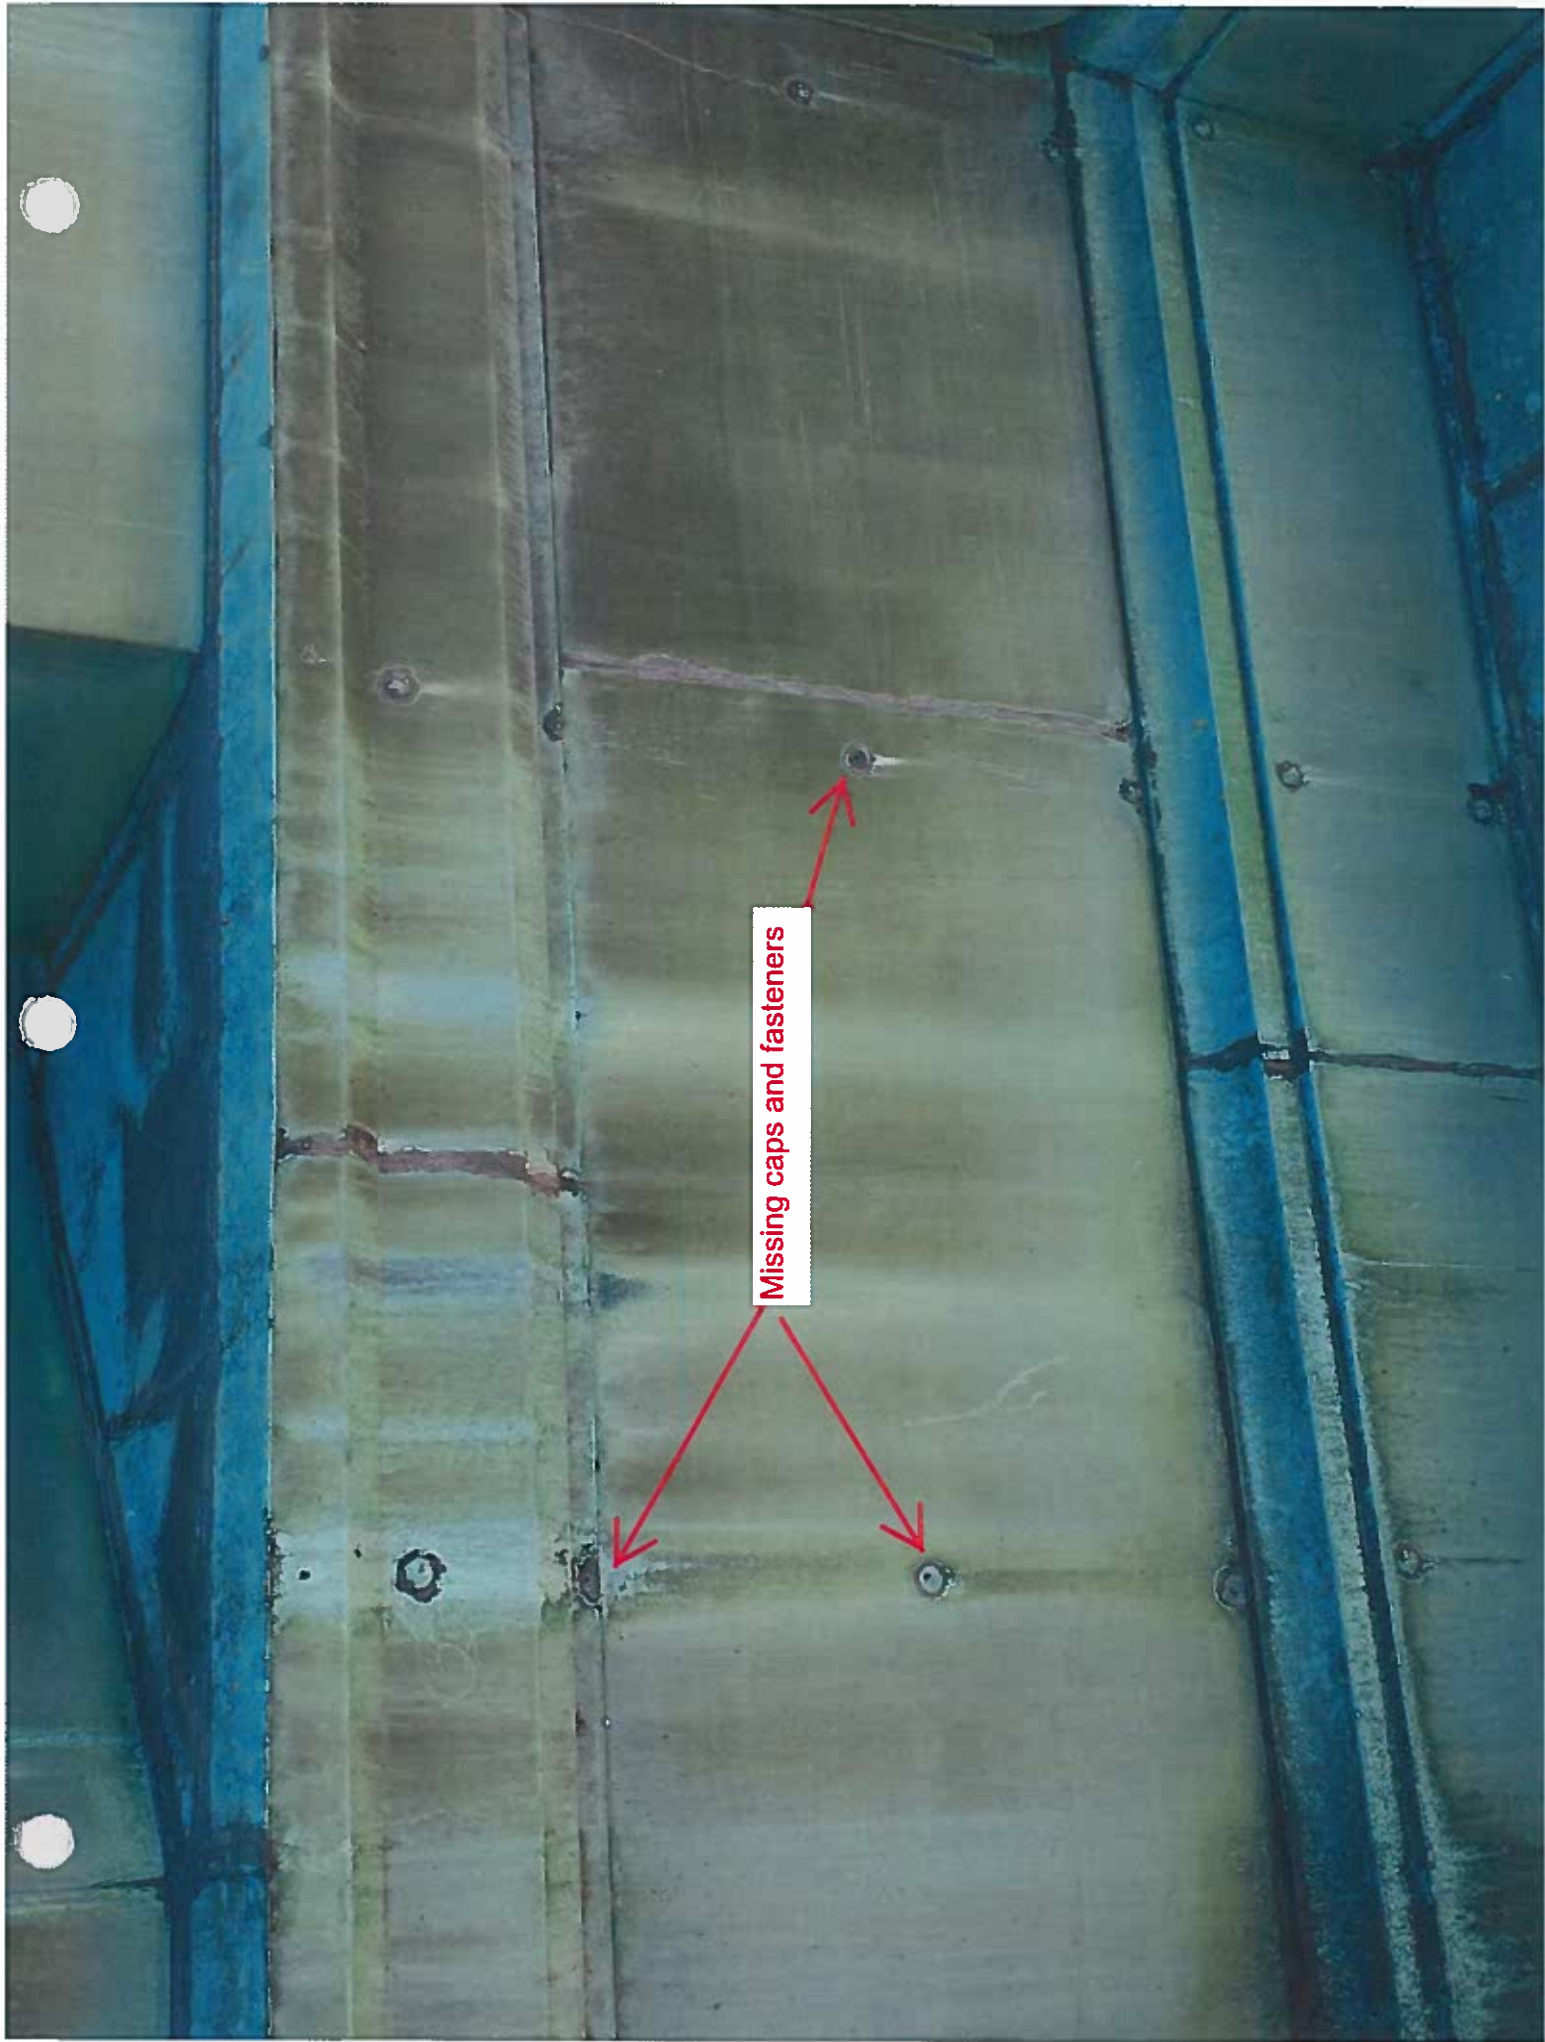
Missing caps and fasteners
