COUNTY DOME AND FACILITY IMPROVEMENTS STUDY

DATE: 05/01/2022
DRAWING SET: ARCHITECTURAL SCOPING
PROJECT NO.: 2022011

ATTIC PLAN

ORIGINAL TOWER STRUCTURAL DRAWINGS

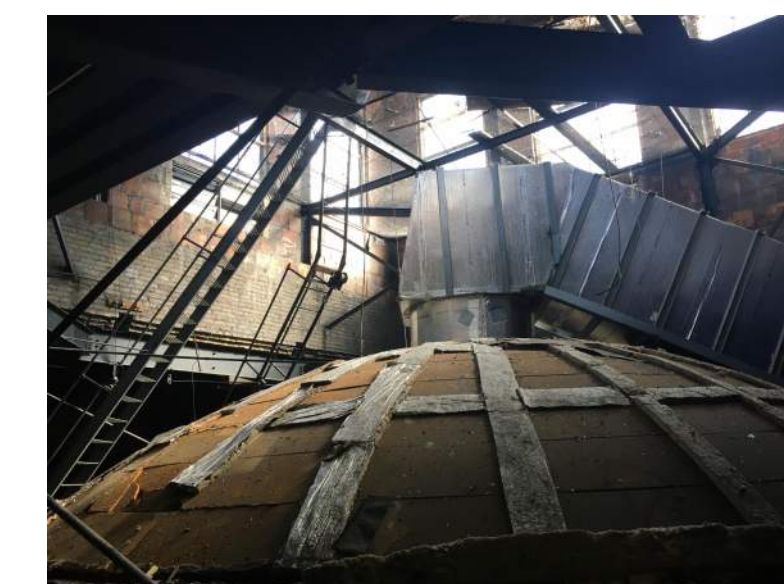
INTERIOR ATRIUM DOME (INSULATED) AND CURRENT RETURN AIR DUCT BELOW BASE OF CLERESTORY. EXISTING STAIR TO DOME (FOREGROUND) AND ABANDONED ORIGINAL LADDER (BACKGROUND).

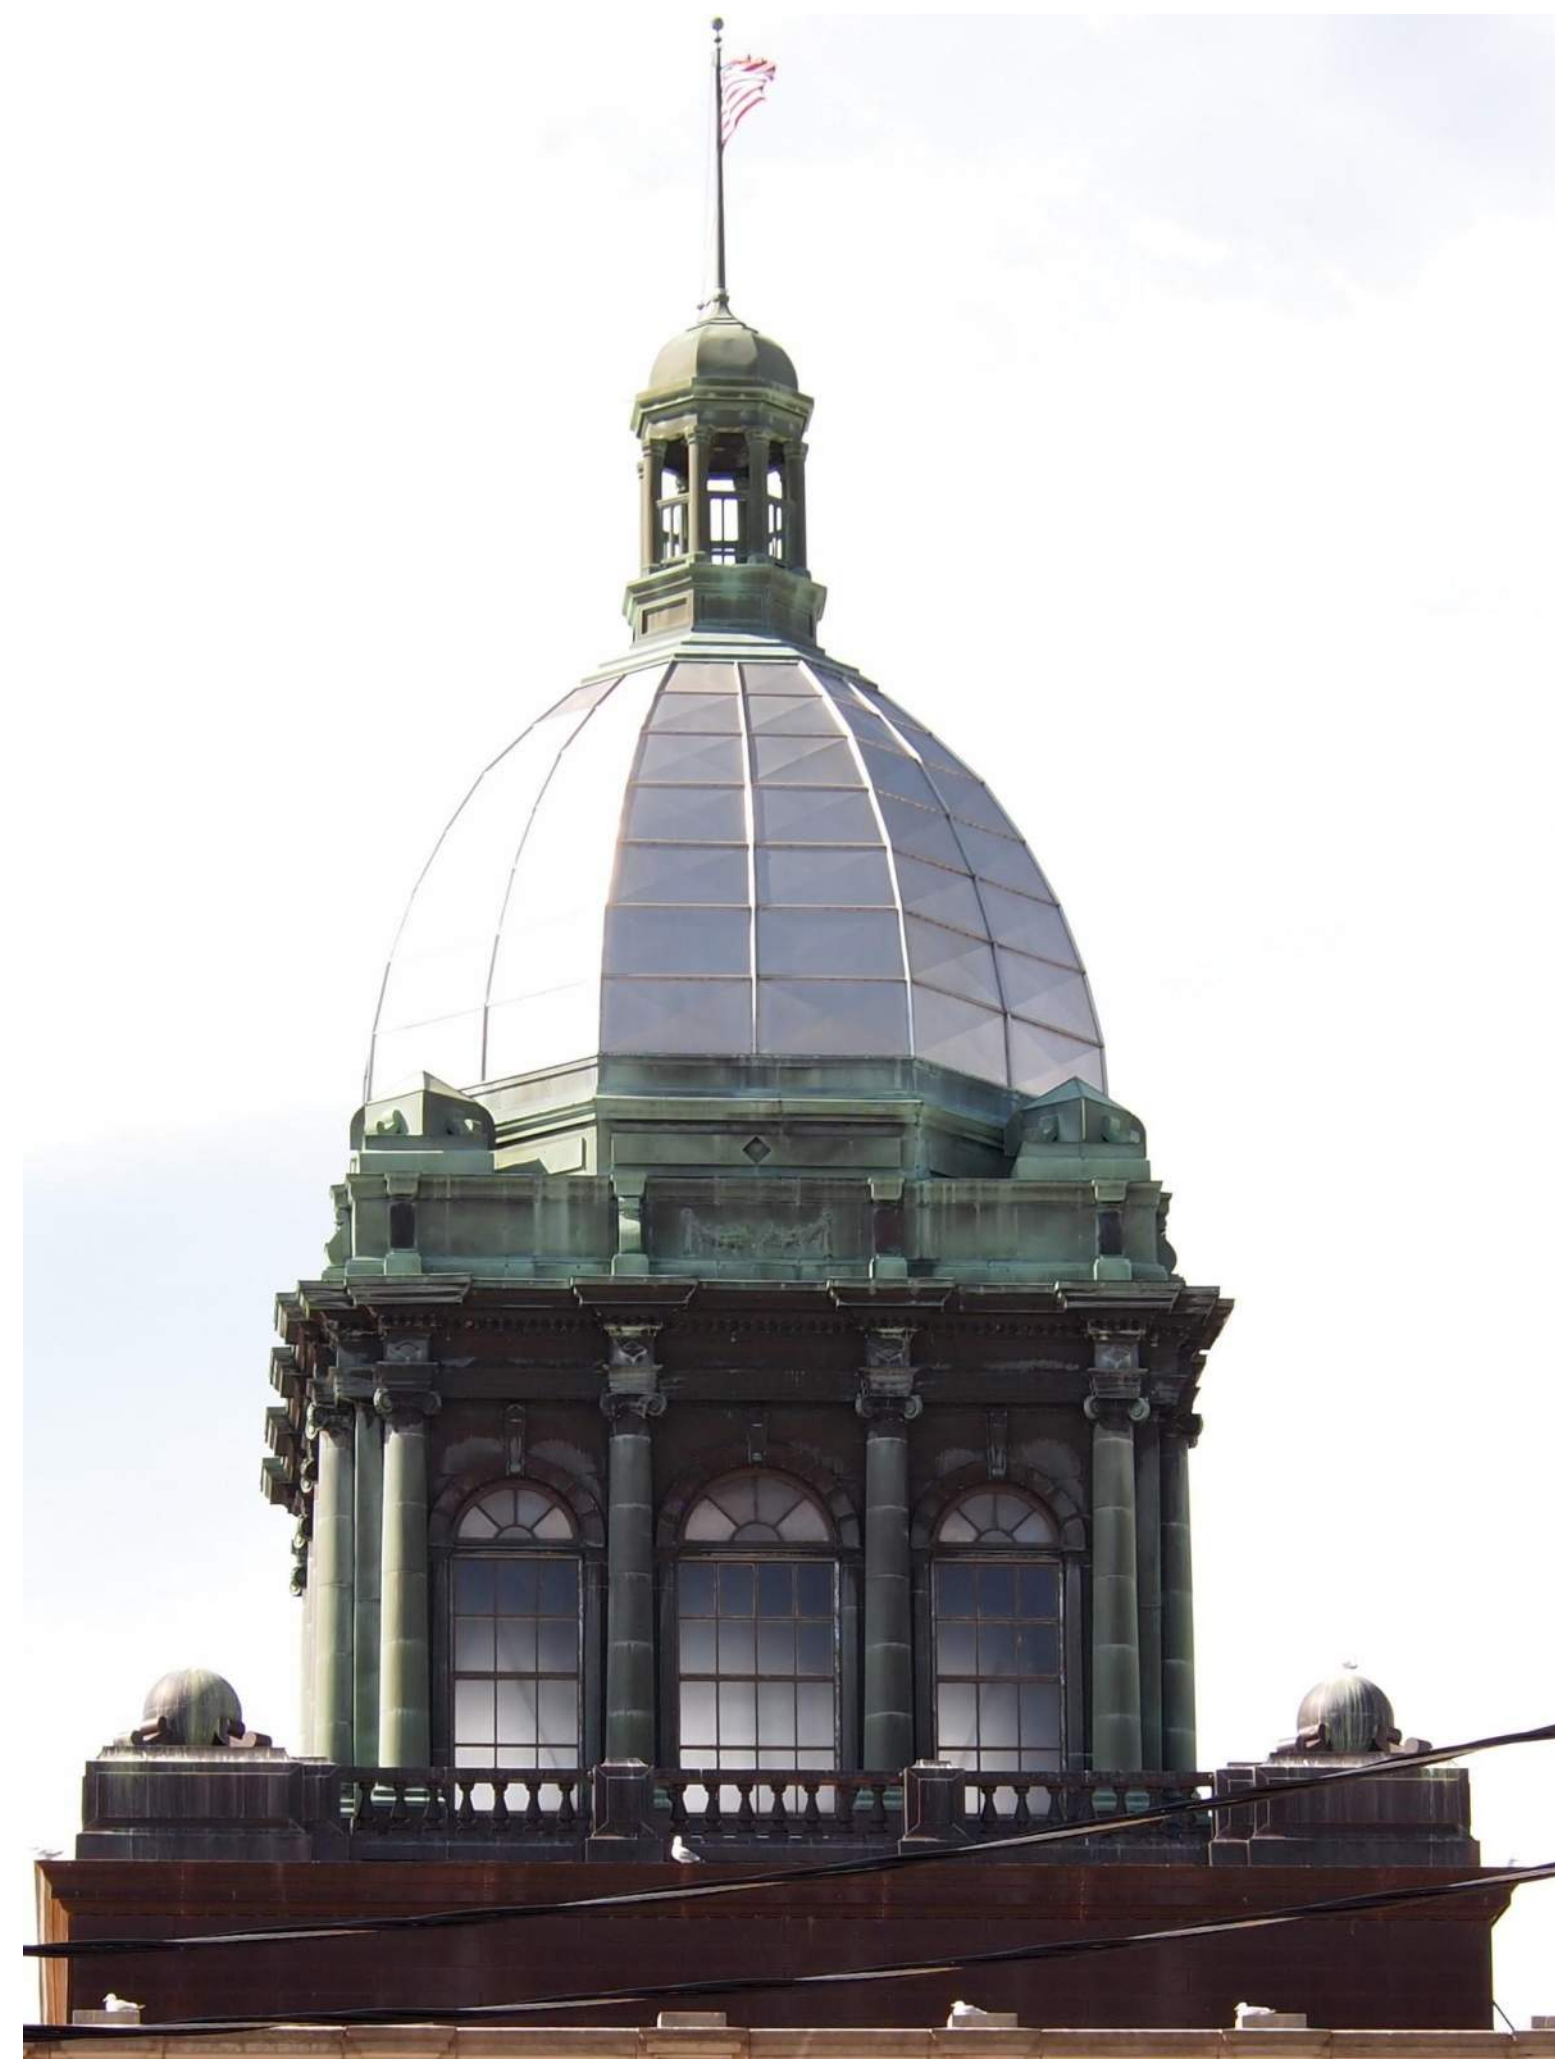
CURRENT CONDITION AS PARTIALLY RECLAD IN 1950s

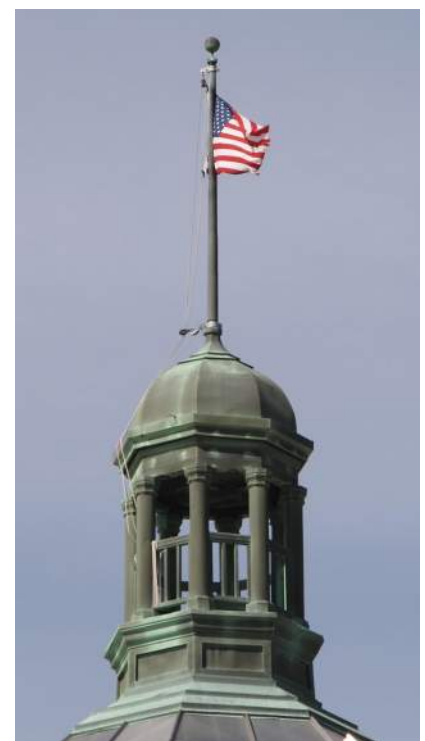
SIMPLIFIED LANTERN AND SKIRT. DOME IS FRAMED OVER ORIGINAL ROOF FRAMEWORK.

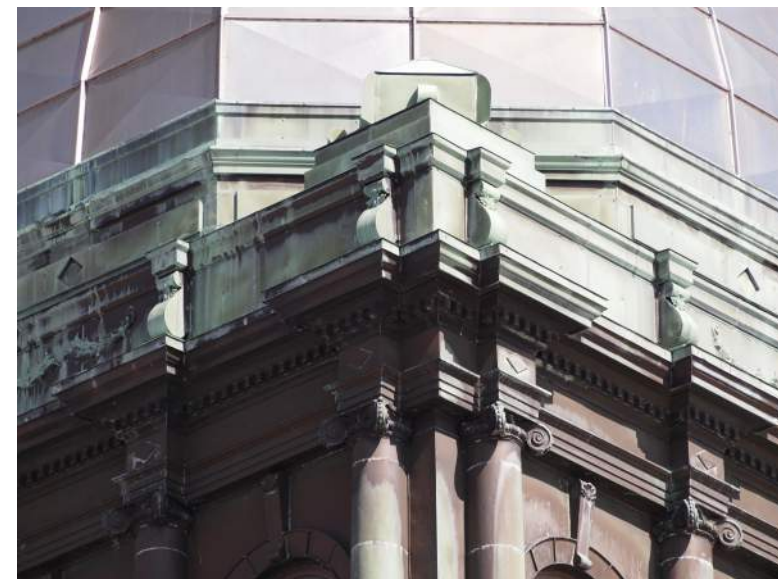
ORIGINAL ENTABLATURE, SIMPLIFIED REPLACEMENT BRACKETS AND CORNER ORNAMENT

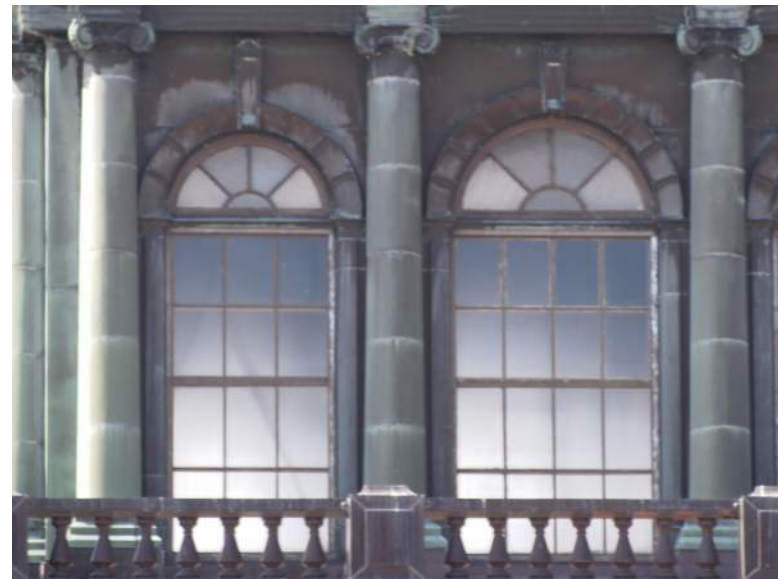
CLERESTORY WINDOWS WITH MODIFIED ARCH ORNAMENT

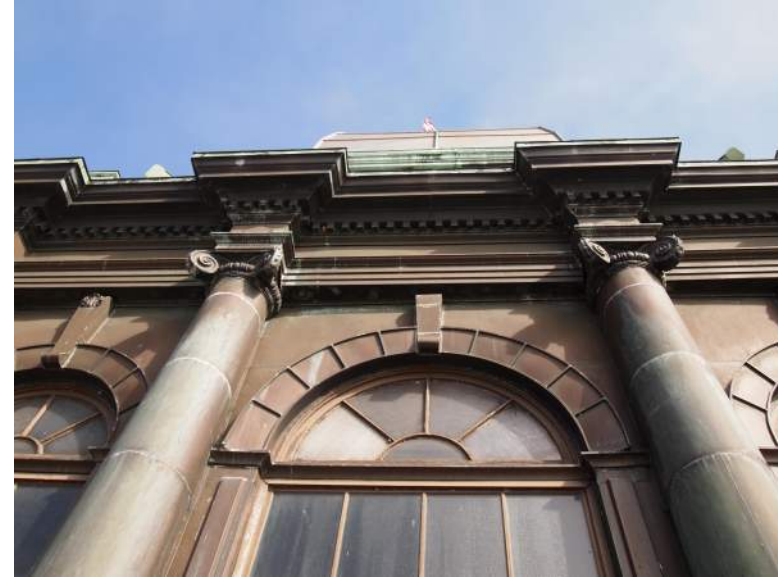
ORIGINAL WOOD SUNBURST WINDOW FRAME AND SASH, SIMPLIFIED WINDOW SURROUND ORNAMENT

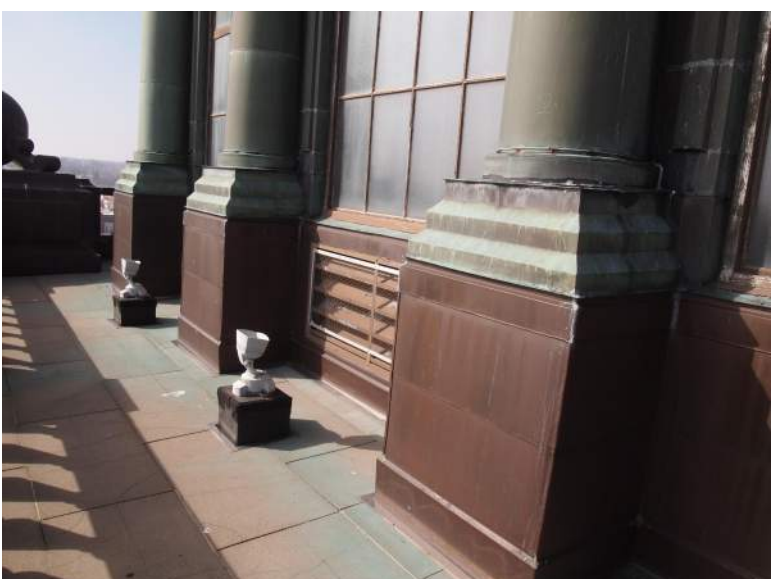
SIMPLIFIED COLUMN BASE REPLACEMENTS AND PLINTH CAPS. NOTE ARCHITECTURAL UPLIGHTS

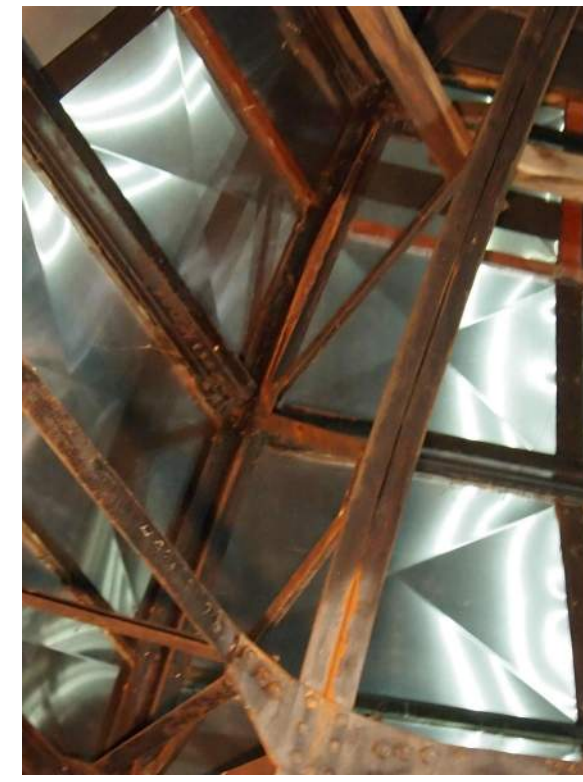
RUST JACKING OF 1 OF 2 TRUSSES, ADDITIONAL SURFACE CORROSION BELOW

STRUCTURAL REPAIR (SISTERING OR SPLICE IN) OF HEAVILY CORRODED BACK TO BACK TOP CHORDS OF (2) DOME TRUSSES, MILDER POSSIBLE SISTERING AT REMAINING (6).

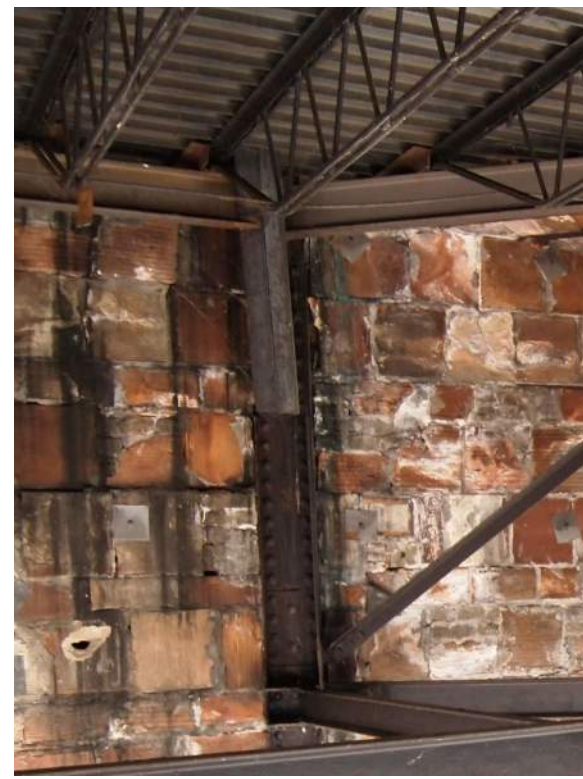
EXTENSIVE STRUCTURAL CLAY TILE WATER DAMAGE AND CORROSION OF TOP OF COLUMN/CONNECTION TO DOME TRUSS

AT ALL (8) LOCATIONS: TOP 8" OF STRUCTURAL CLAY TILE ALONG TRUSS-COLUMN CONNECTION TO BE REMOVED. TOP 6" OF STEEL COLUMN AND CONNECTION TO DOME TRUSS TO BE REPLACED. TOOTH IN REPLACEMENT STRUCTURAL CLAY TILE.

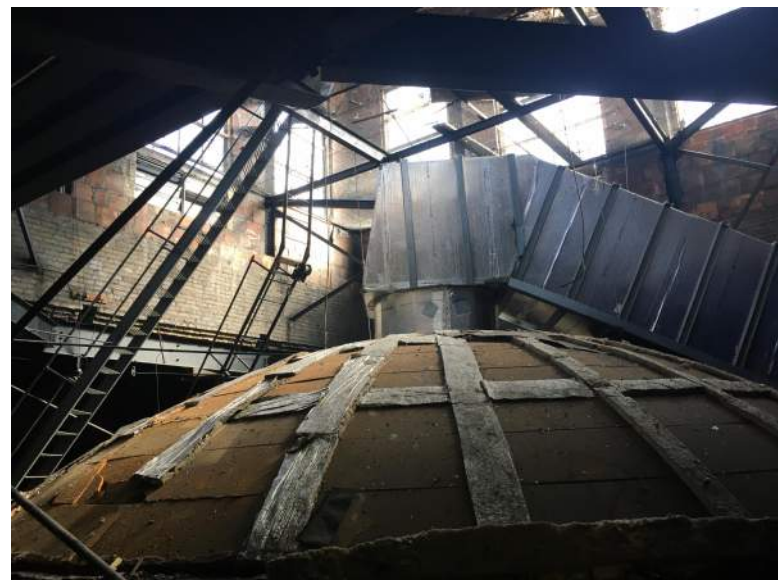
INTERIOR ATRIUM DOME (INSULATED) AND CURRENT RETURN AIR DUCT BELOW BASE OF CLERESTORY

REWORKED RETURN AIR DUCT. 6" DIAMETER DUCT RISING UP FROM CENTER OF DOME, TRANSITION TO 5" DIAMETER DUCT, DROP DOWN IN CORNER OF CLERESTORY AT PIER AND RETURN TO FLOOR MOUNTED DUCT BEHIND CORNER PIER. SEE HVAC PLANS FOR ADDITIONAL WORK TO DOWNSIZE DUCT. SEE SHEET A204.

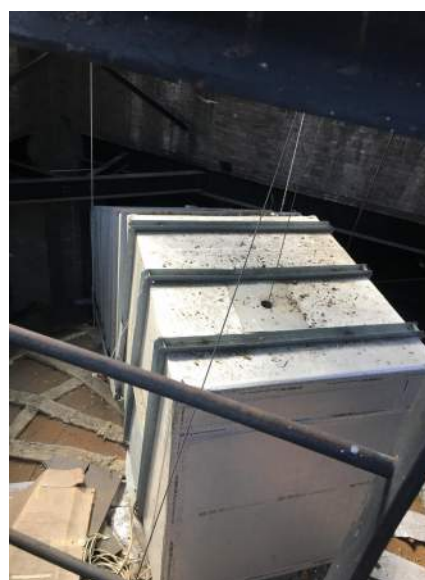
CHANDELIER SUPPORT CABLE THRU RETURN AIR DUCT

REPLACE EXISTING CHANDELIER HOIST SYSTEM WITH ELECTRIC. REMOTE CONTROLLED 1000LB RATED HOIST WITH CABLE DRUM AND ELECTRIC CABLE COILING DRUM SYSTEM. RELOCATE DRUM/DRIVE TO STEEL LINTELS.

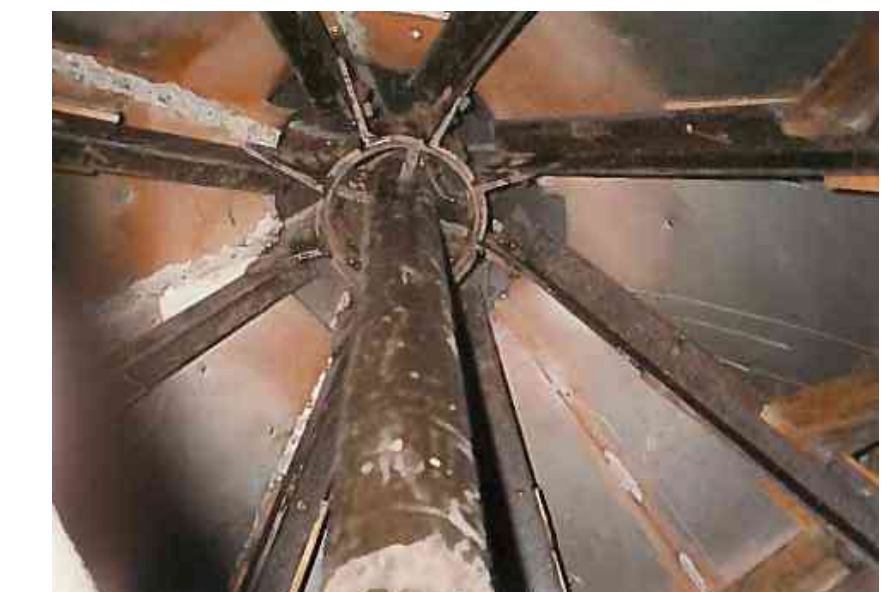
ORIGINAL LANTERN FRAMING WITH FLAGPOLE INSERTED AND WOOD FRAMING INSERTED TO CREATE EXISTING LANTERN DOME
