# *Manitowoc* COUNTY COURT HOUSE

*Historic Structure Report, August 2004*

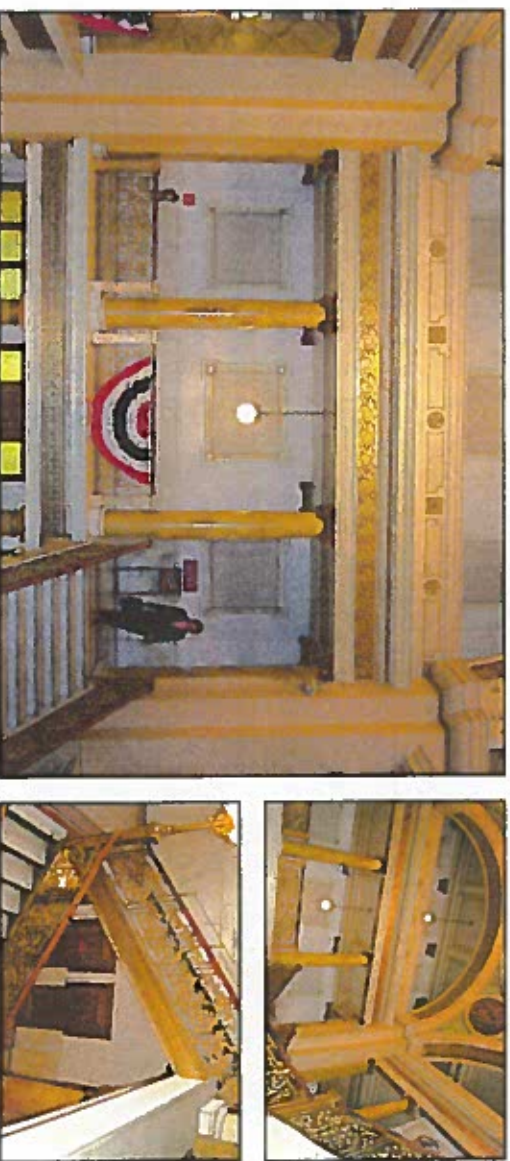
EXISTING WALLS AT WHICH MURALS DO NOT OCCUR; CENTRAL, OPEN STAIR

Original, well-maintained murals that depict the history of the Manitowoc region are located on walls that surround the rotunda. They can be viewed from a variety of locations throughout the rotunda. In addition, other niches or recessed, painted plaster walls are located within other walls that encompass the rotunda. These areas may be considered candidates for installing new murals or other art work that would complement the original murals and character of the interior space. If considered, implementation of a carefully defined process for adding new murals is recommended. This will ensure that the completed results will be sympathetic to the original design and to the history of the building and community. Defined procedures for implementing the solicitation of interested artists and for selecting the final artwork have been used in other communities and by the Wisconsin Arts Board for many years.
