## County Dome and Facility Improvements Study

Prepared for:  
Manitowoc County Department of Public Works  
Manitowoc, Wisconsin

Strang Project #2022011

June 30, 2022

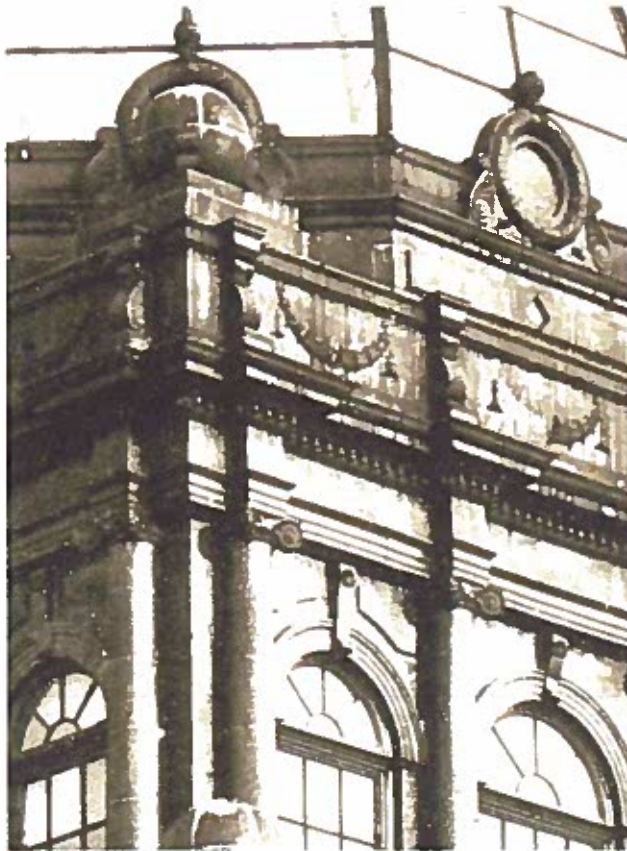
When compared to the historic photographs and historic construction drawings, the lantern roof, skirt at the base of the lantern, ornament on top of the entablature, and cladding and ornament around the clerestory windows appear to be simplified versions of the originals or wholly unrelated designs.

Original clerestory copper ornament circa 1915. Note missing swag above right window.

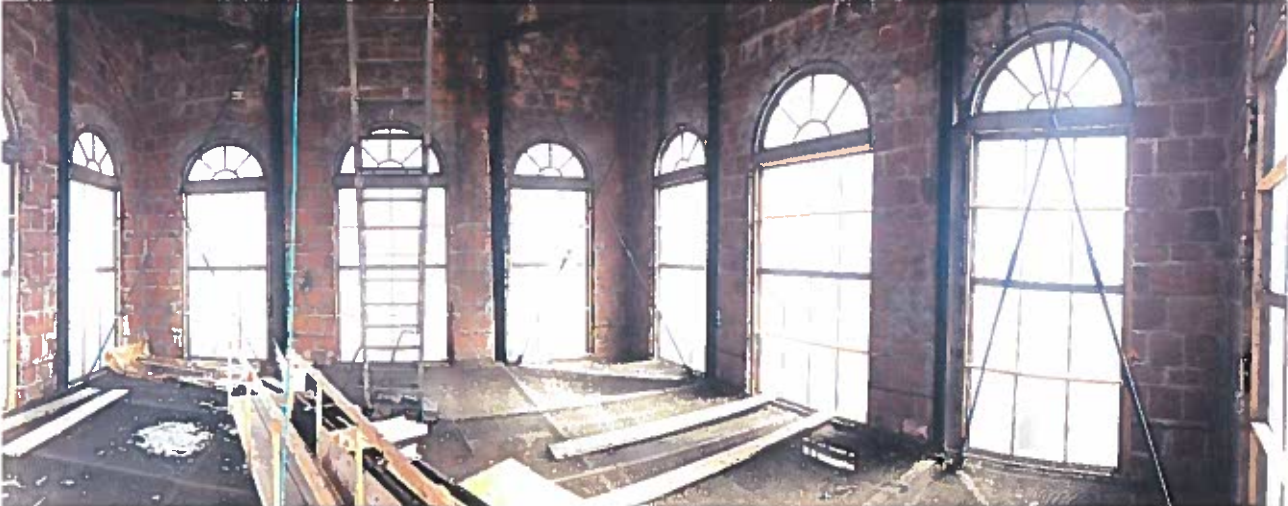
The tower steel is painted black and may be an original coating applied during construction as there are only limited signs of paint on the adjacent masonry infill. The coating is thin and failing. Mild surface corrosion is visible sporadically at the lower steel but becomes increasingly more extensive and severe further up the clerestory. From an area just below the upper level of horizontal bracing through the column attachment to the dome trusses and to the underside of the dome

floor deck, the exposed steel columns, the dome trusses, and horizontal bracing connections are covered in heavy surface corrosion. This also occurs on portions of the embedded steel beams supporting the clay tile ceiling in the corners of the clerestory. These areas originally supported the now missing corner spheres at the base of the dome drum. The extent of corrosion on the embedded portions of the steel columns and beams could not be observed.

Interior of clerestory. Note structural clay tile, steel columns, wood bracing of windows, wood catwalk, and debris screen over lower cross bracing. The ship ladder in the center leads to the dome.

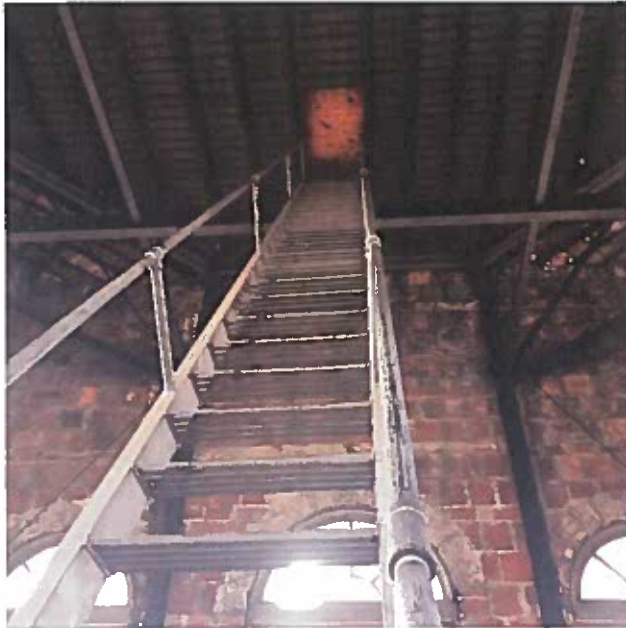
Ship ladder to dome. Note dome floor deck and joists.

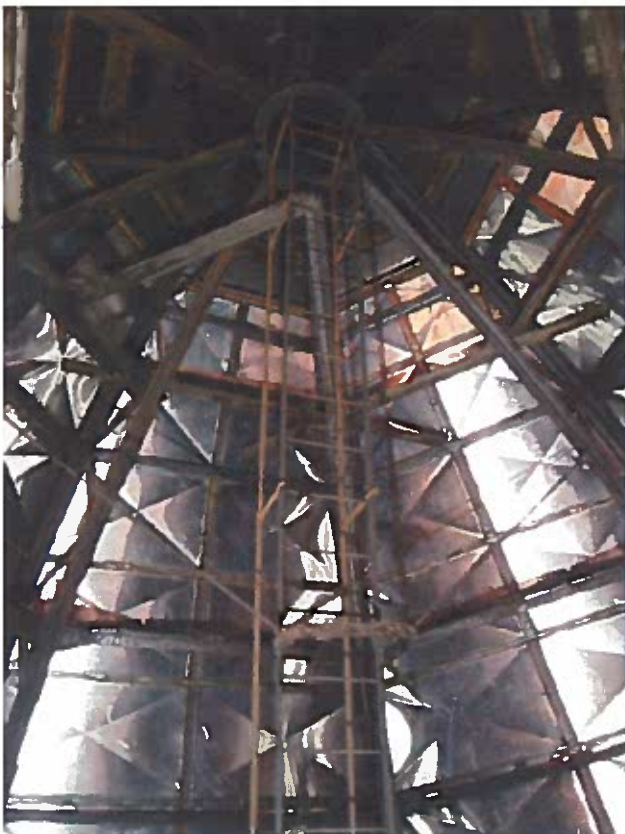
The coating on the visible structural steel of the dome and lantern is thin and heavily compromised. Mild surface corrosion can be seen on most surfaces. Of greater concern are the concentrated areas of intense corrosion located about three quarters of the way up on all the trusses. Two of the eight trusses have extensive delamination of the steel angle top chords while the other six exhibit minimal to heavy surface corrosion. Corrosion on the various elements of the trusses continues downstream of these locations. The condition of the lantern framing is hidden within the lantern construction and could not be observed.

Dome structural trusses connect to a compression ring at top of dome. Note ladder to lantern through ring.

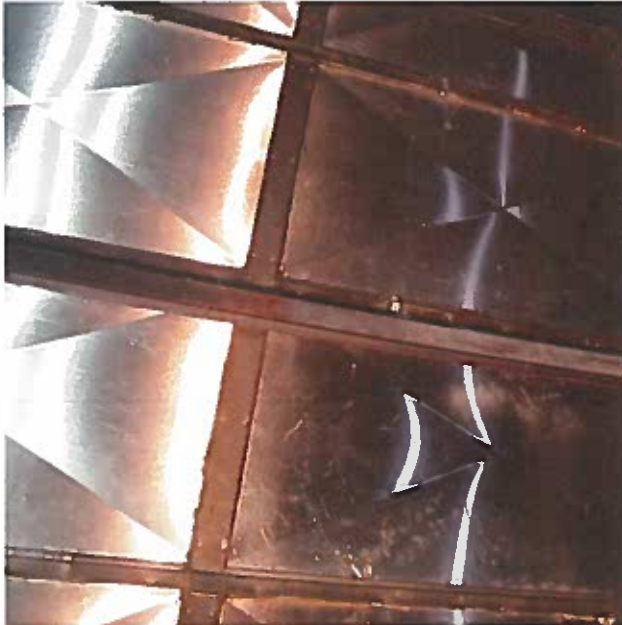
How the original glass was secured to the armature is unknown. Mild to heavy surface corrosion is visible on the unclad ends of the armature framing and on the support brackets at many locations. Most of the armature framing is wrapped in copper and is not visible for observation. Two colors of copper cladding were noticed, a greenish black, likely the original copper cladding, and a reddish brown likely from subsequent repairs.

The armature for the copper clad dome drum consists of galvanized steel members and sheets. Wood flooring was used to provide continuous support the skyward faces. The galvanized sheet metal has mostly rusted away and the galvanized steel members also have some surface corrosion.

Copper clad metal armature originally supported the dome glazing.

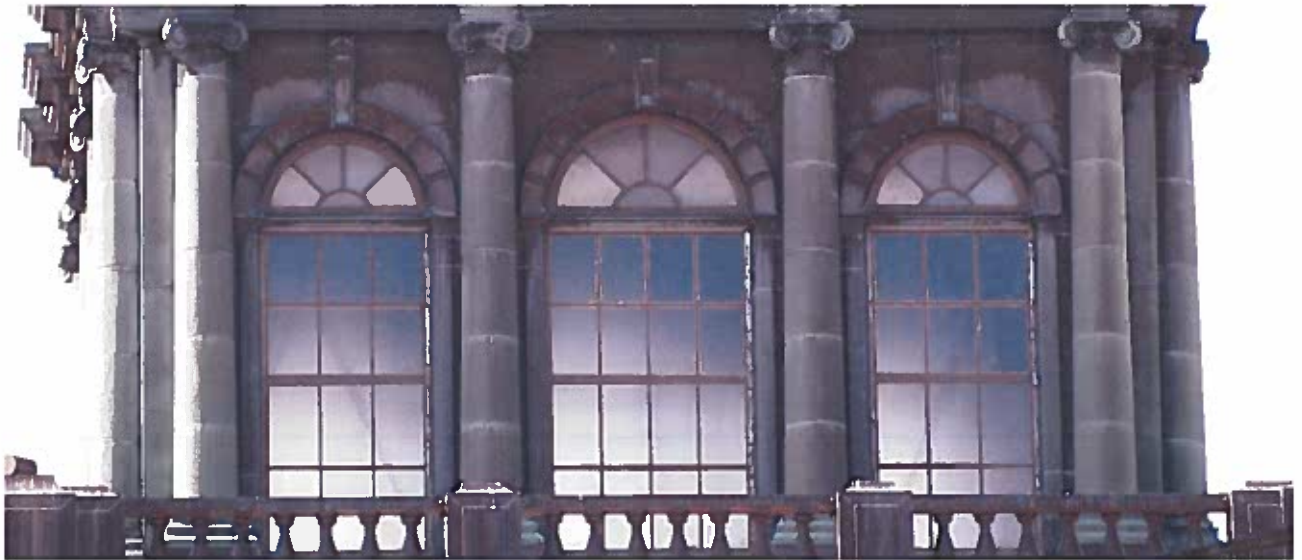
The half round sunburst windows appear to be the original painted wood windows, and largely contain the original prismatic glass. The exterior brown paint and glazing compound is failing and the sills appear to be heavily weathered. The light grey paint on the interior is thin and worn with only some flaking observed. The wood appears dry but remarkably well preserved if original.

The clerestory windows; the half round sunburst windows are original with original glass.

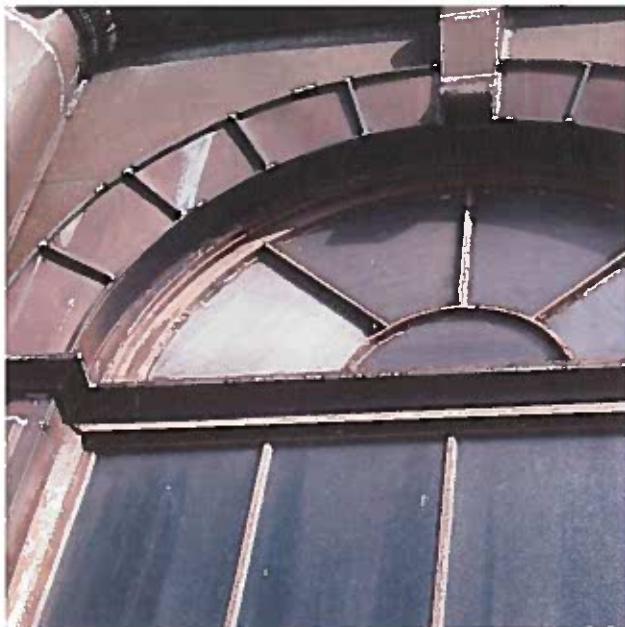
The frame and muntins of the original sunburst windows are thicker than the replacement sash below.

The stacked sash windows consist of dimensional lumber frames and either painted aluminum or wood replacement sash with true divided single glazed frosted glass. All replacement sashes are non-operable and reinforced with 2x4 bracing on the interior. The wood replacement sash muntins are thinner and shallower than those of the half round windows, and are likely easily damaged considering the collection of broken glass and muntins seen on the wire mesh debris screen. The exterior paint has failed, resulting in weathering of the wood.

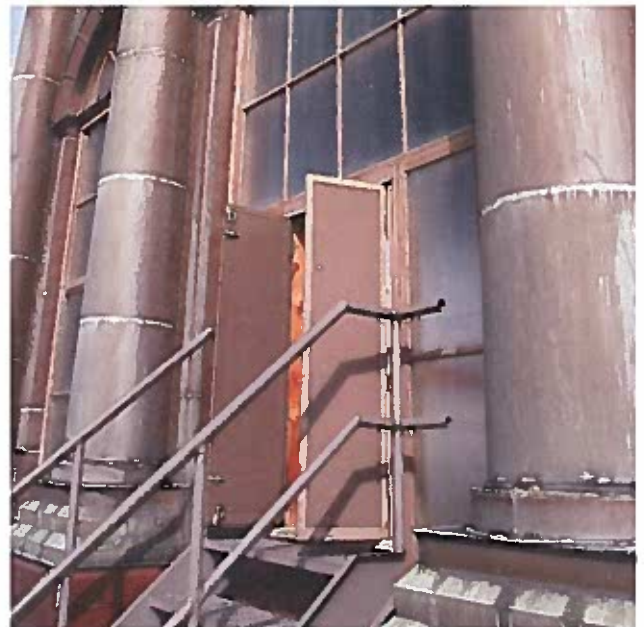
Access from clerestory to promenade deck.

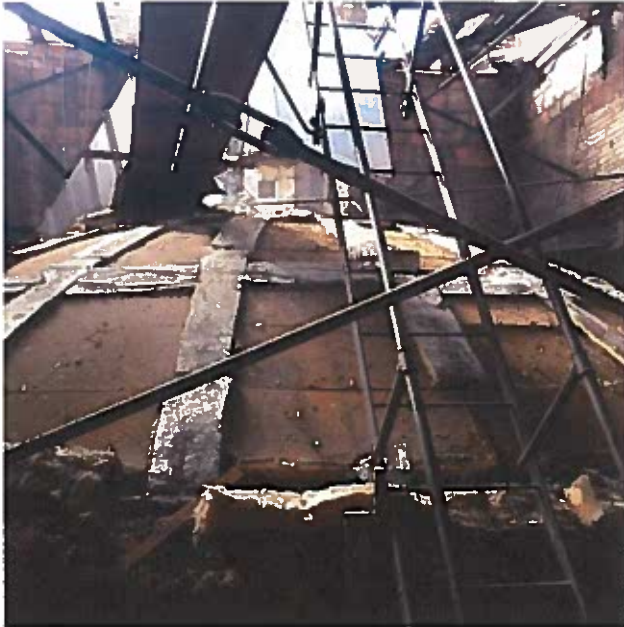
polyisocyanurate insulation. The stainless steel panels, which drape to follow the horizontal and vertical curve of the dome, are held in place by steel pins which are in turn held tight by wood wedges. The domes original 6' diameter center ventilation grate, through which the atrium chandelier is hung, is now attached to the large galvanized sheet metal return air duct. The duct slopes down the dome and would likely be seen in silhouette if the original glazing was still in place.

Insulated topside of Atrium Interior Dome.

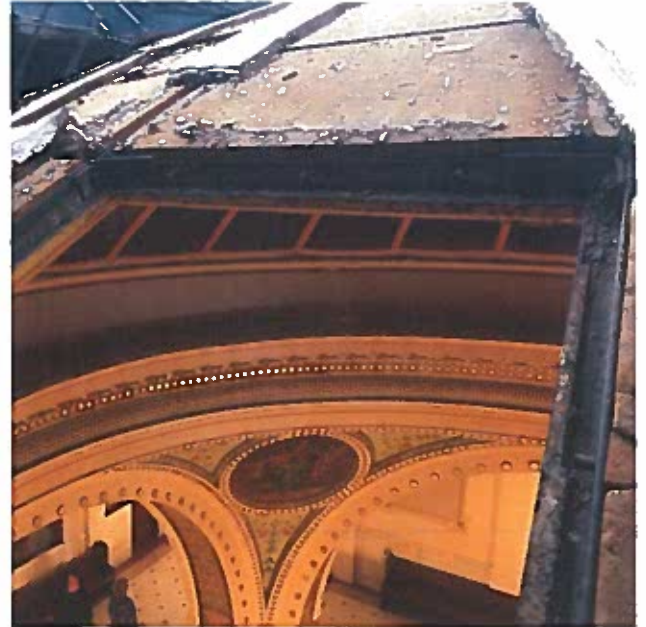
Opening in dome frame at removed stainless steel panel.

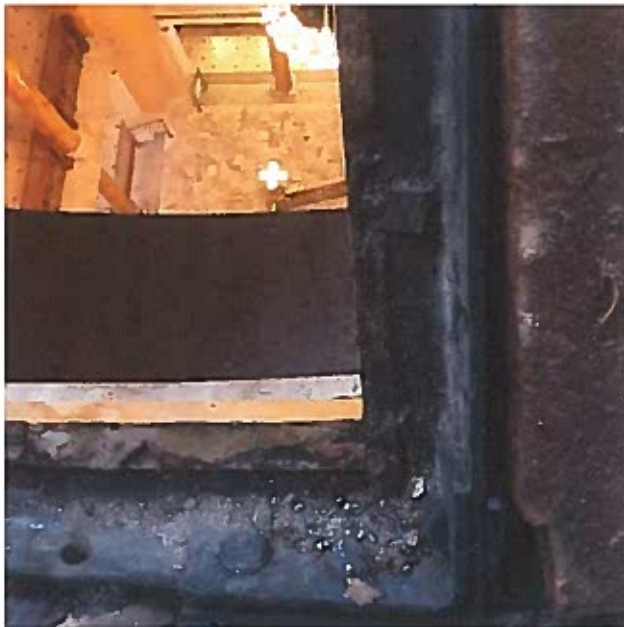
The atrium interior dome consists of an approximately 30' diameter shallow steel framed dome, faced with bent wood trim and set on a plaster faced structural clay tile drum. Surface corrosion on limited specific areas of the dome were observed. The wood is held to the steel frame by small metal tabs screwed into the trim and which grip the frame. One wood rib is cracked and is slightly warped. The existing bullnosed profiled plaster just below the dome is water damaged in many places. The outer face of the drum is bare structural clay tile wrapped in dust filled batt insulation that is falling off the face of the drum. The dome itself is set with stainless steel panels in lieu of the prismatic glass and is covered in deteriorating

Metal clip securing wood trim to metal dome frame.
