EQUIPMENT RECORDING SONAR MAPPED JULY 1976

Source: Wisconsin Department of Natural Resources 608-266-2621  
Hartlaub Lake – Manitowoc County, Wisconsin DNR Lake Map  
Date – Jul 1976 - Historical Lake Map - Not for Navigation  
A Public Document - Please Identify the Source when using it.

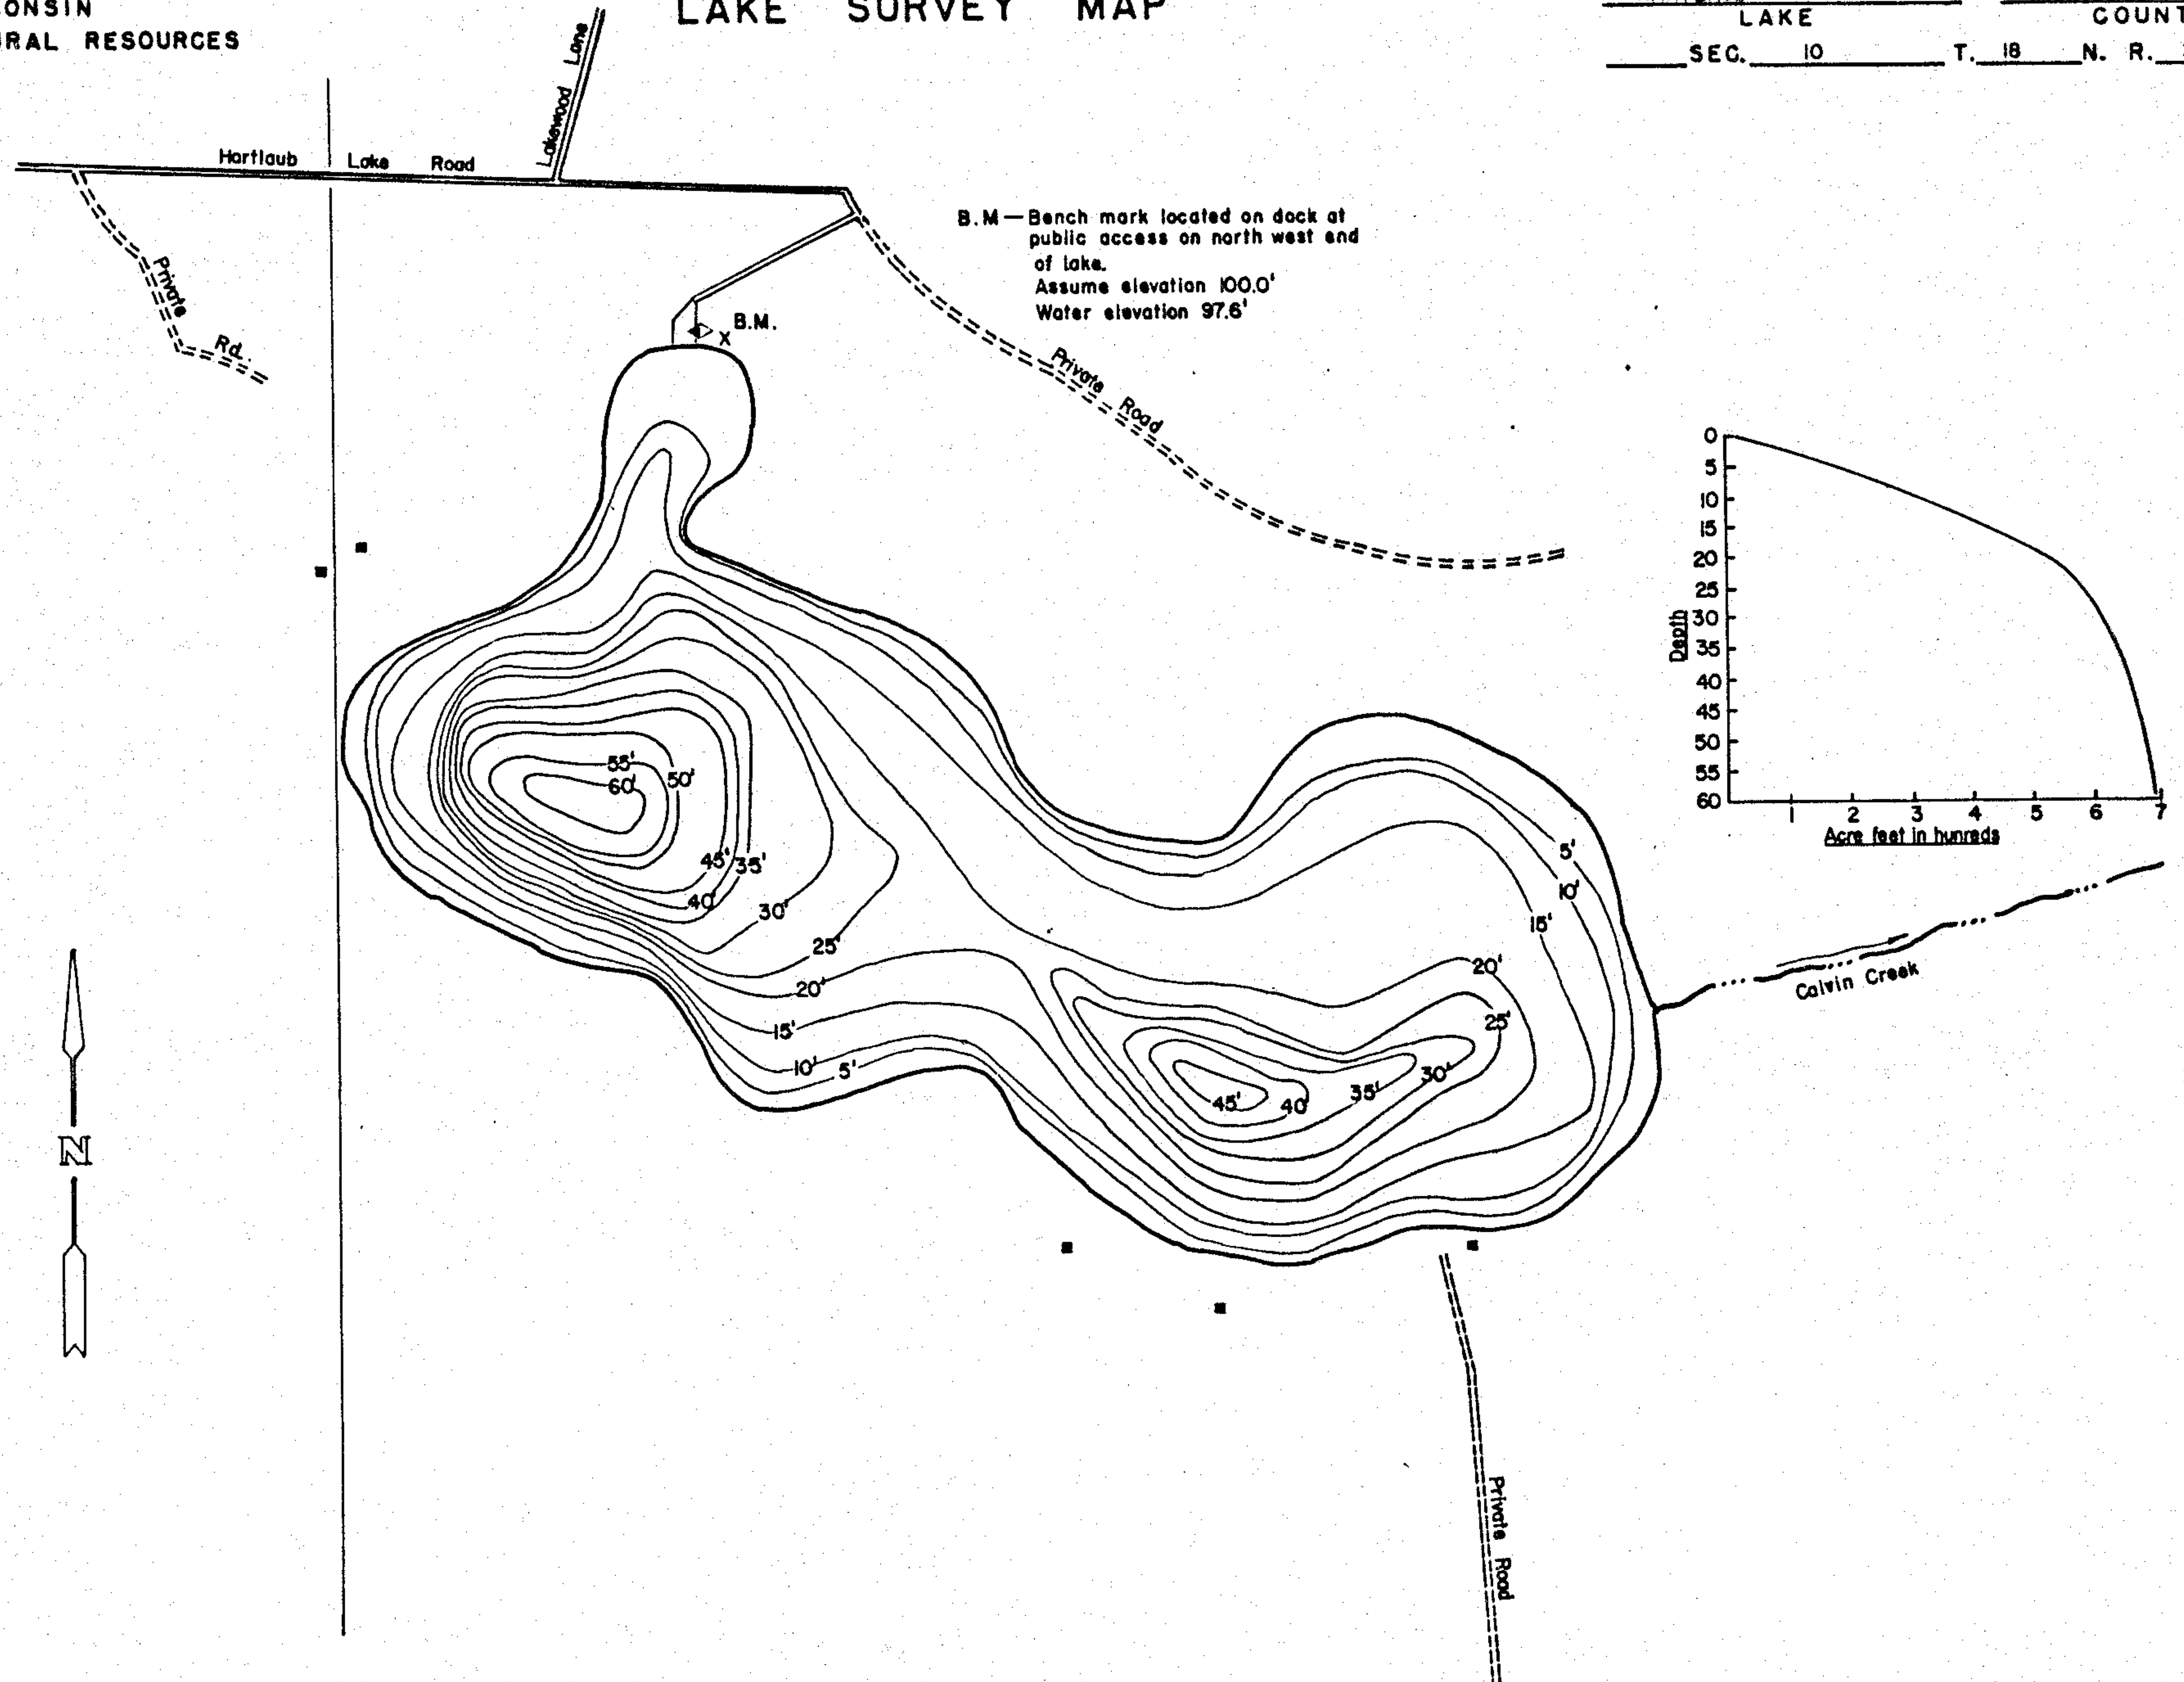
B.M.—Bench mark located on dock at public access on north west end of lake.  
Assume elevation 100.0'  
Water elevation 97.6'

WATER AREA 34.18 ACRES  
 UNDER 5 FT. 43 %  
 OVER 20 FT. 6 %  
 MAX. DEPTH 60 FEET.  
 TOTAL ALK. 120 P.P.M.  
 VOLUME 684.68 ACRE FT.  
 MAIN SHORELINE 1.2 MI.  
 ISLAND SHORELINE \_\_\_\_\_ MI.
